| <b>Owner</b> | <b>Customer</b> | <b>Upstream MH</b> | <b>Downstream MH</b> | <b>Date</b> | <b>Time</b> |
| | | 1RM11 | 1RM18 | 03-13-2019 | 10:54 AM |
| <b>Size</b> | <b>Material</b> | <b>Sewer Use</b> | <b>Purpose</b> | <b>Length</b> | |
| 8 | Vitrified Clay Pipe | Sanitary | Routine Assessment | | |

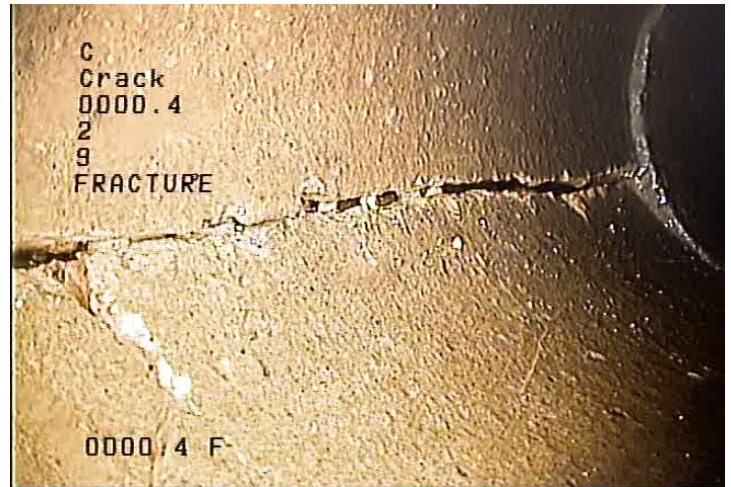
| | Ftg. | Code | Description | Position | Severity | Comment |
|---|---|---|---|---|---|---|
| | 0.4 | C | Crack | 9 | 2 | FRACTURE |

C - Crack @ 0.4 ft. FRACTURE

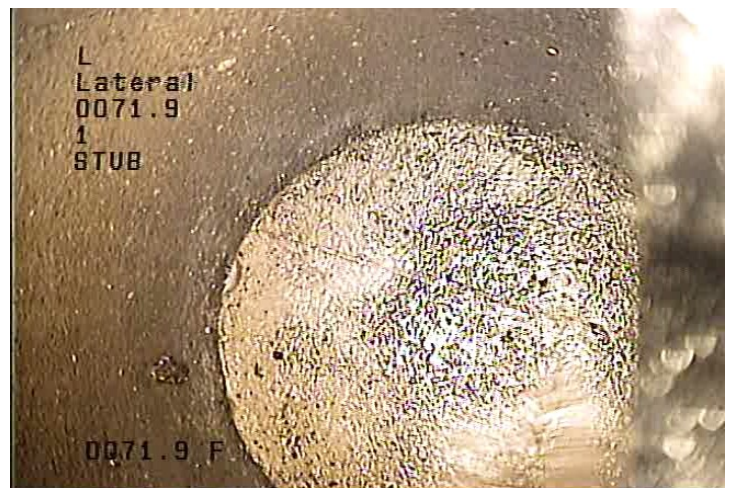
L - Lateral @ 71.9 ft. STUB

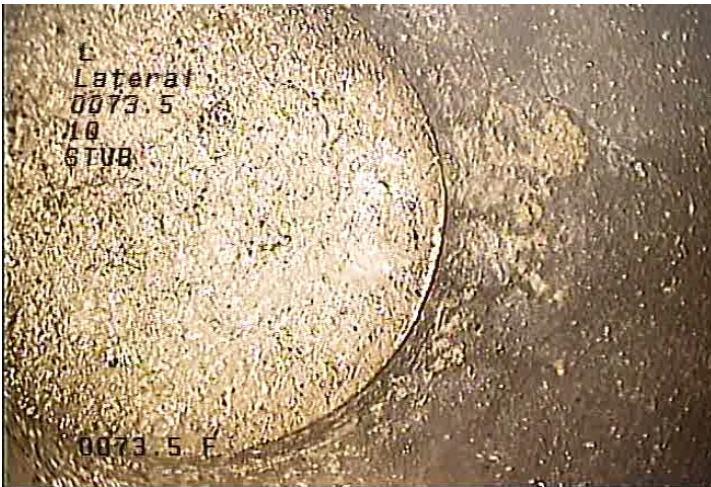
L - Lateral @ 73.5 ft. STUB

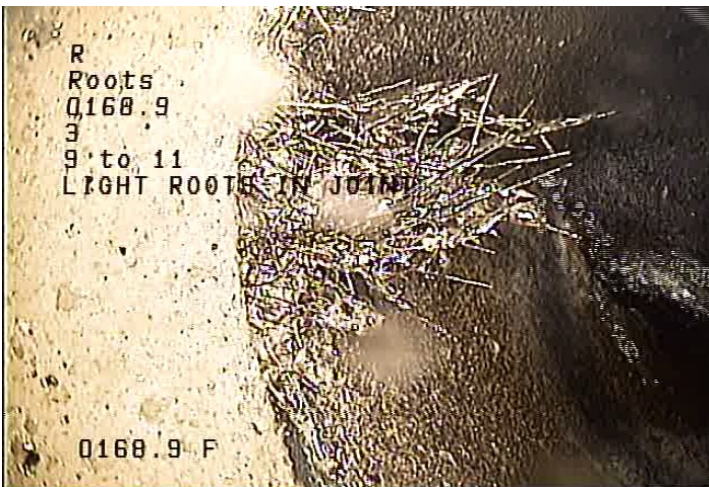
| | Ftg. | Code | Description | Position | Severity | Comment |
|---|---|---|---|---|---|---|
| | 168.9 | R | Roots | 9 to 11 | 3 | LIGHT ROOTS IN JOINT |

R - Roots @ 168.9 ft. LIGHT ROOTS IN JOINT

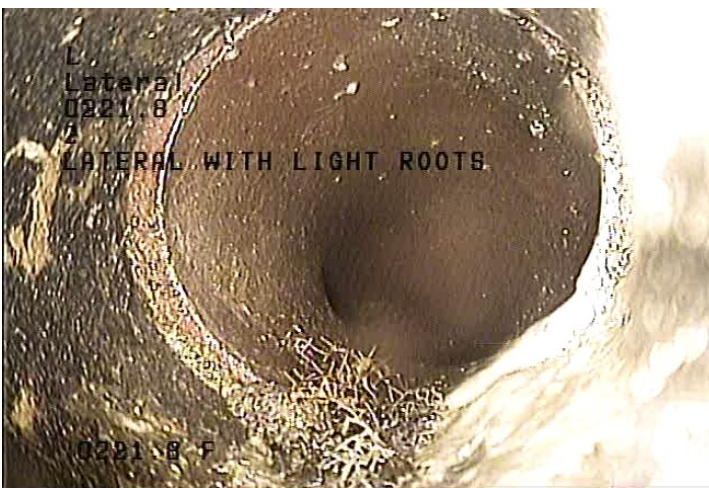
L - Lateral @ 221.8 ft. LATERAL WITH LIGHT ROOTS

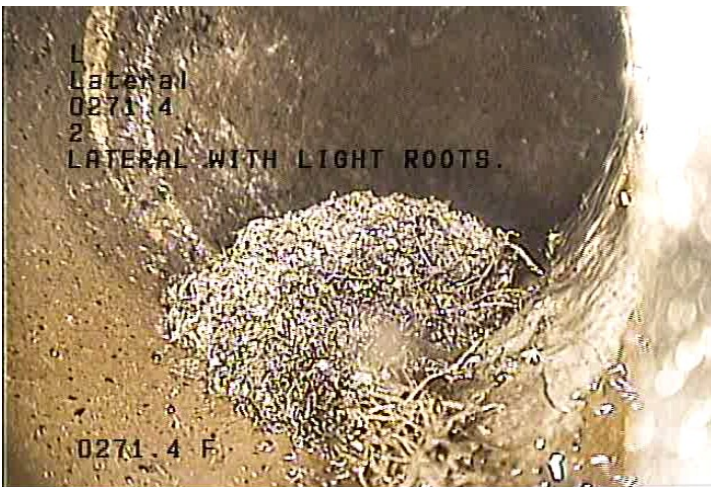
L - Lateral @ 271.4 ft. LATERAL WITH LIGHT ROOTS.
