Protocol of recordings

Date 24/02/2022
Recording 1RM25- 1RM37 Illinois 8 in clay downstream 2-24-2022

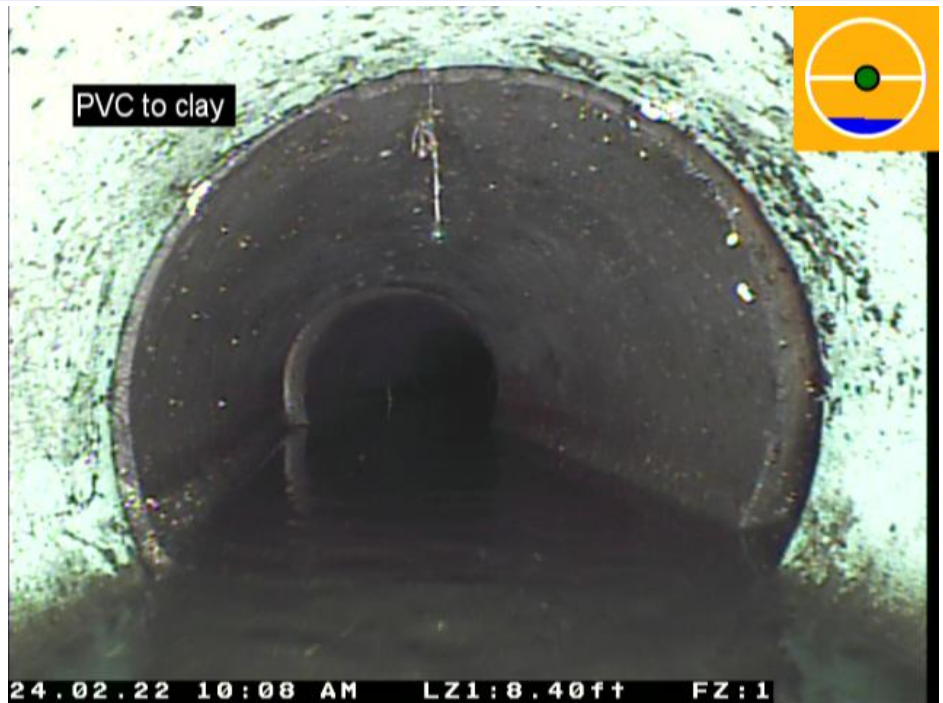
Picture 001

PVC to clay

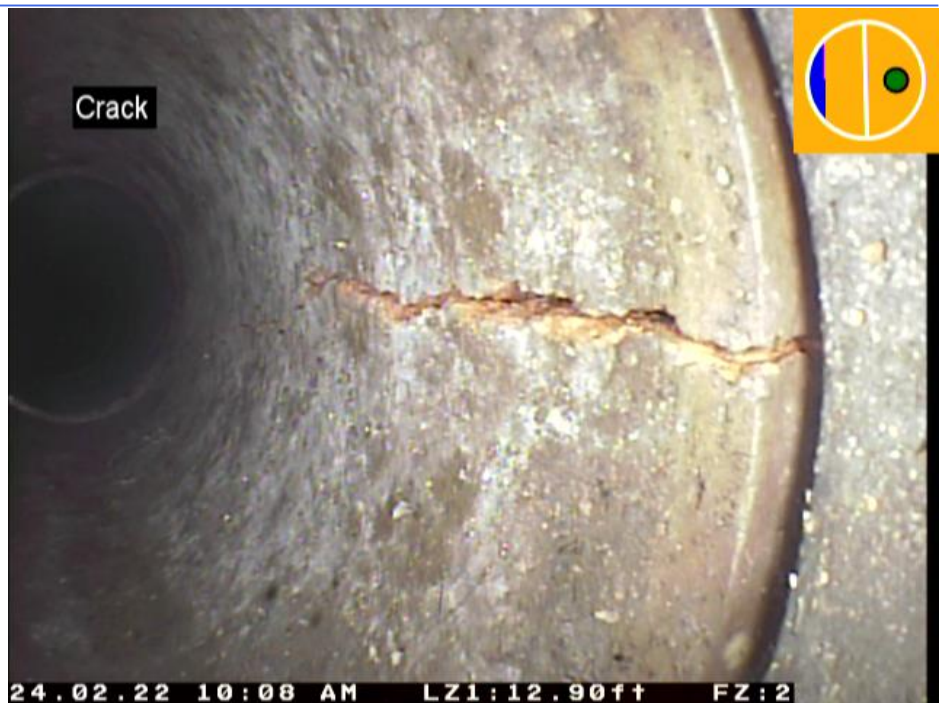
Picture 002

Crack

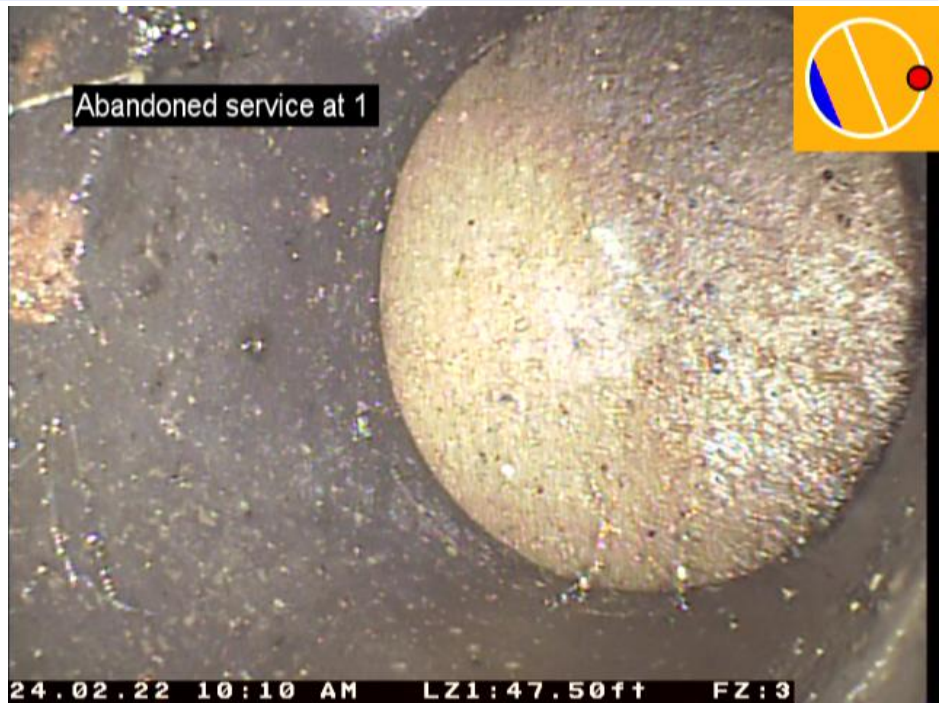
Picture 003

Abandoned service at 1

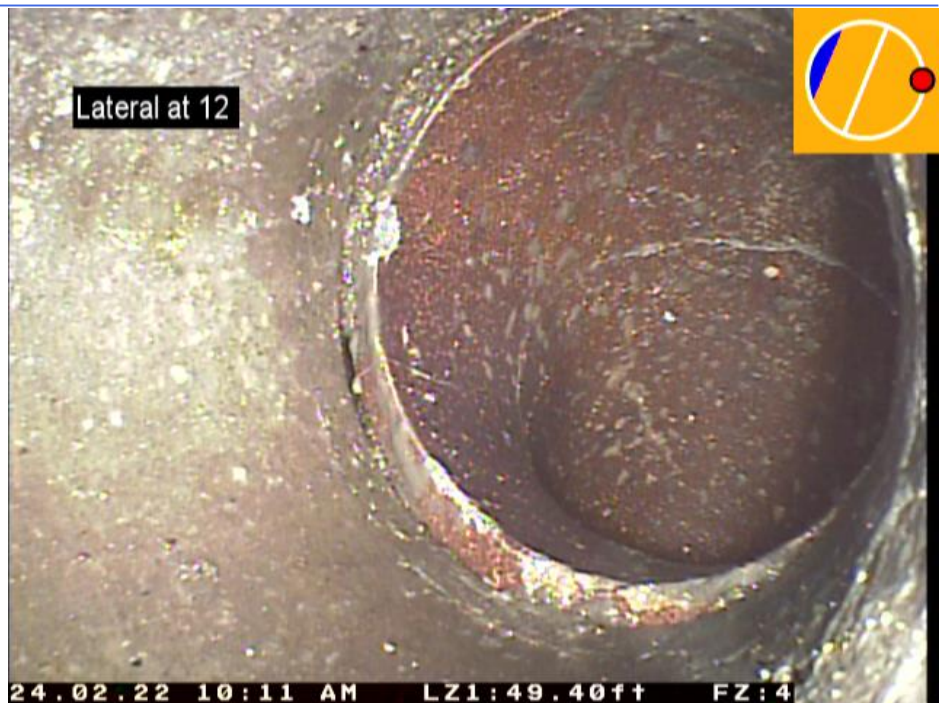
Picture 004

Lateral at 12

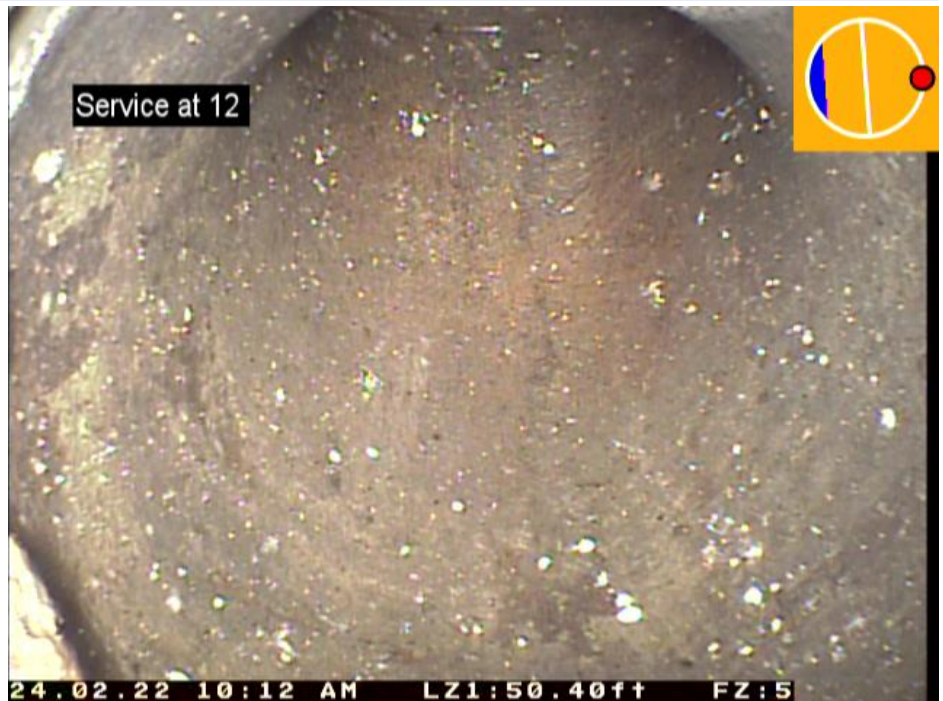
Picture 005

Service at 12

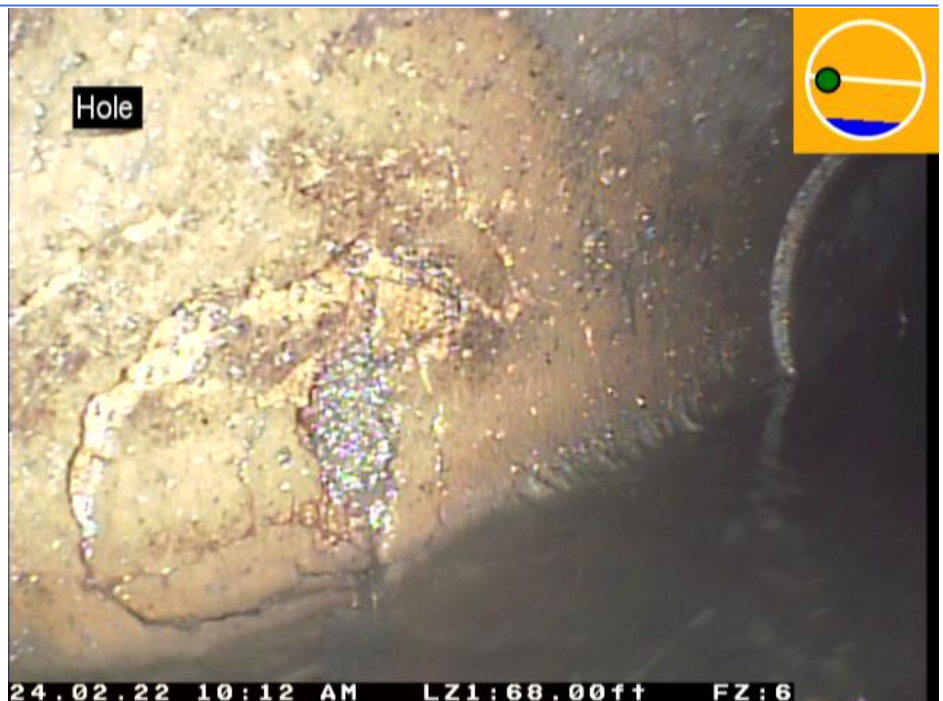
Picture 006

Hole

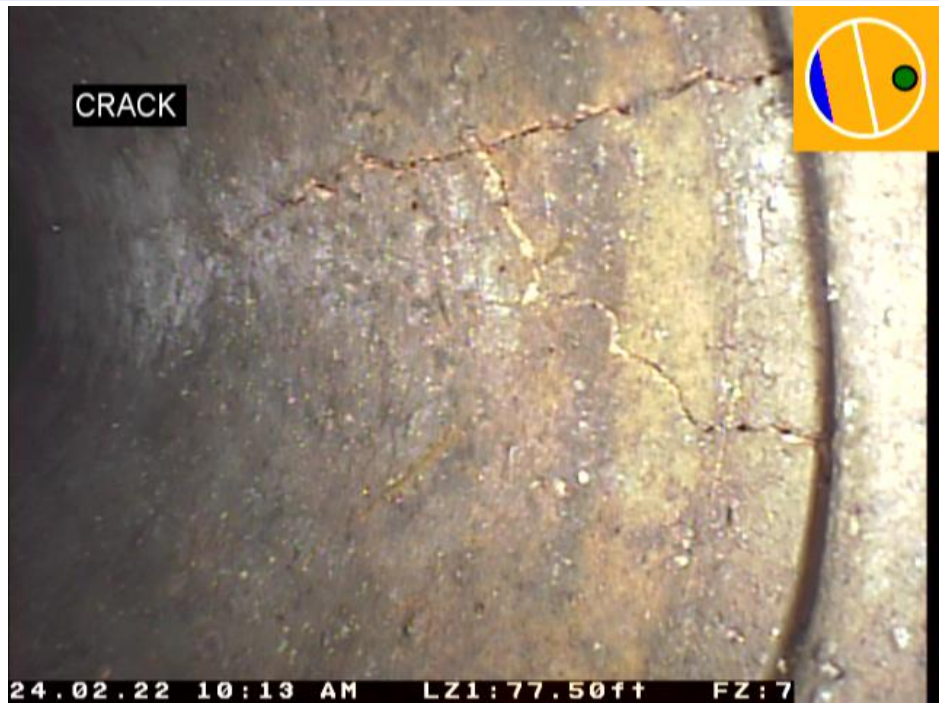
Picture 007

CRACK

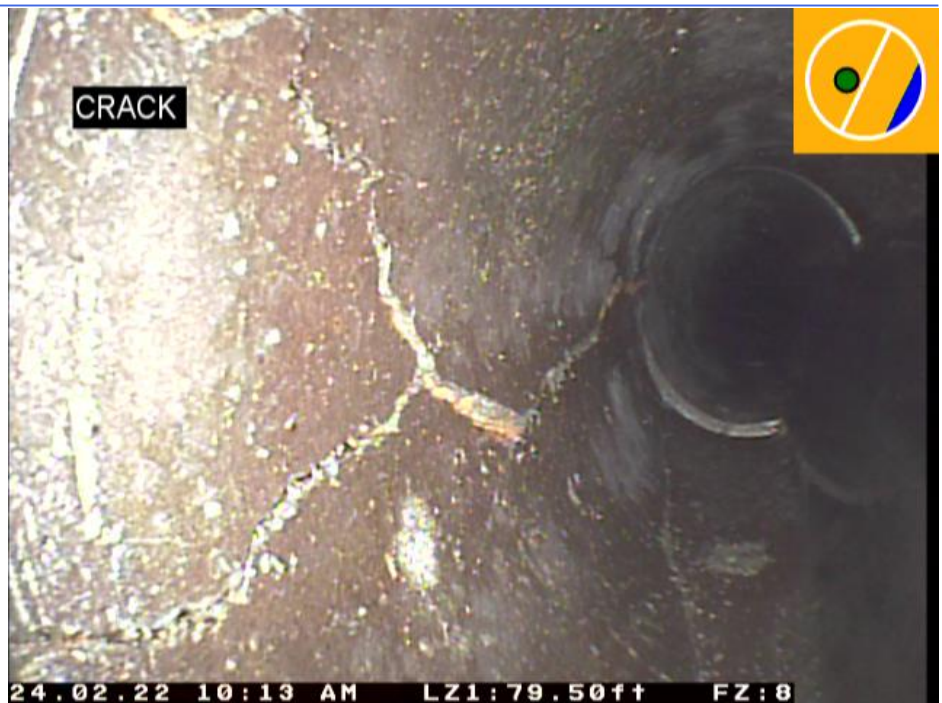
Picture 008

CRACK

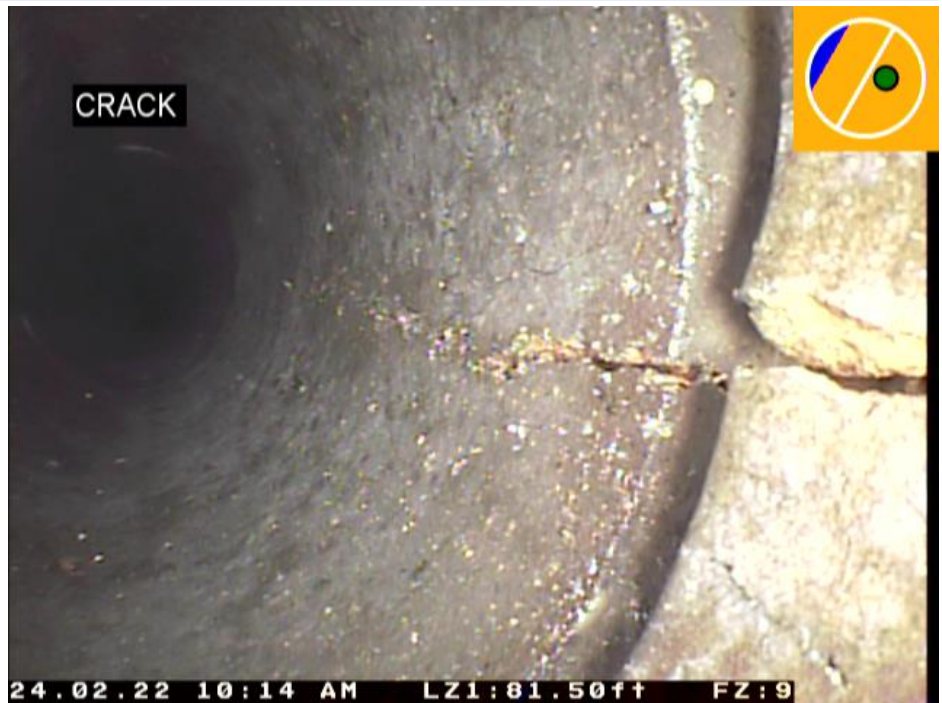
Picture 009

CRACK

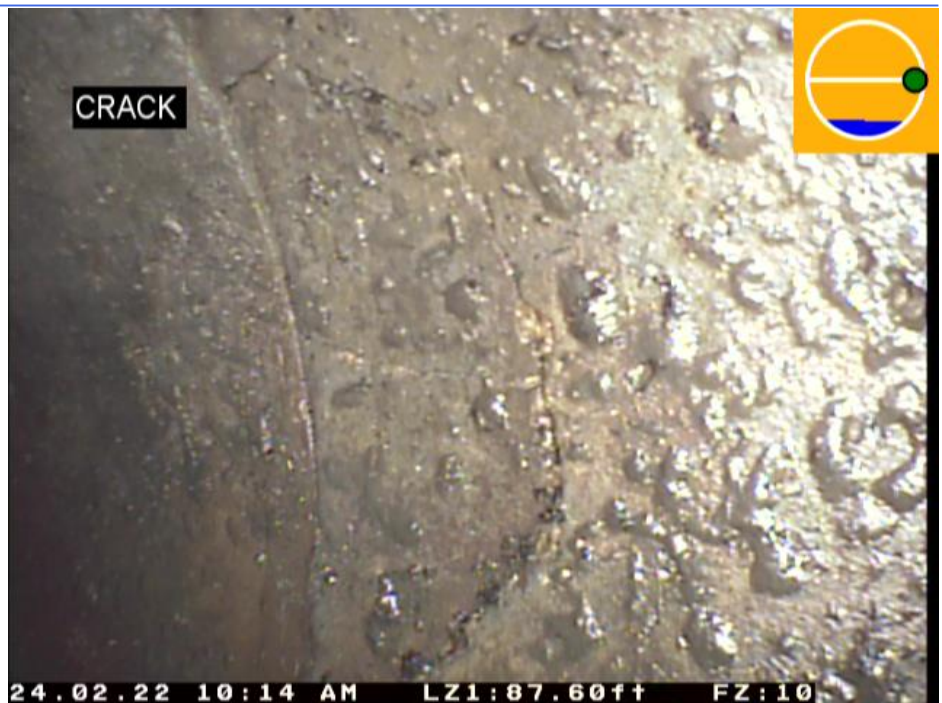
Picture 010

CRACK

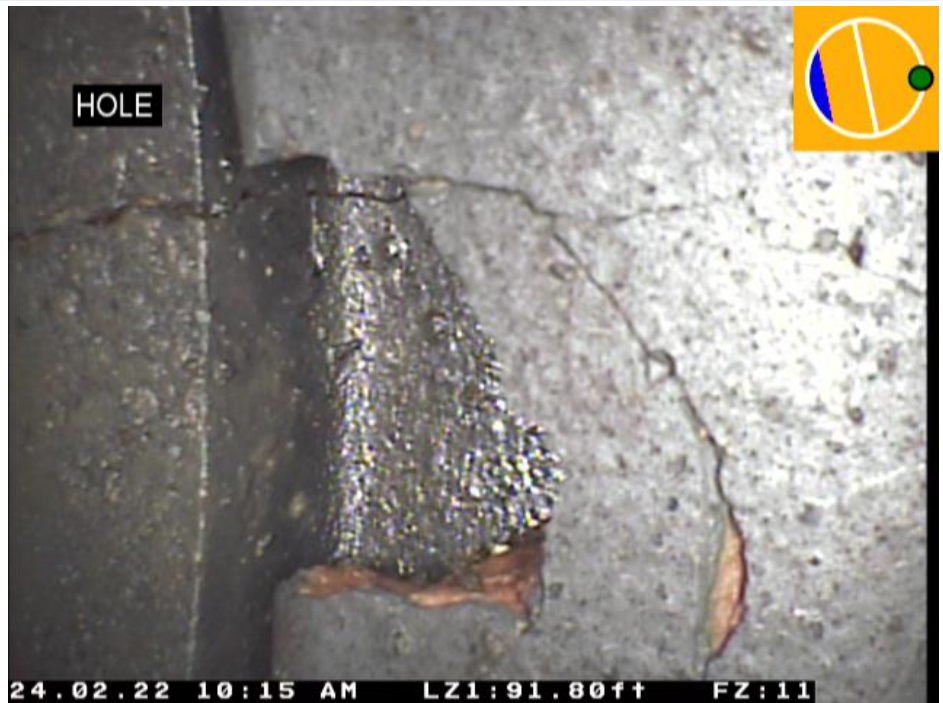
Picture 011

HOLE

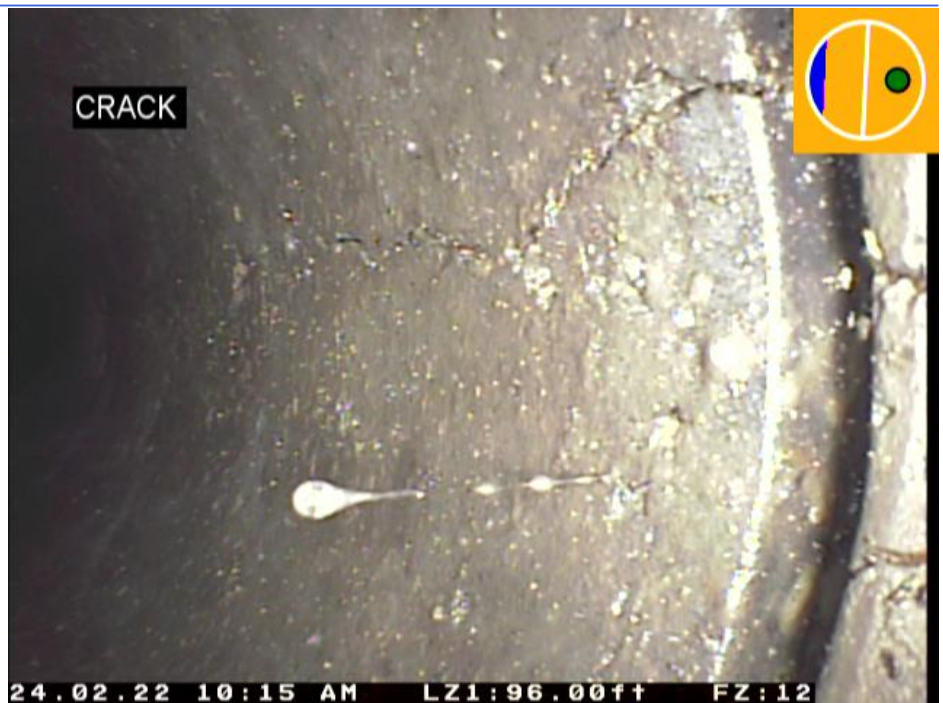
Picture 012

CRACK

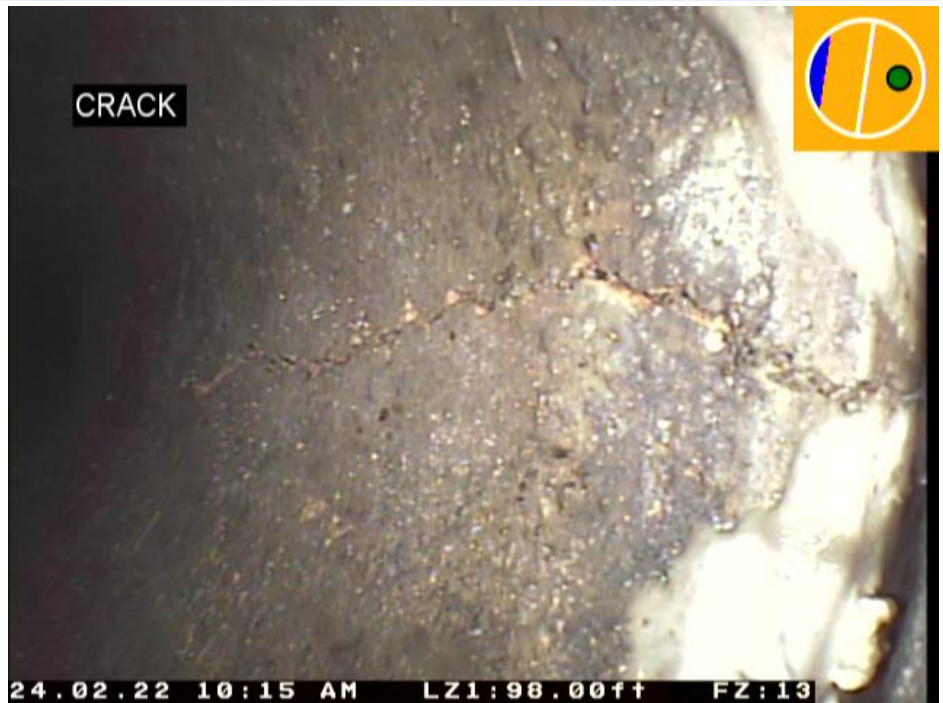
Picture 013

CRACK

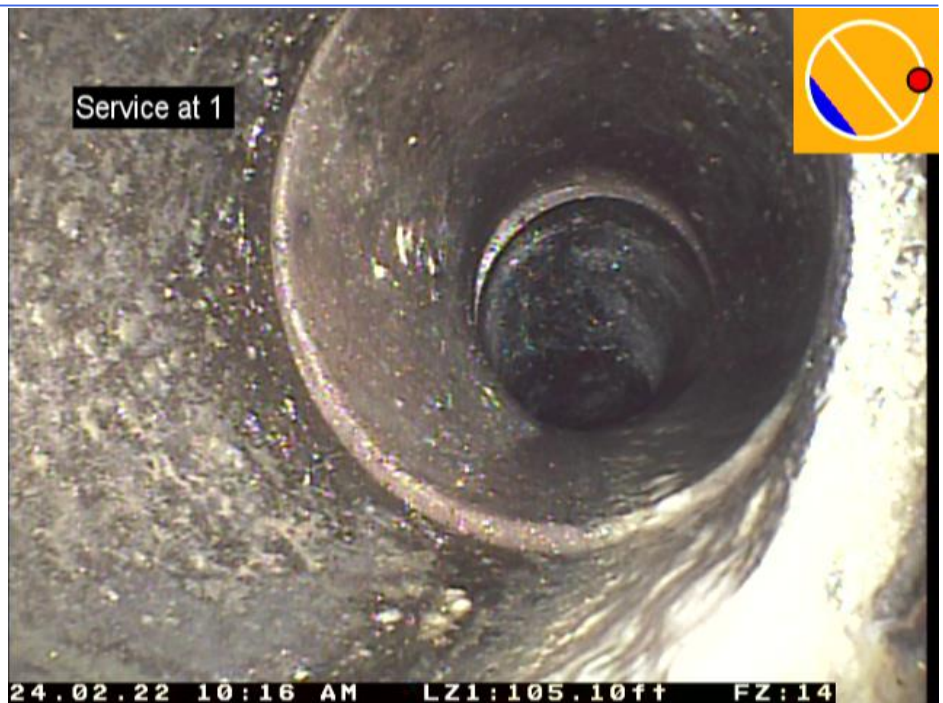
Picture 014

Service at 1

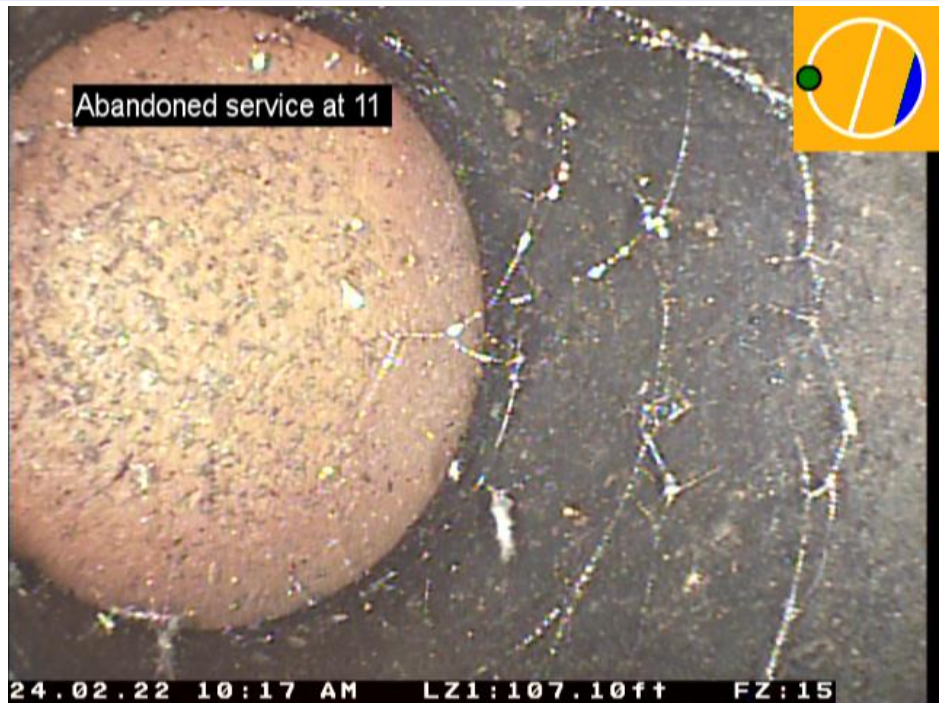
Picture 015

Abandoned service at 11

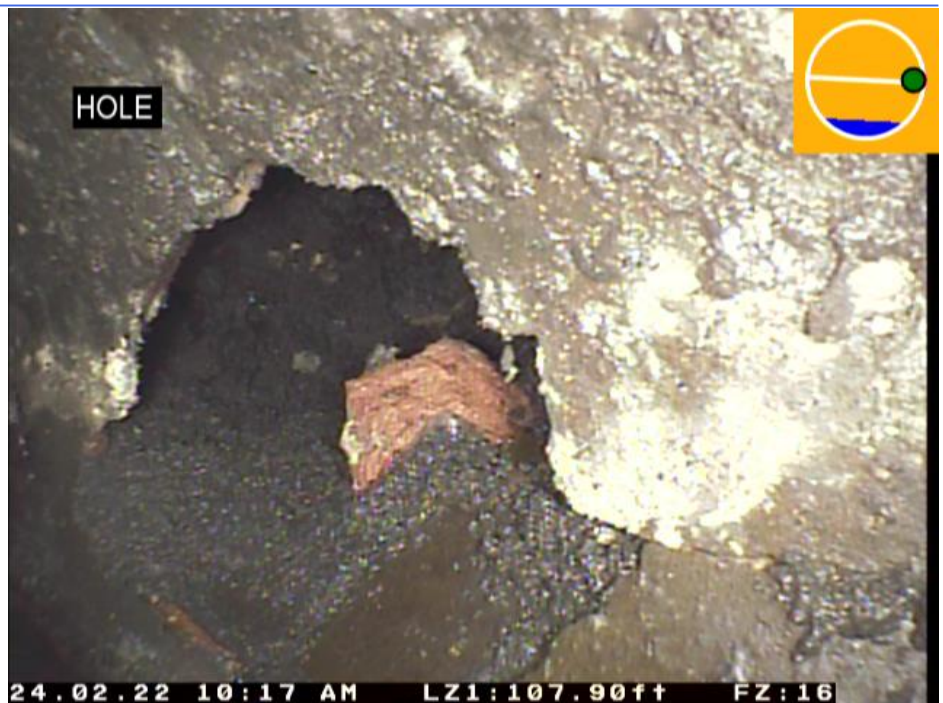
Picture 016

HOLE

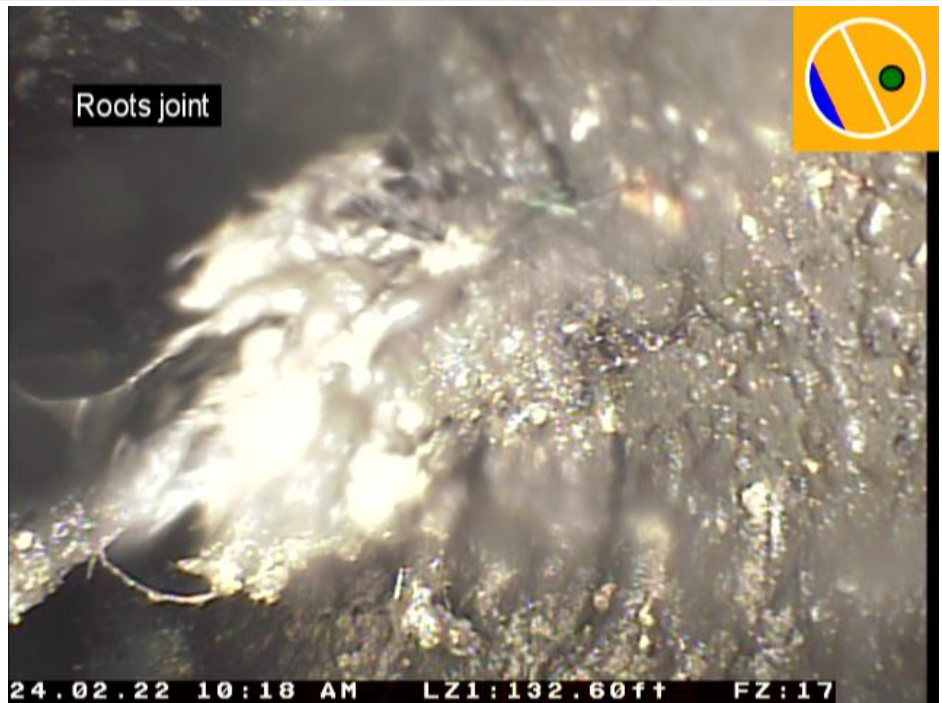
Picture 017

Roots joint

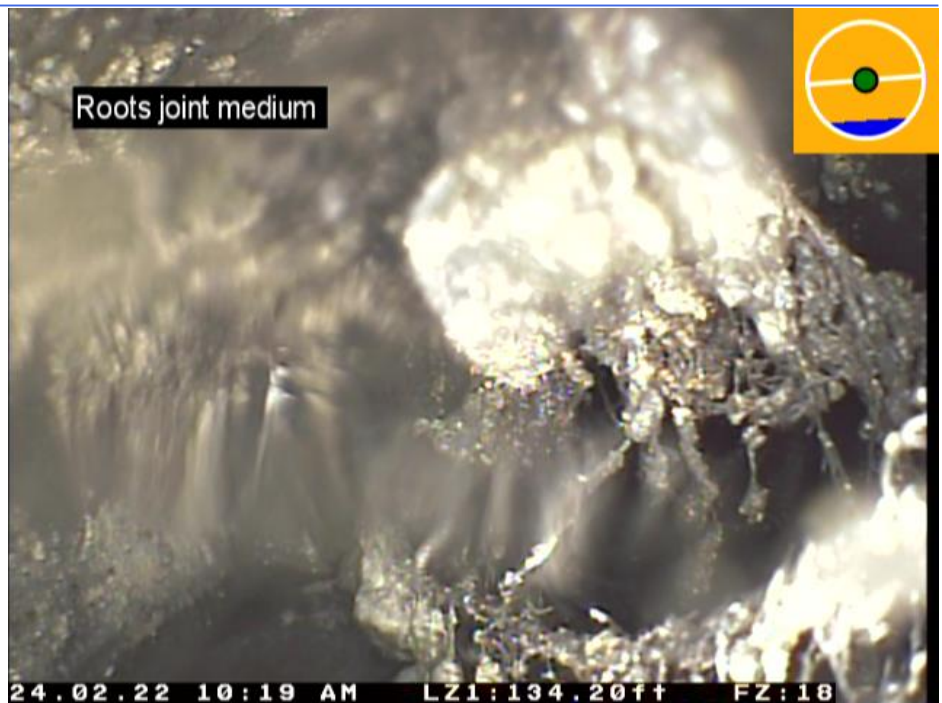
Picture 018

Roots joint medium

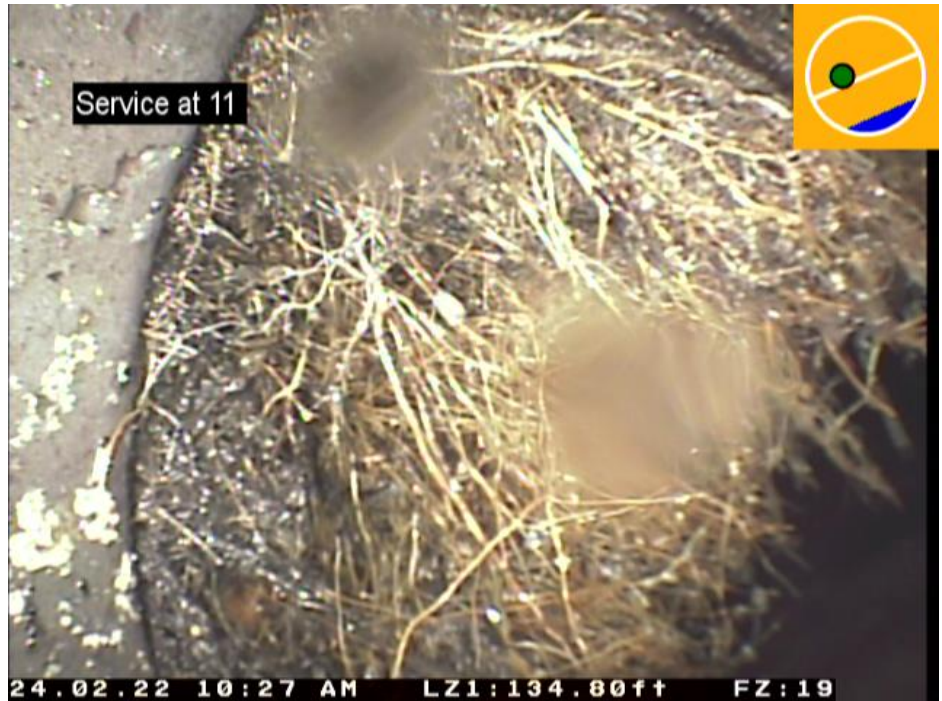
Picture 019

Service at 11

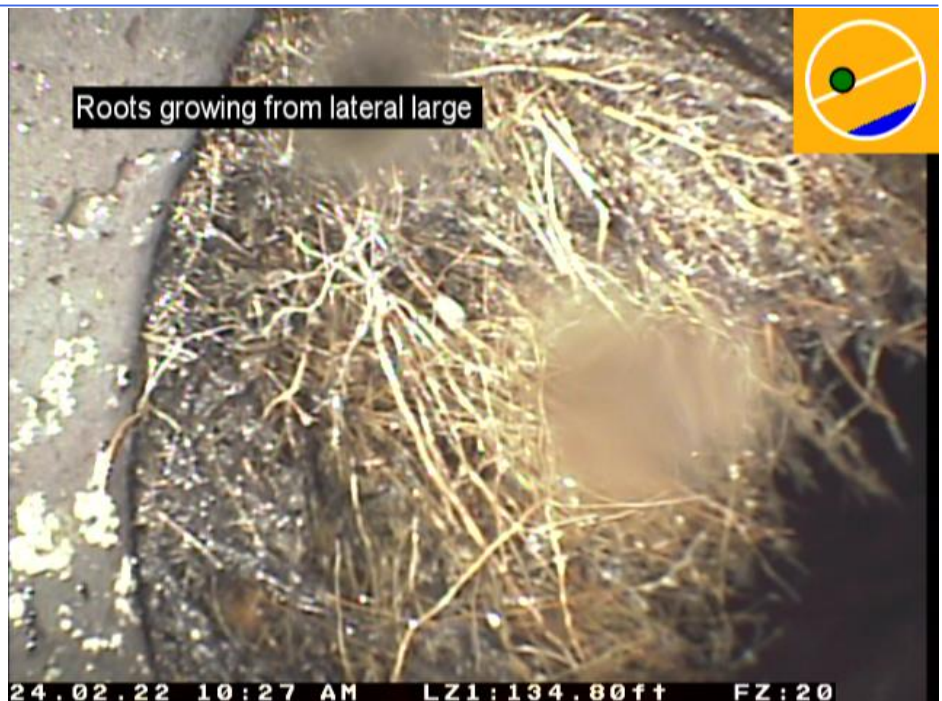
Picture 020

Roots growing from lateral large

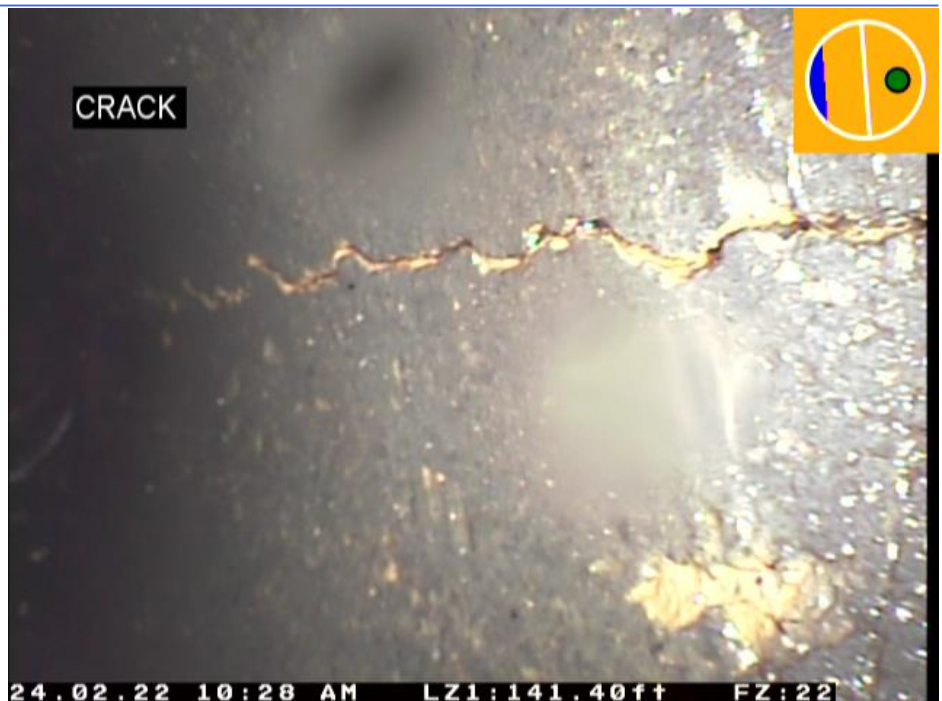
Picture 022

CRACK

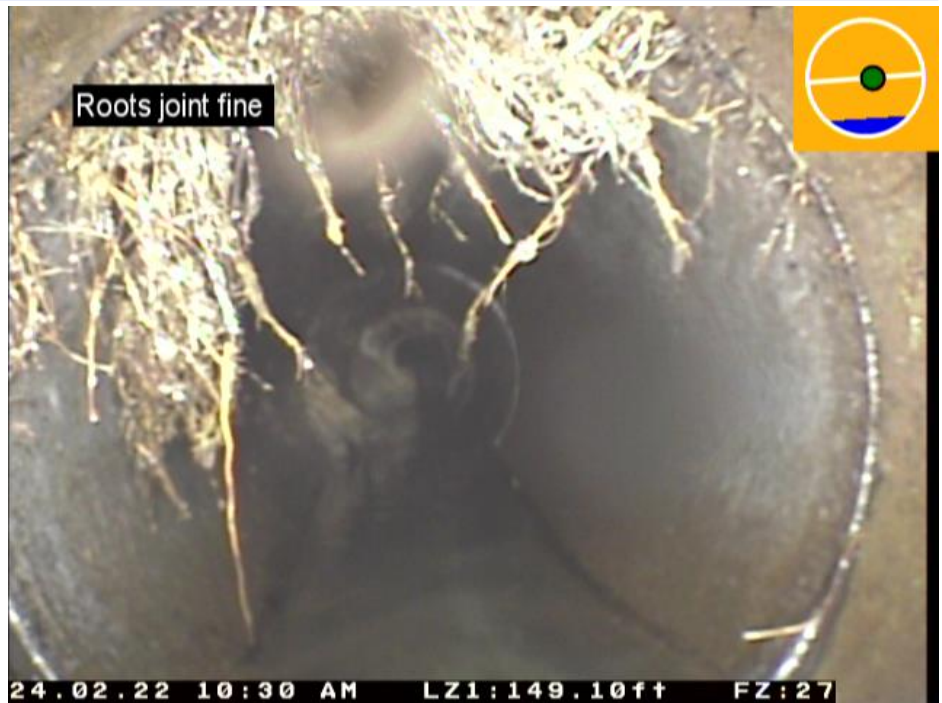
Picture 027

Roots joint fine

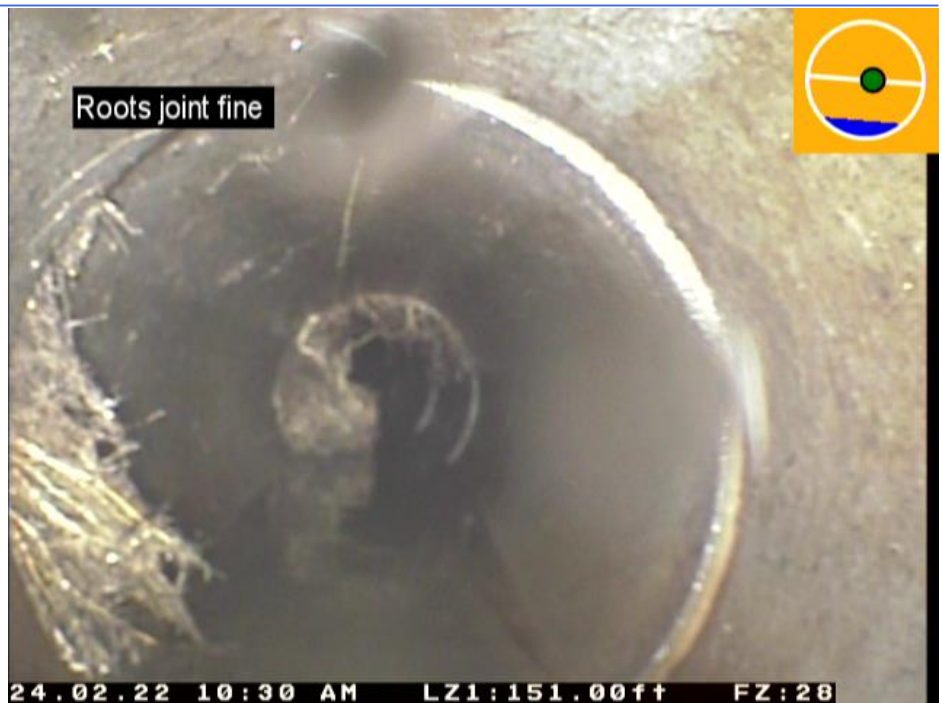
Picture 028

Roots joint fine

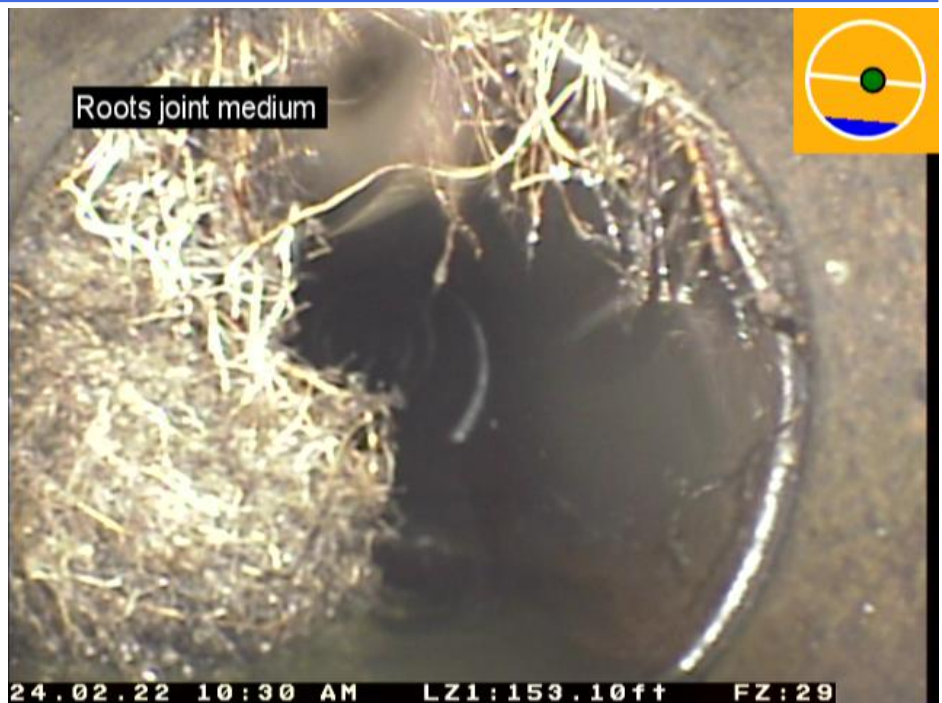
Picture 029

Roots joint medium

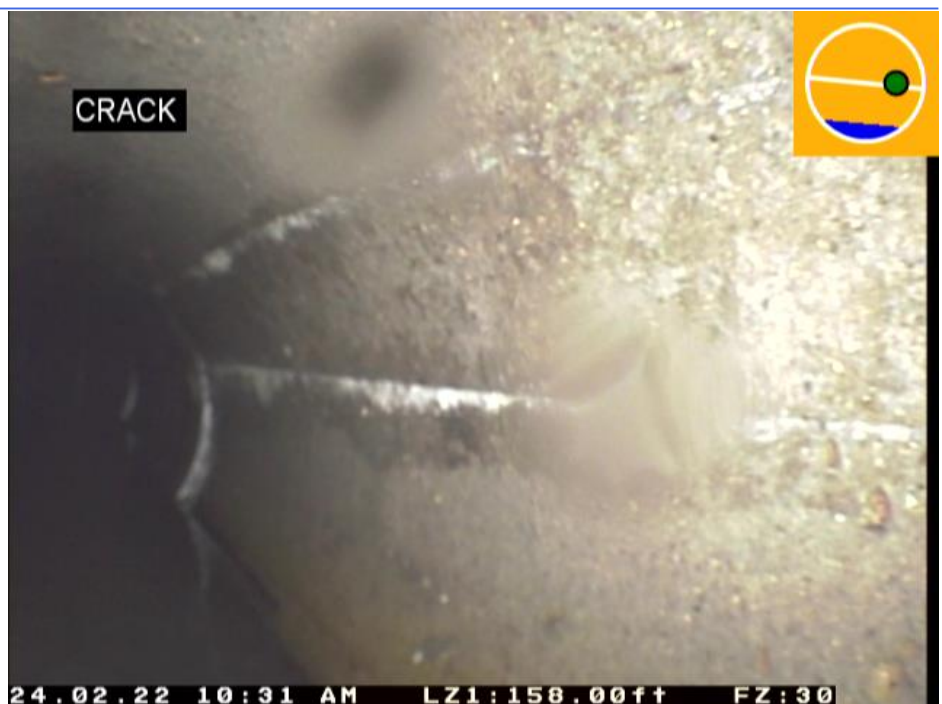
Picture 030

CRACK

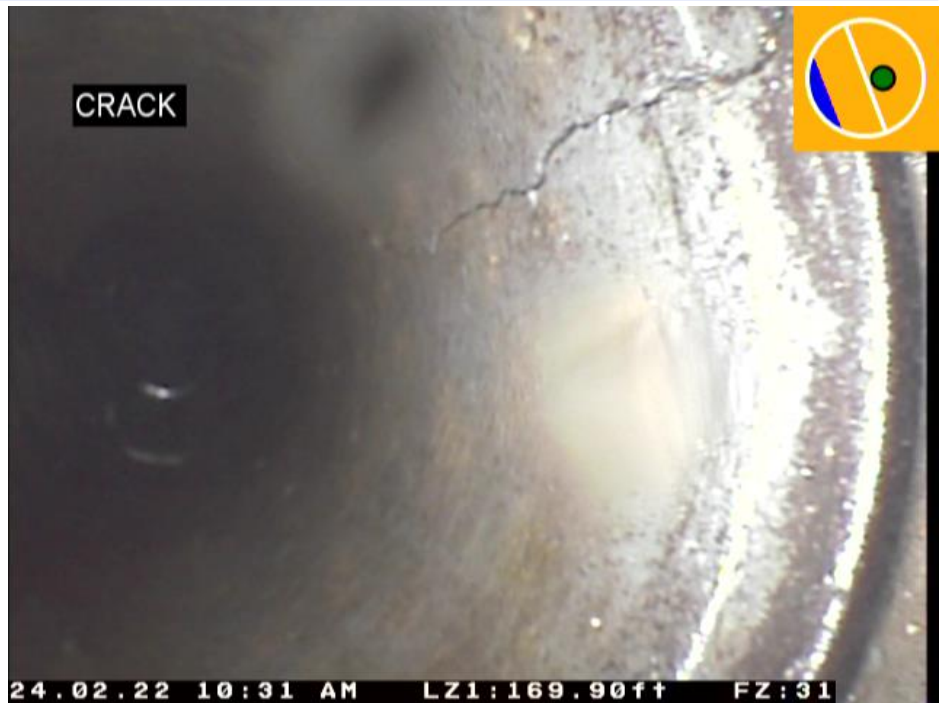
Picture 031

CRACK

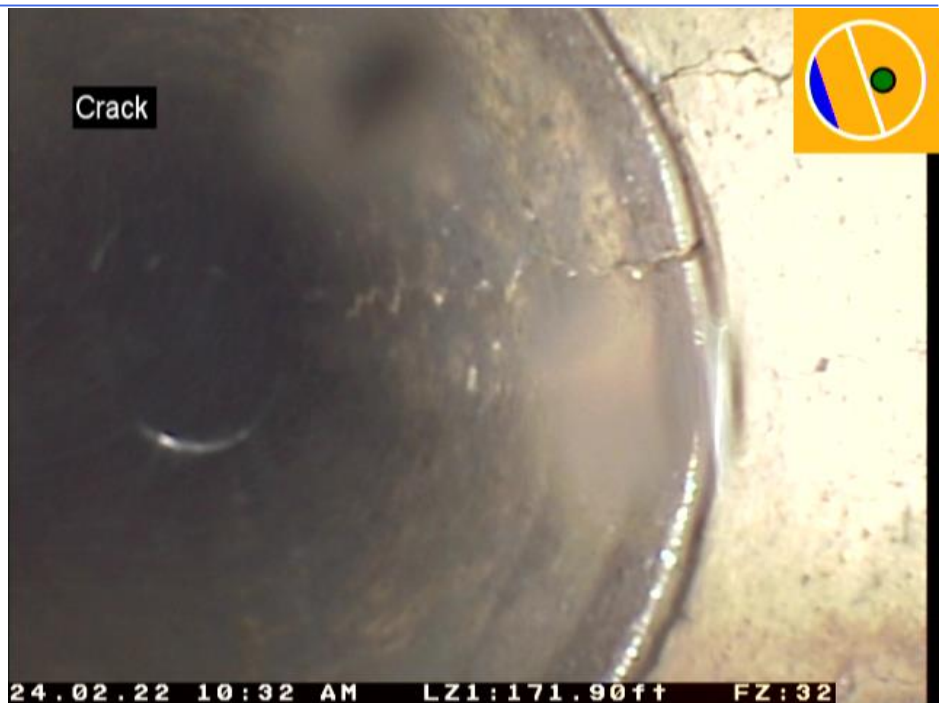
Picture 032

Crack

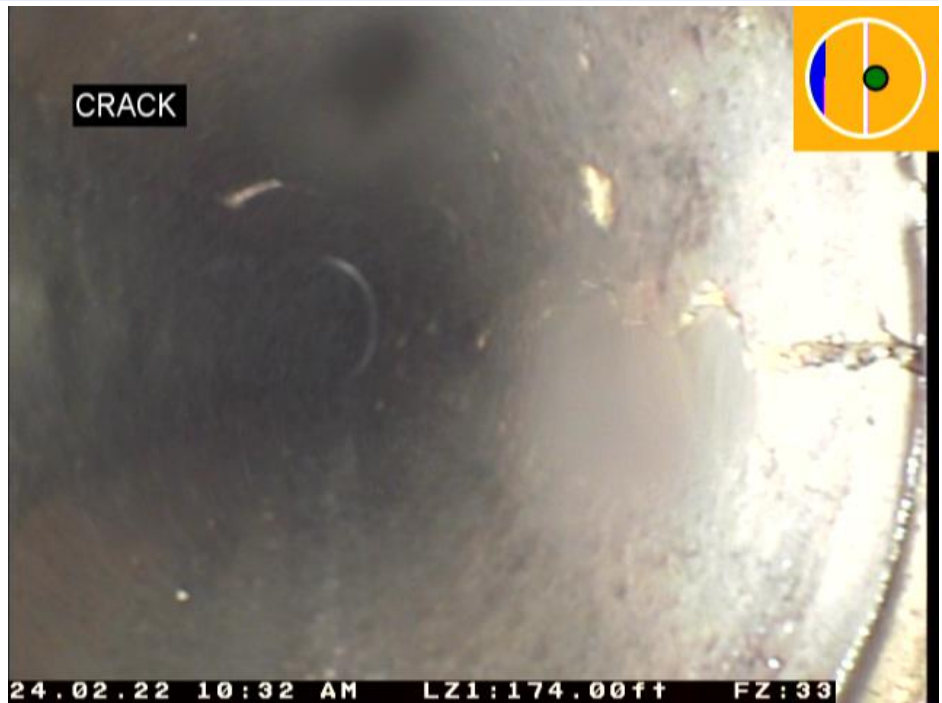
Picture 033

CRACK

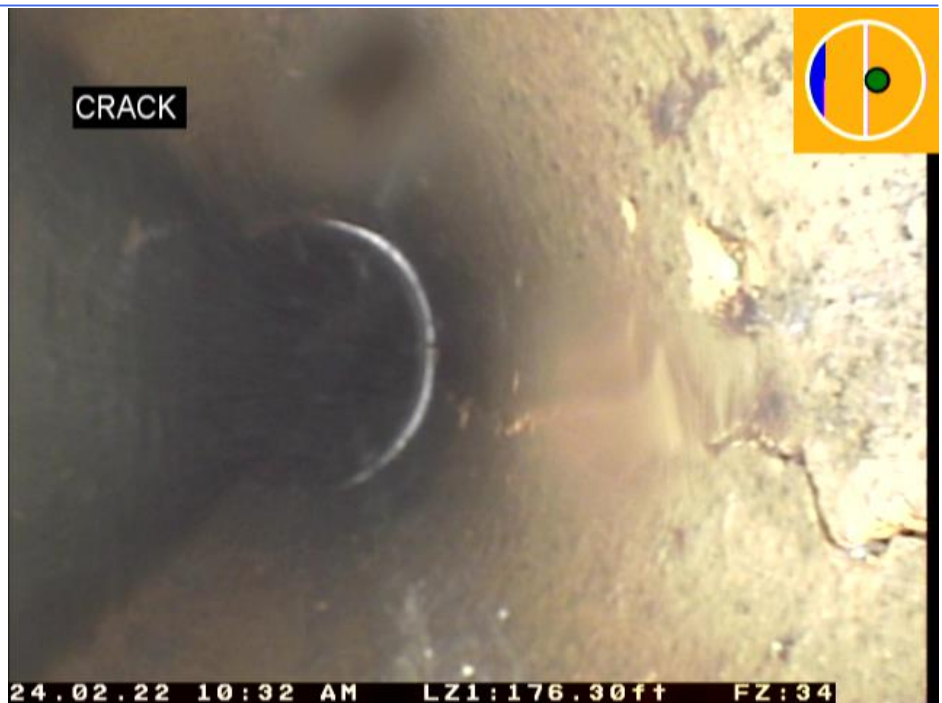
Picture 034

CRACK

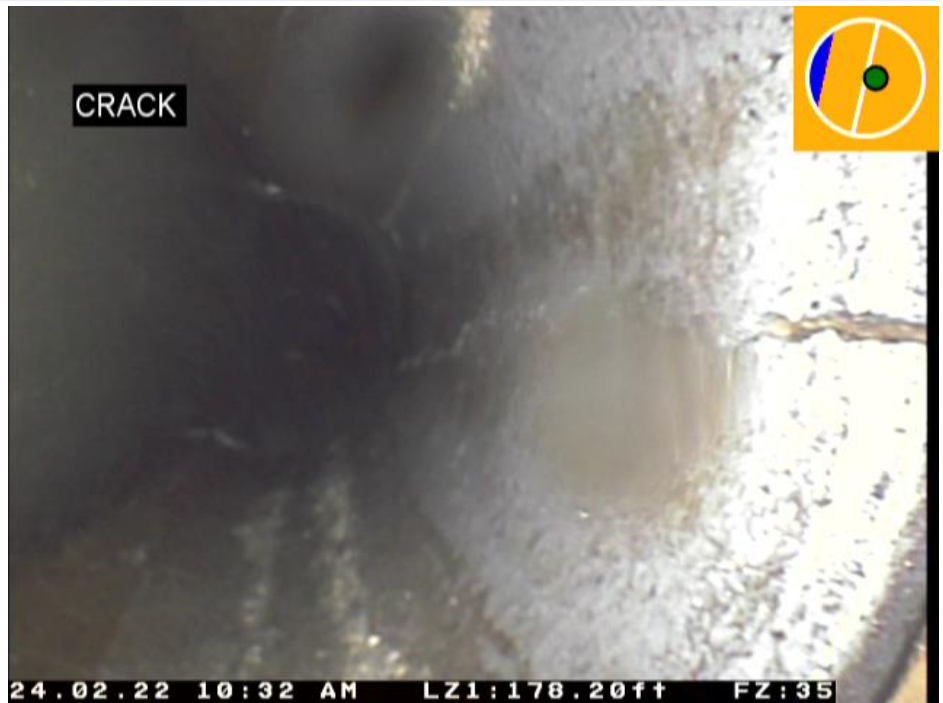
Picture 035

CRACK

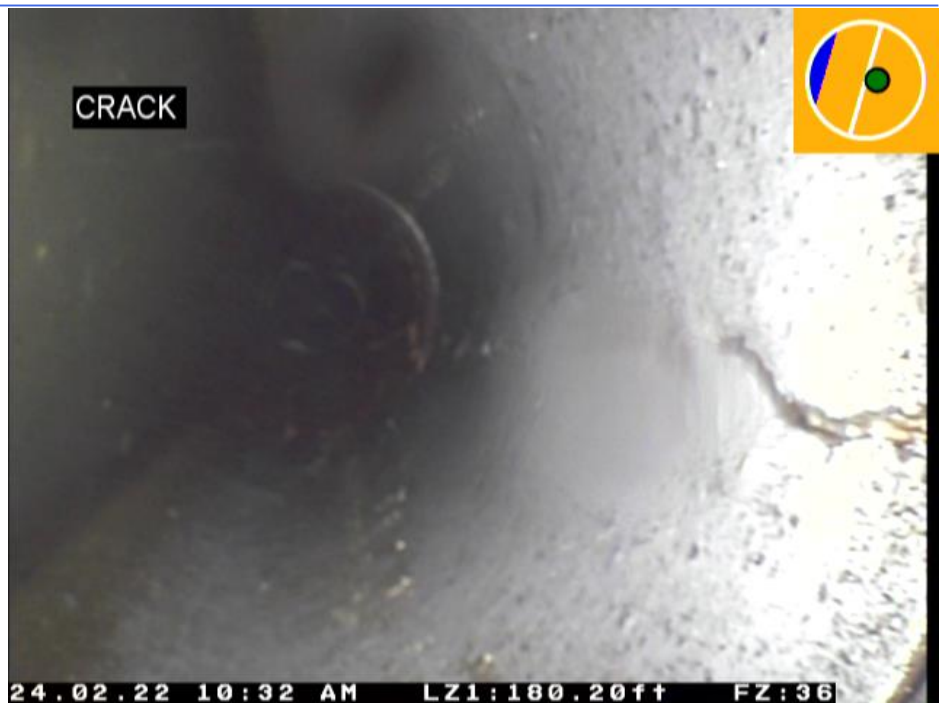
Picture 036

CRACK

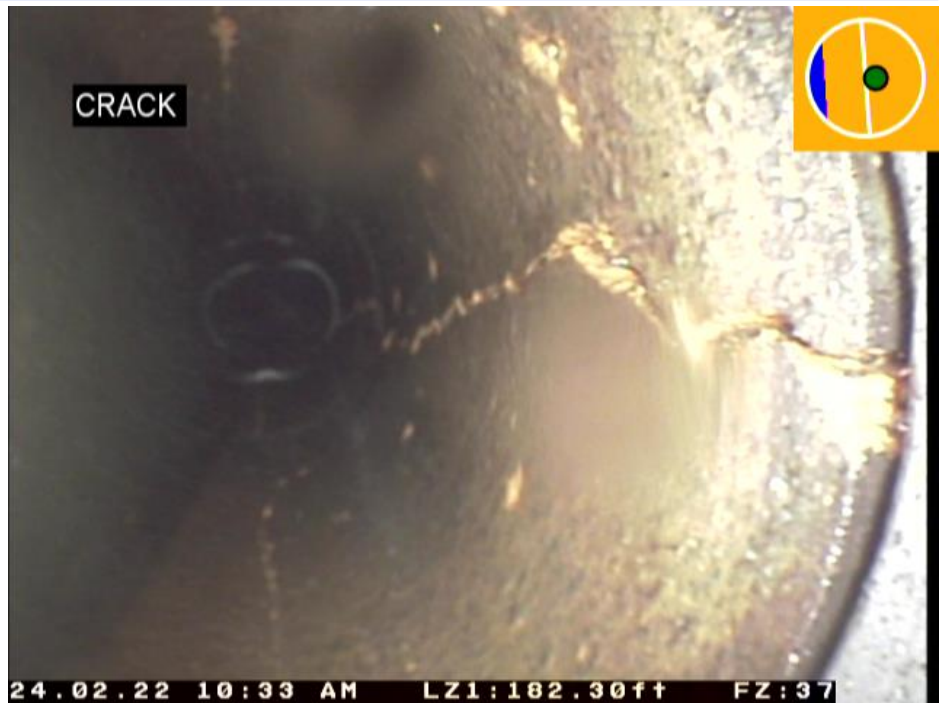
Picture 037

CRACK

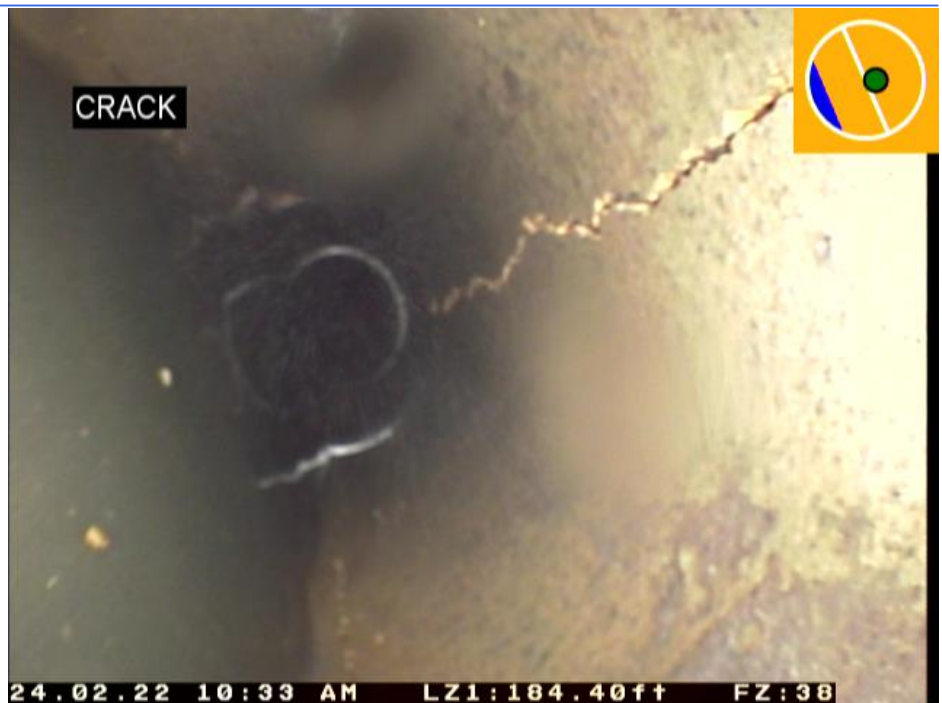
Picture 038

CRACK

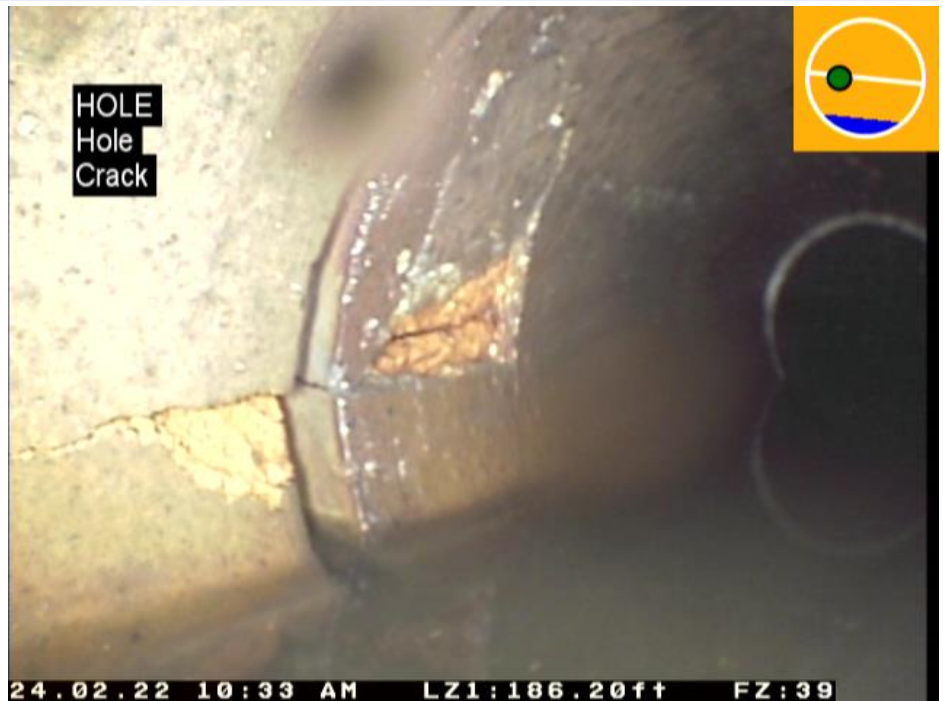
Picture 039
Video 00:21:28
Distance 186.20 m
HOLE, Hole, Crack

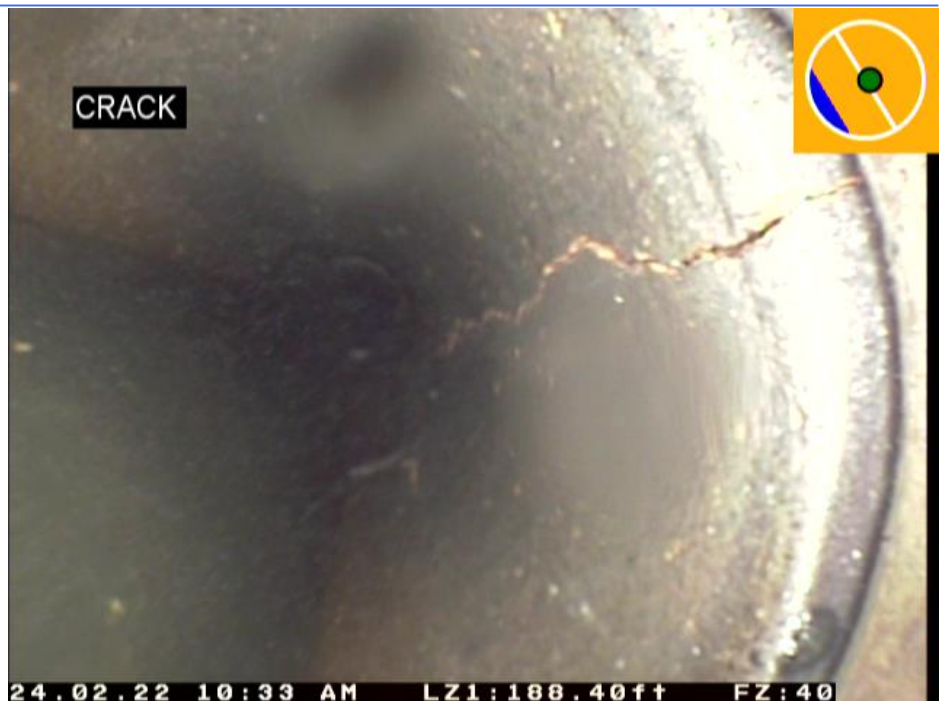
Picture 040
Video 00:21:37
Distance 188.40 m
CRACK
