Protocol of recordings

Date 24/02/2022
Recording 1RM25- 1RM37 Illinois 8 in clay downstream 2-24-2022

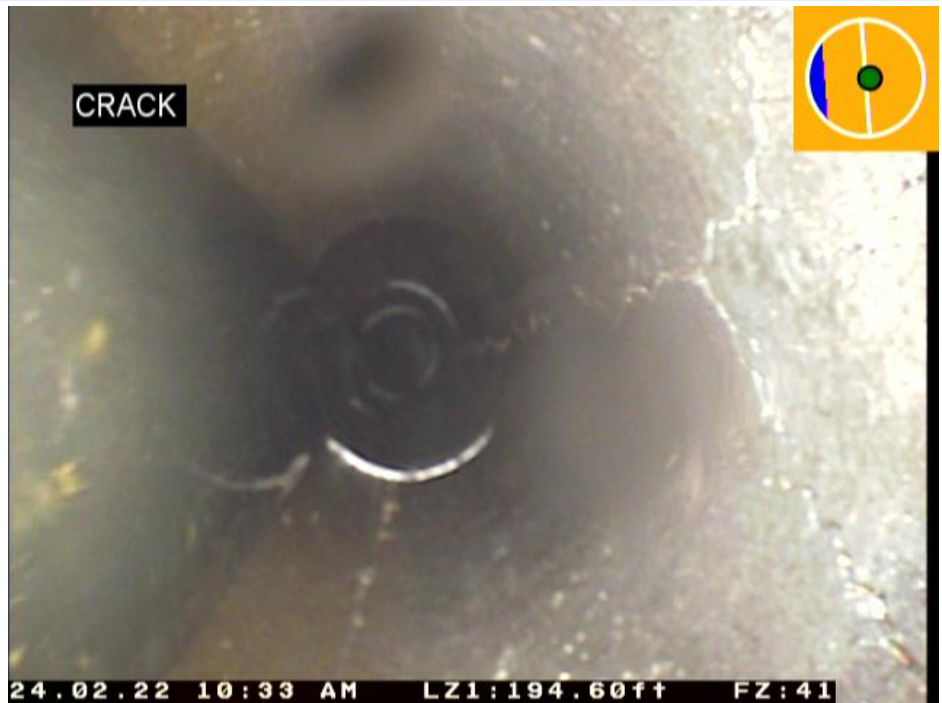
Picture 041

CRACK

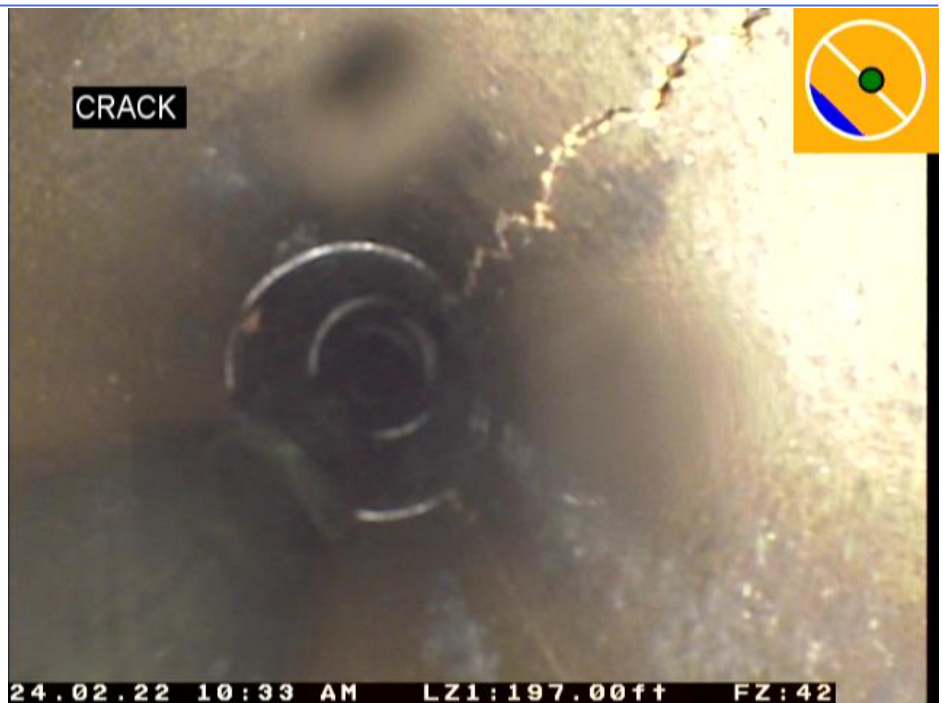
Picture 042

CRACK

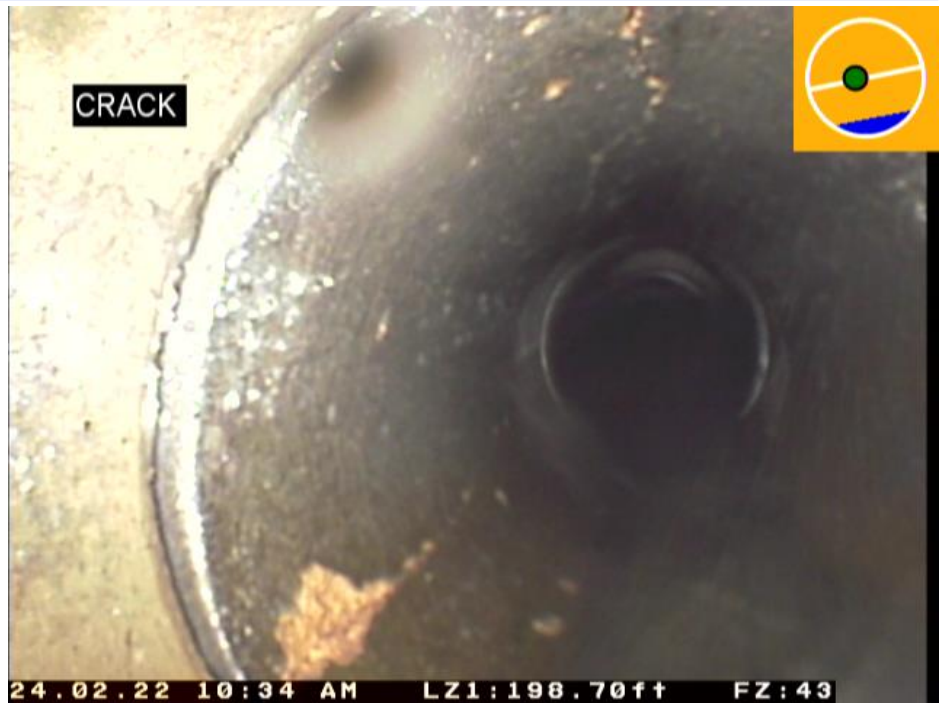
Picture 043

CRACK

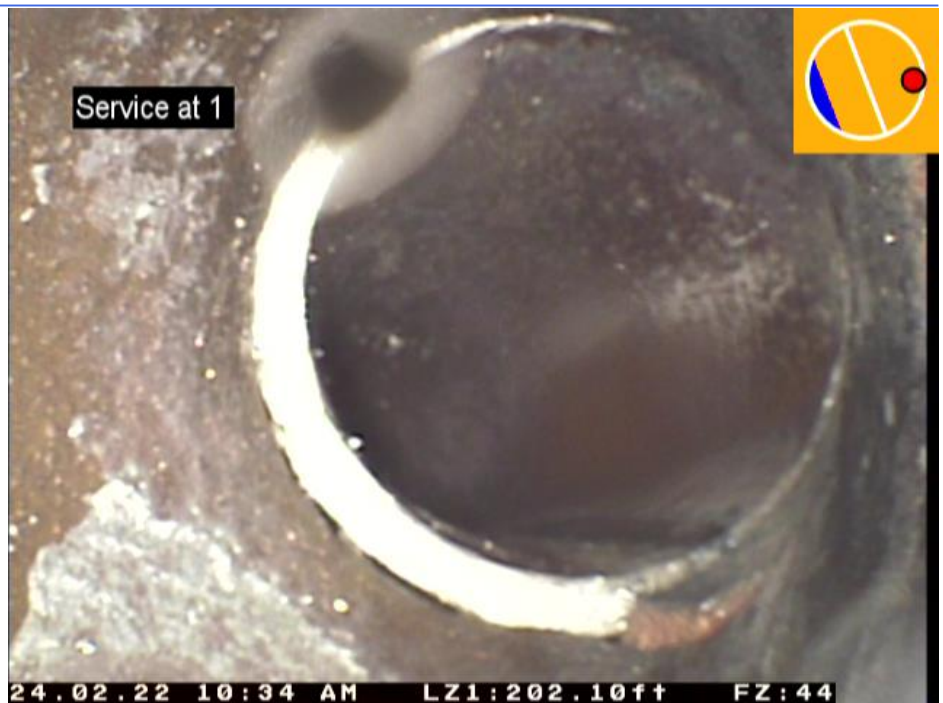
Picture 044

Service at 1

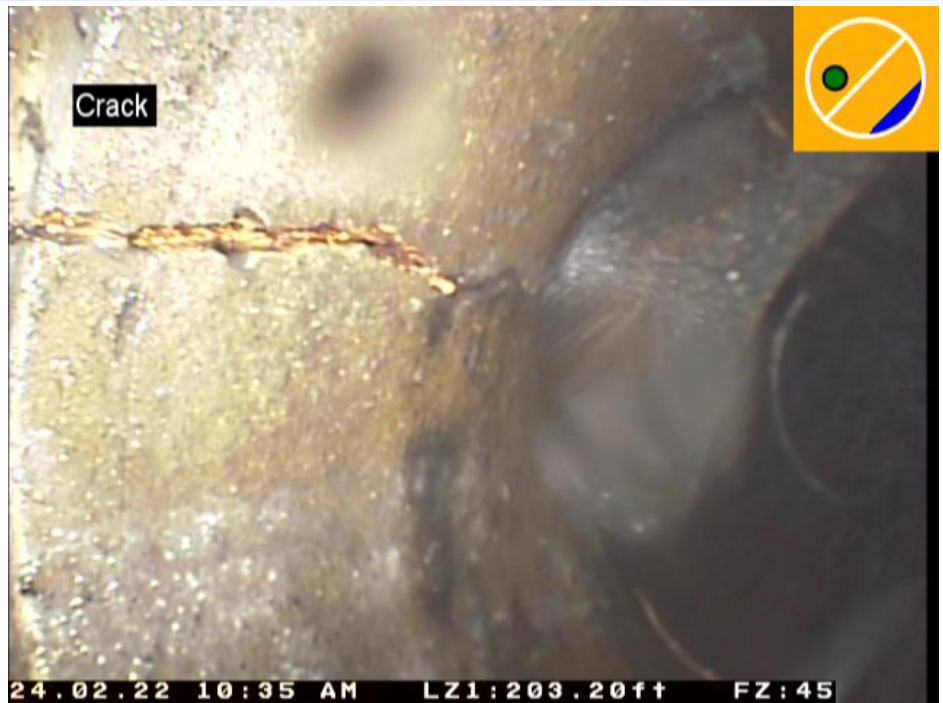
Picture 045

Crack

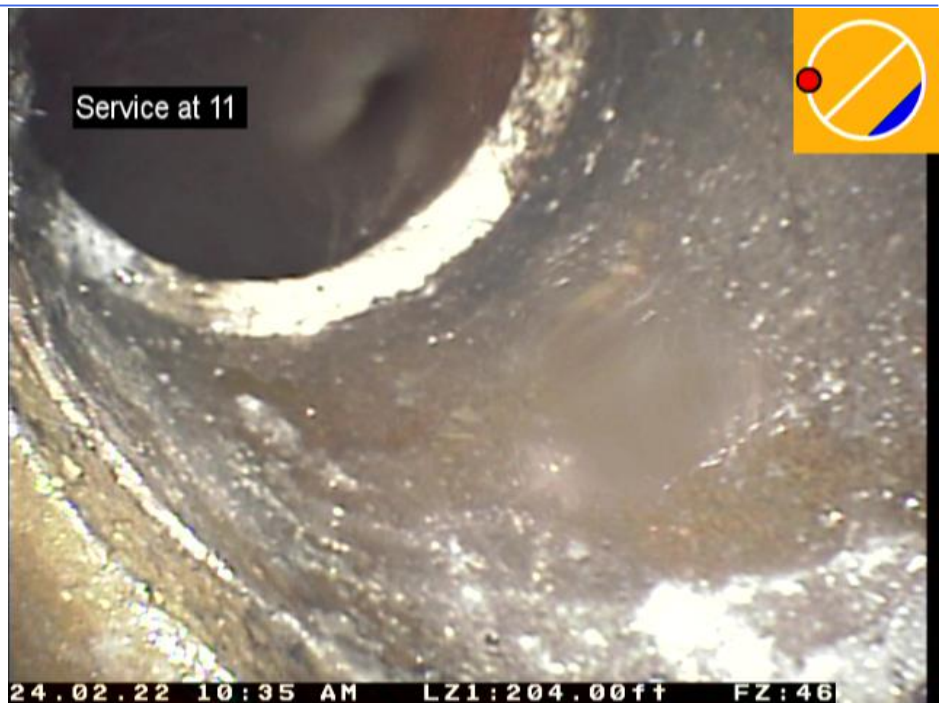
Picture 046

Service at 11

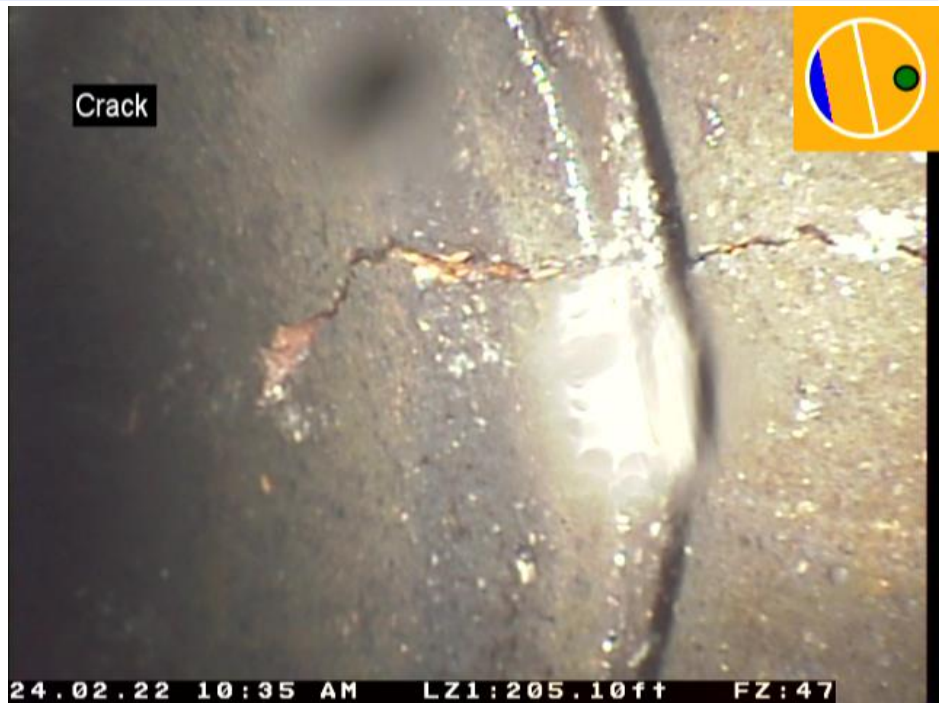
Picture 047
Video 00:23:40
Distance 205.10 m
Crack

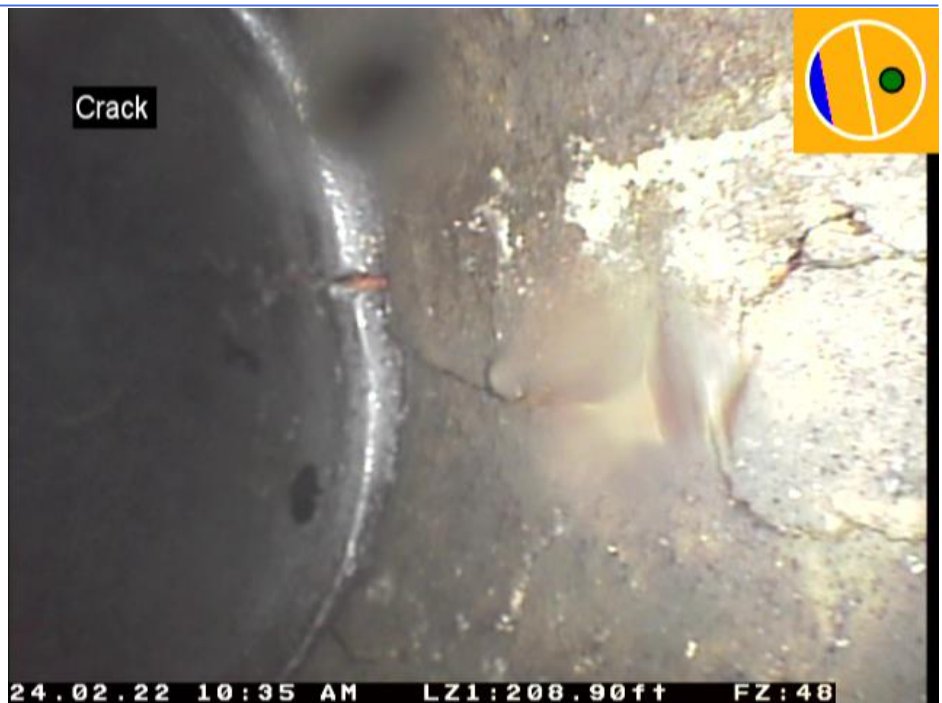
Picture 048
Video 00:23:54
Distance 208.90 m
Crack

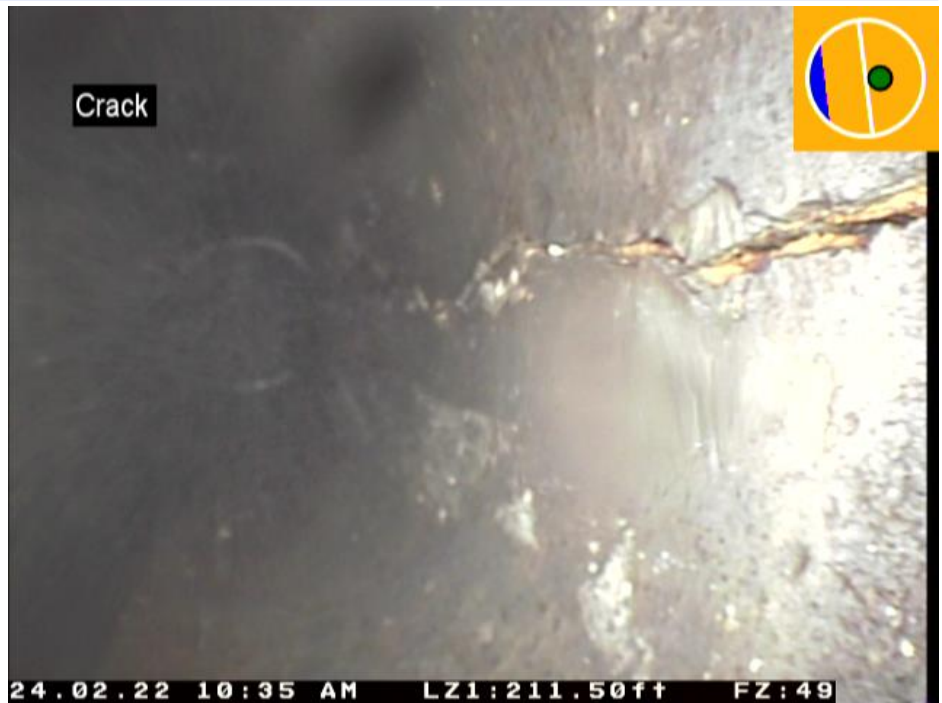
Picture 049

Crack

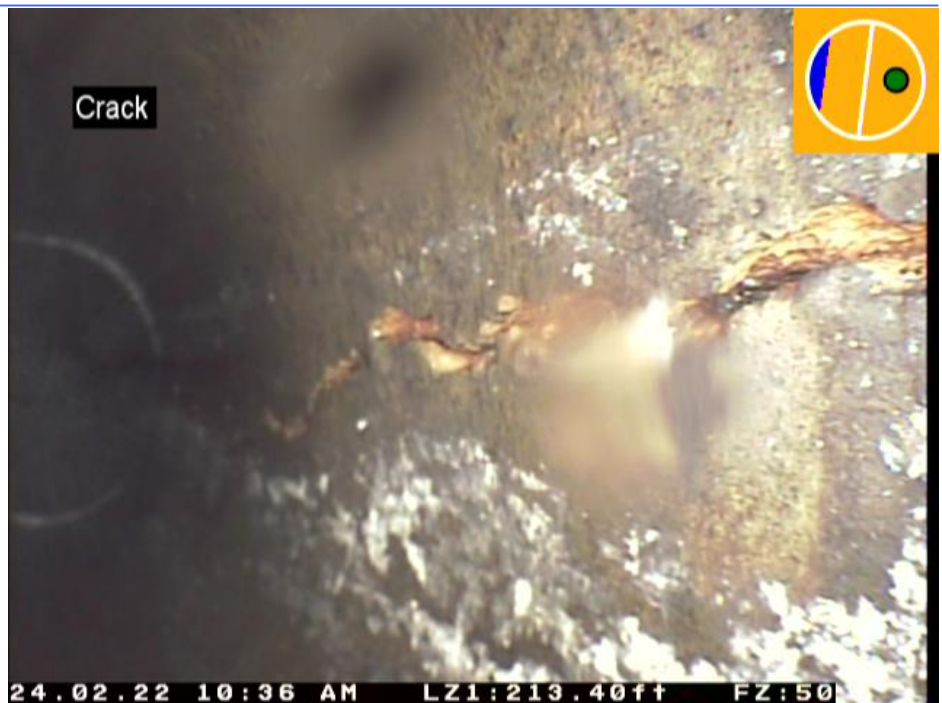
Picture 050

Crack

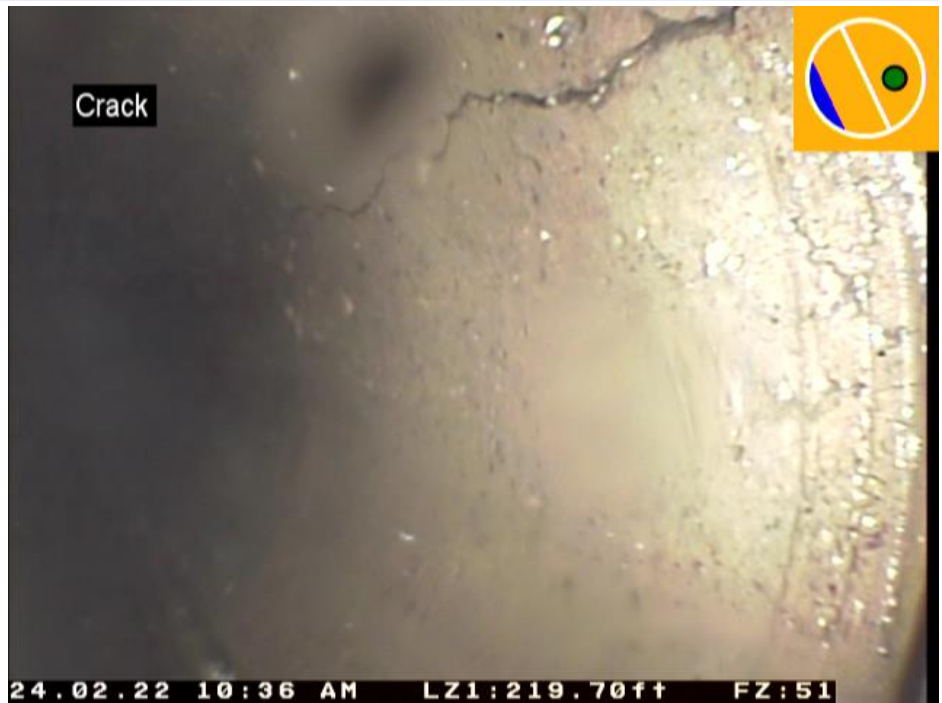
Picture 051

Crack

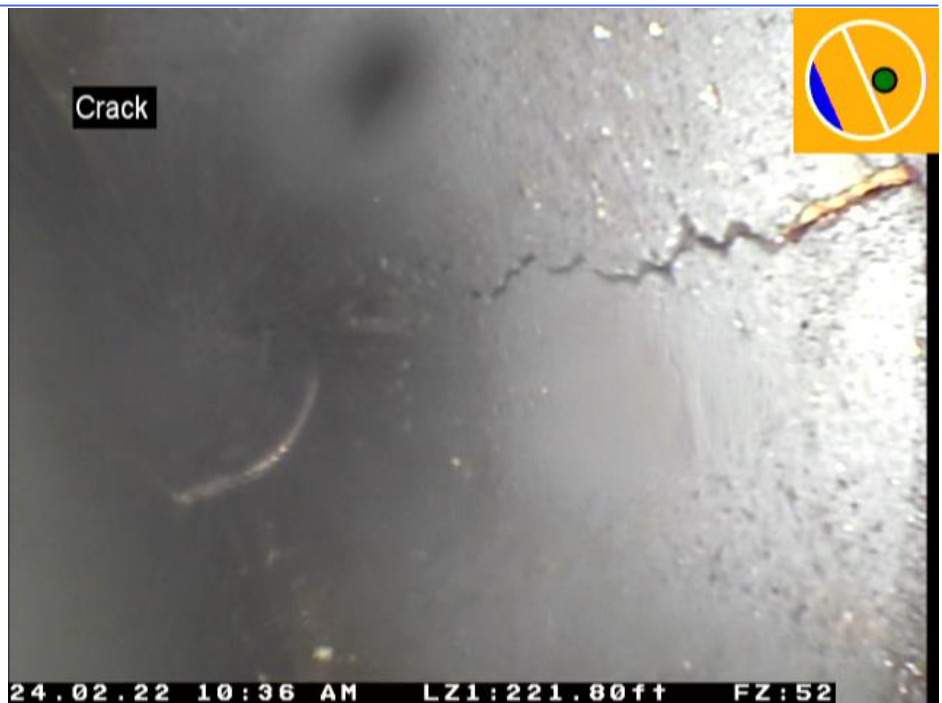
Picture 052

Crack

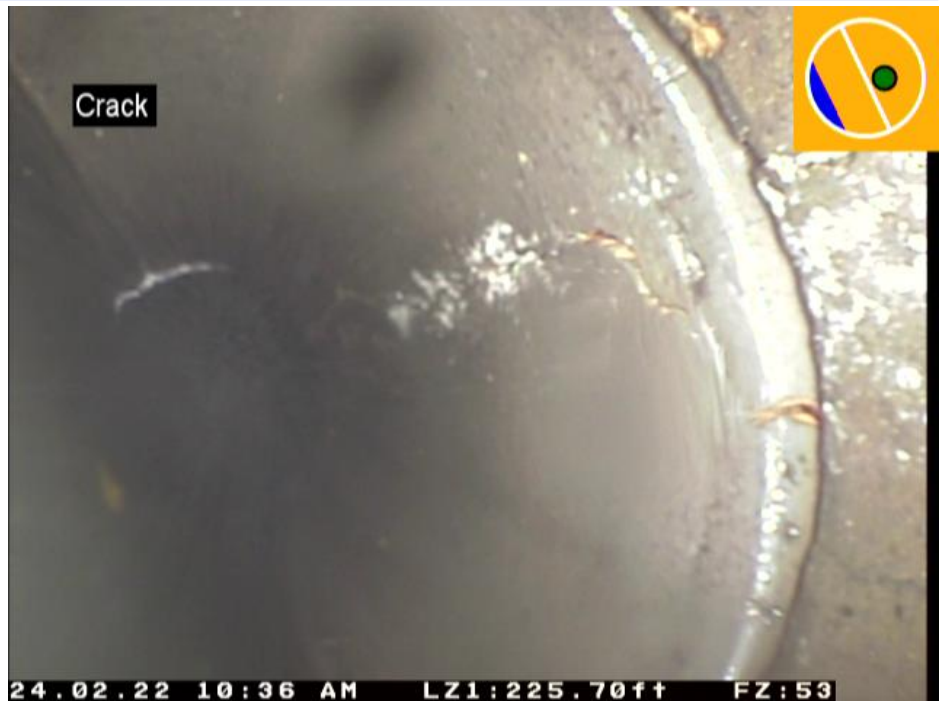
Picture 053

Crack

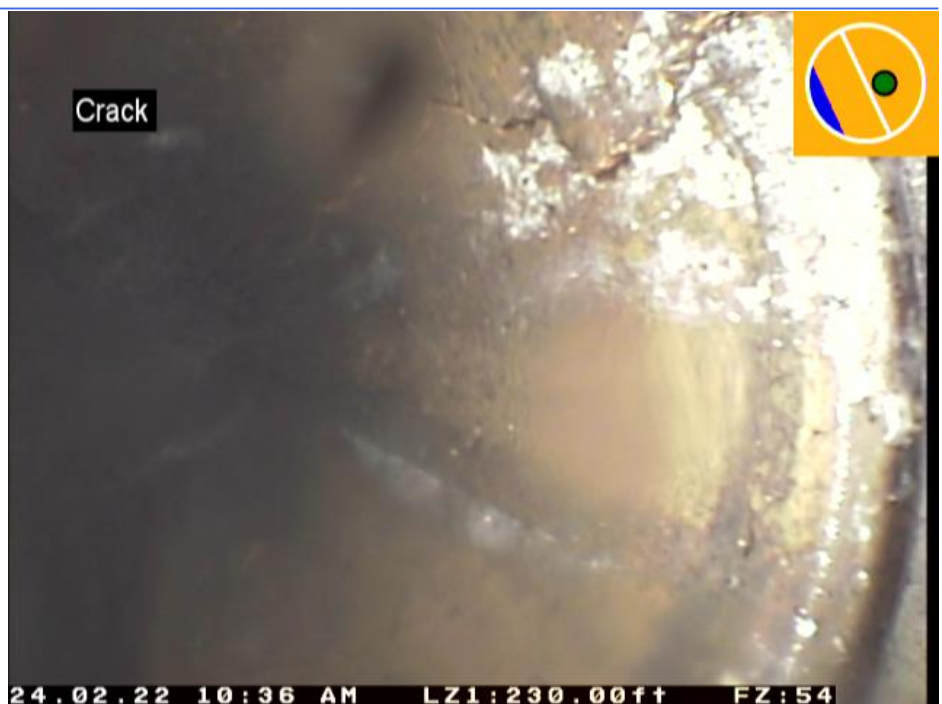
Picture 054

Crack

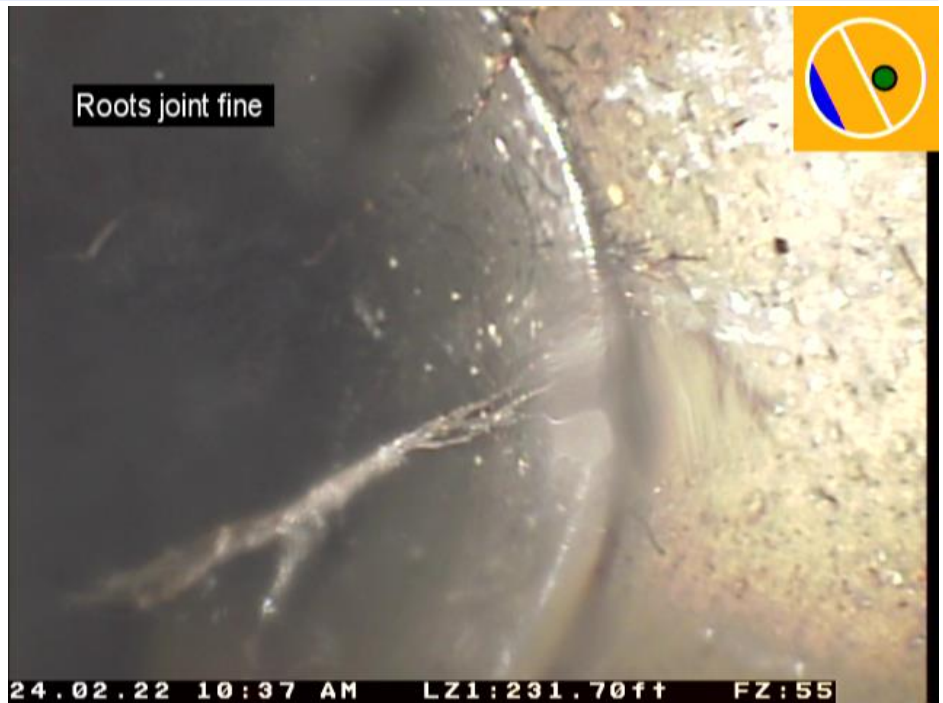
Picture 055

Roots joint fine

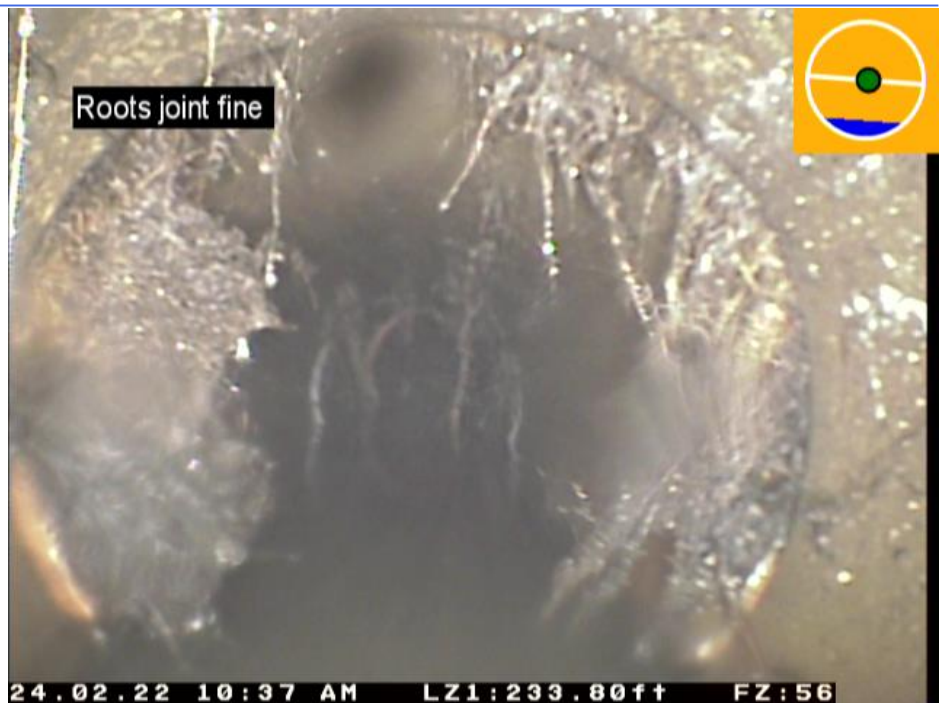
Picture 056

Roots joint fine

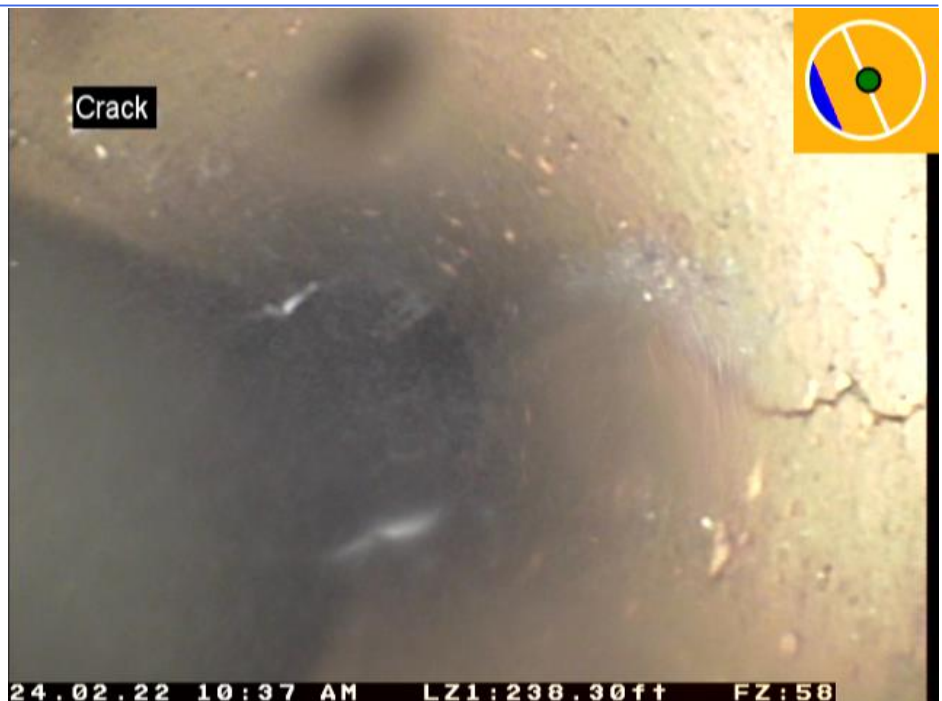
Picture 058

Crack

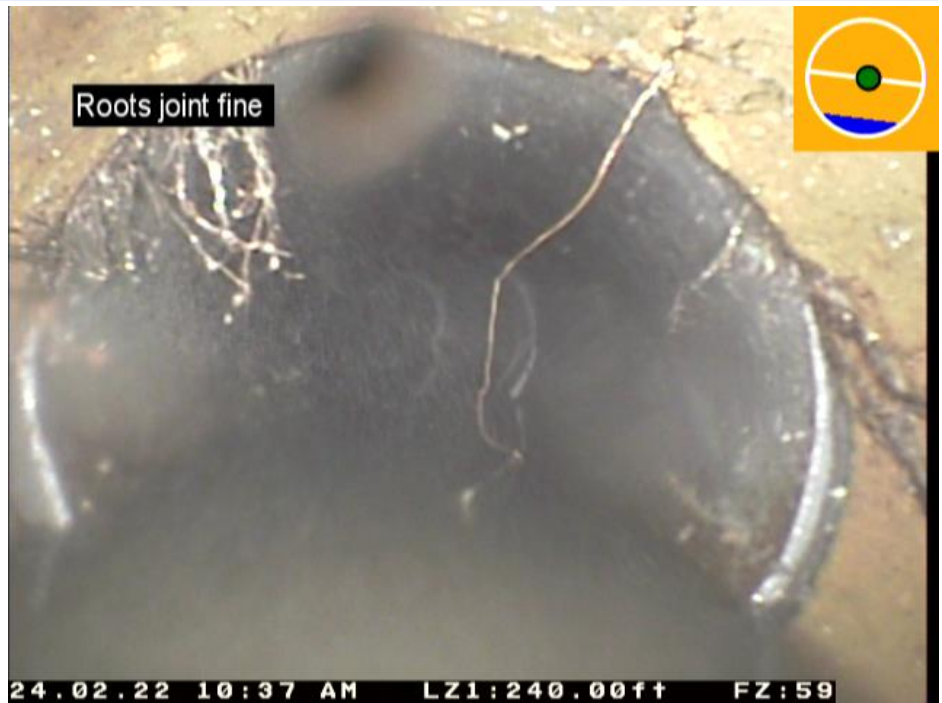
Picture 059

Roots joint fine

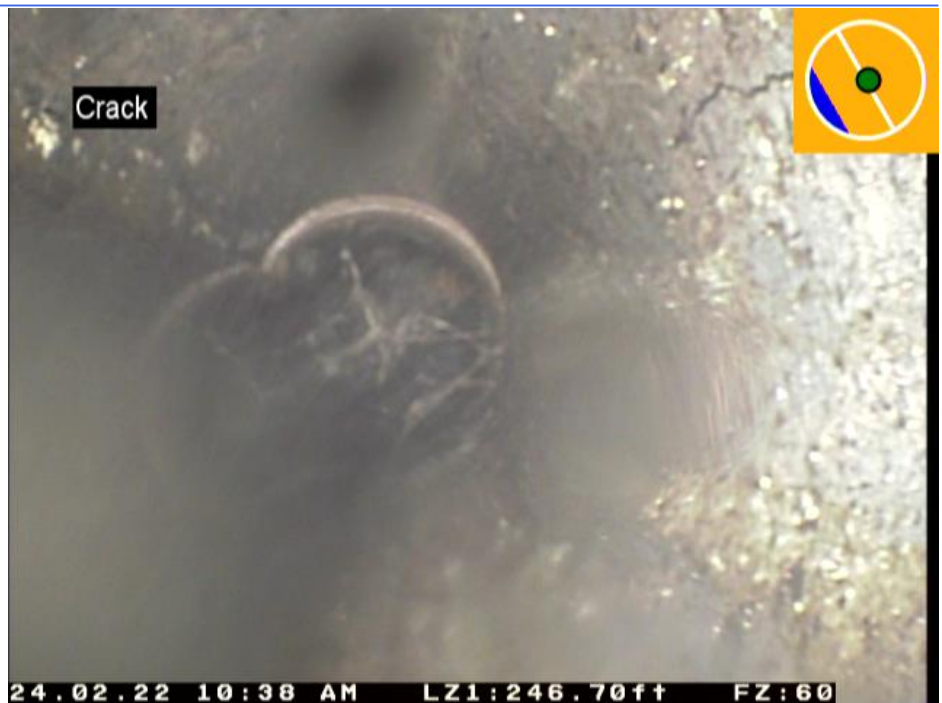
Picture 060

Crack

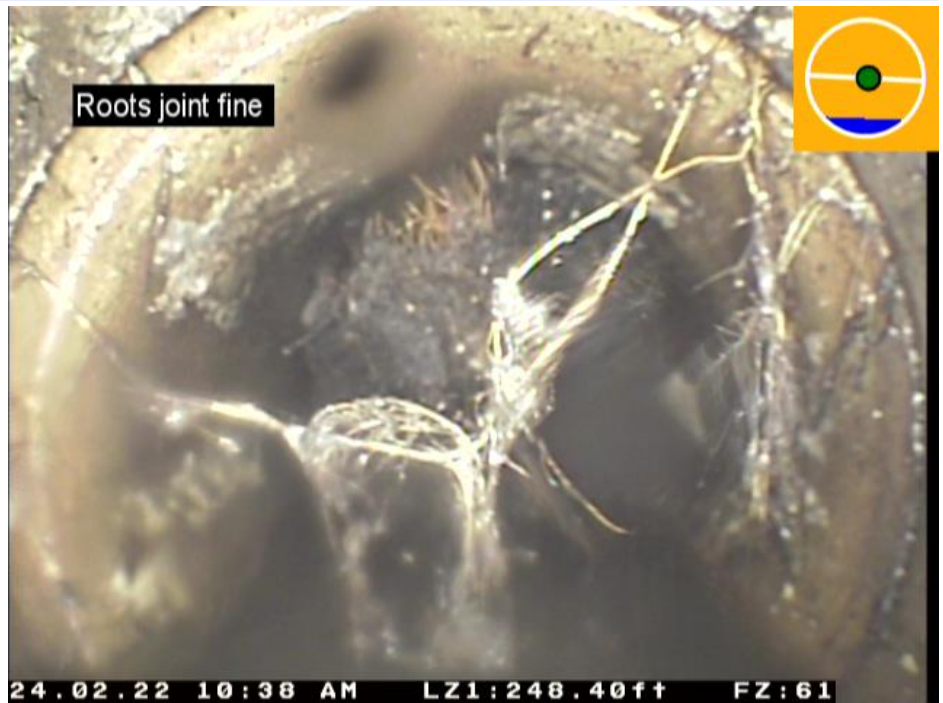
Picture 061

Roots joint fine

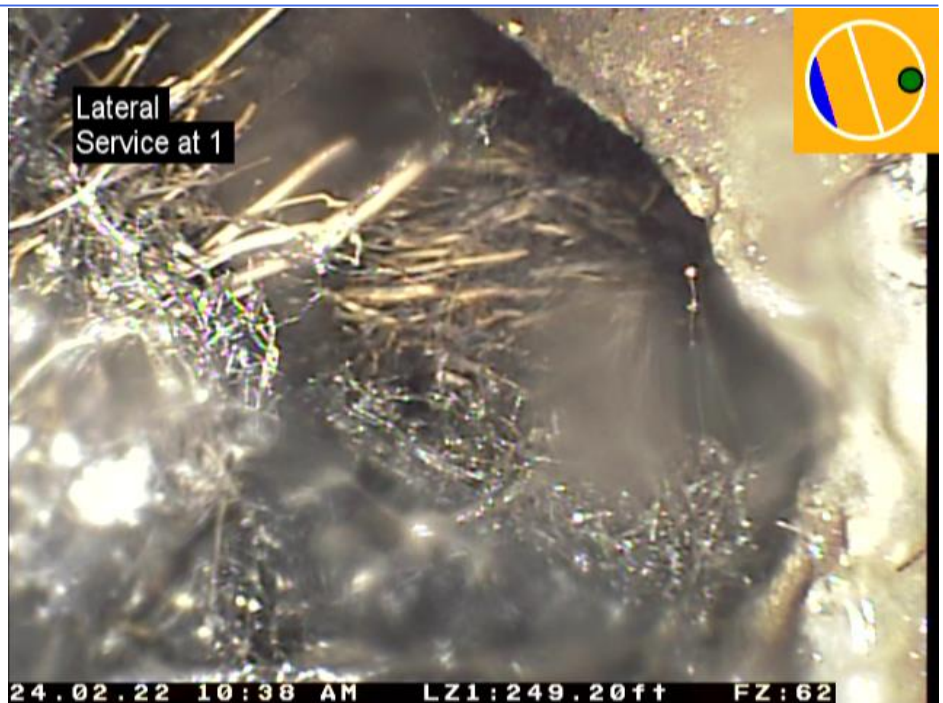
Picture 062

Lateral, Service at 1

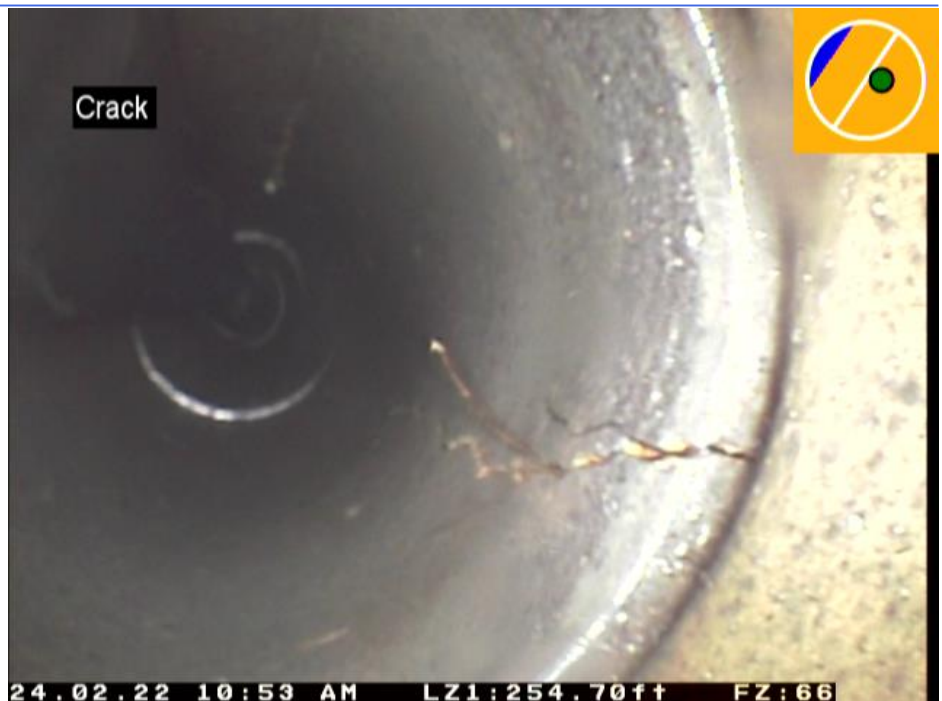
Picture 066

Crack

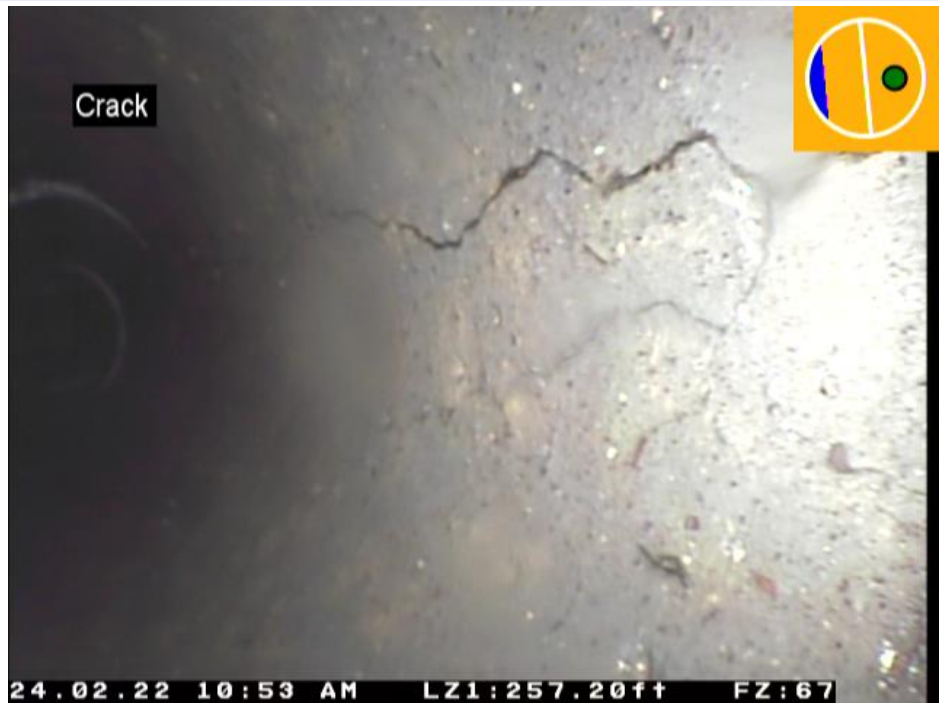
Picture 067

Crack

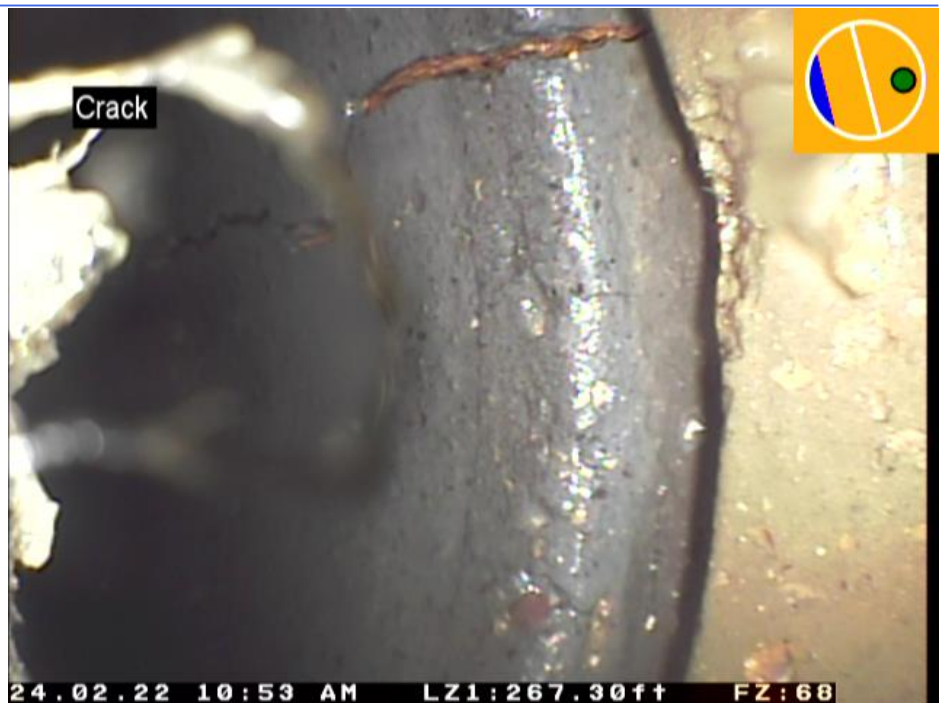
Picture 068

Crack

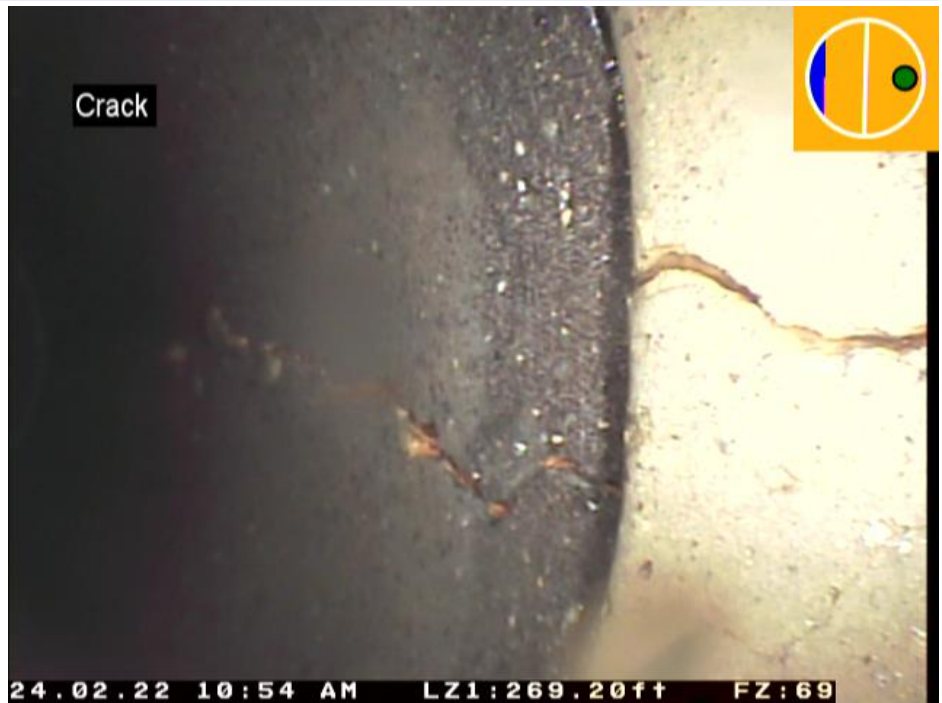
Picture 069

Crack

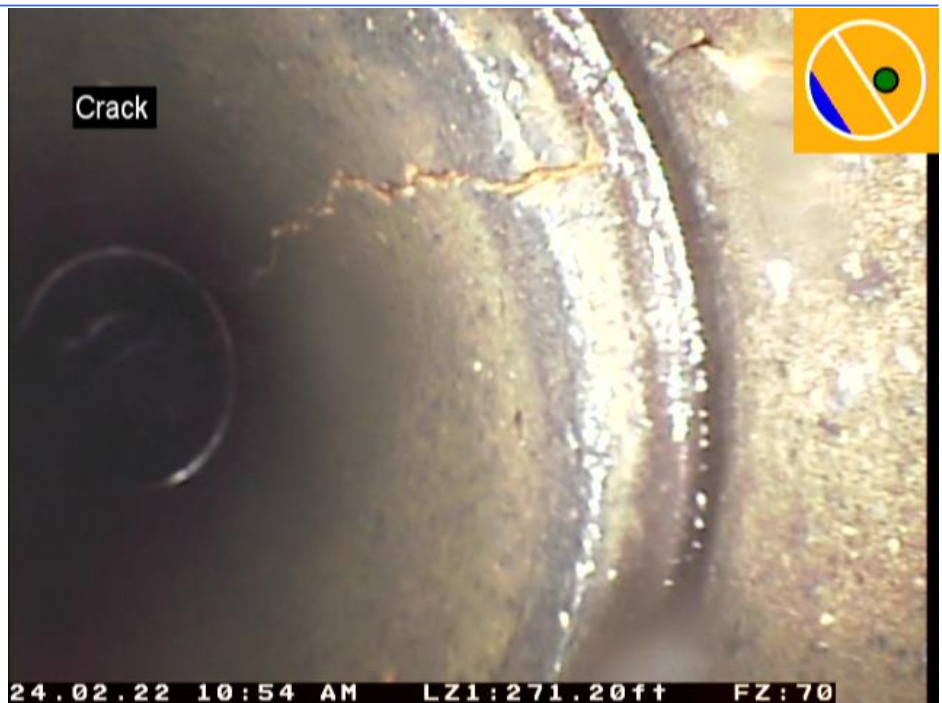
Picture 070

Crack

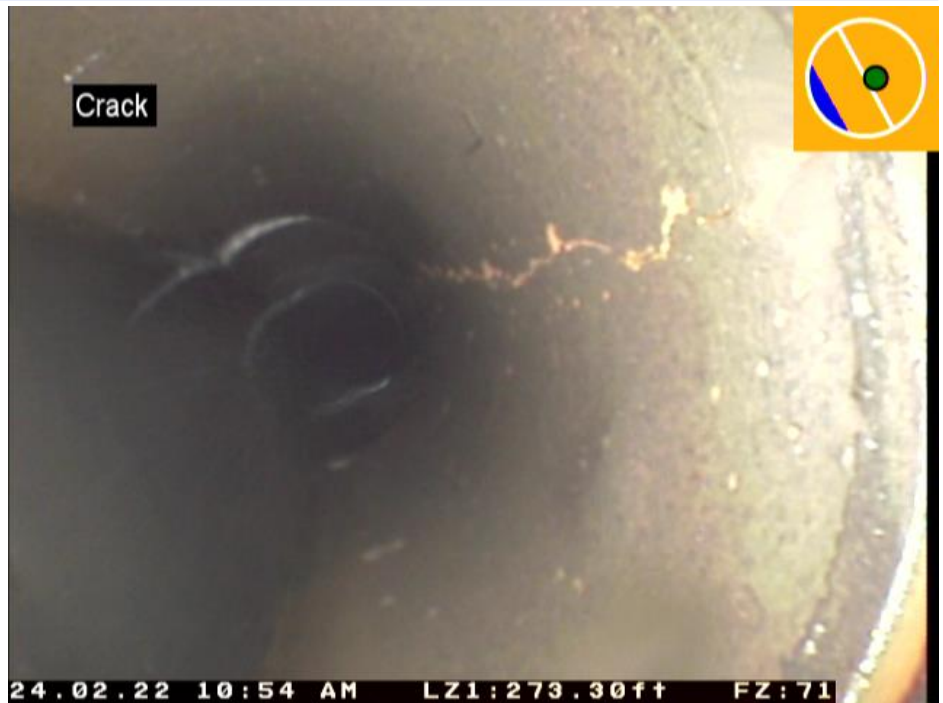
Picture 071

Crack

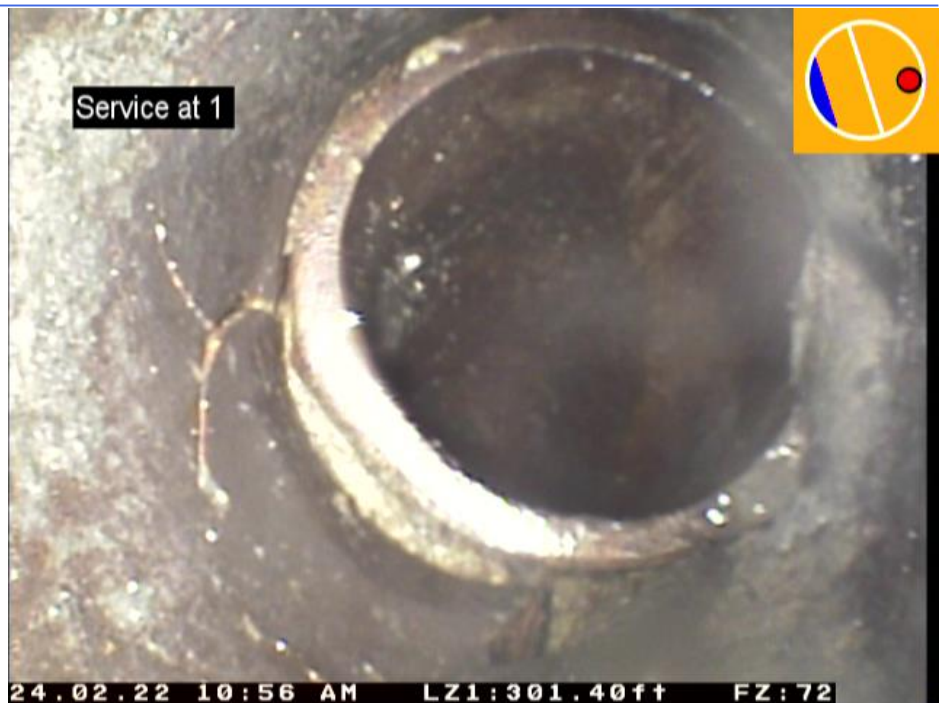
Picture 072

Service at 1

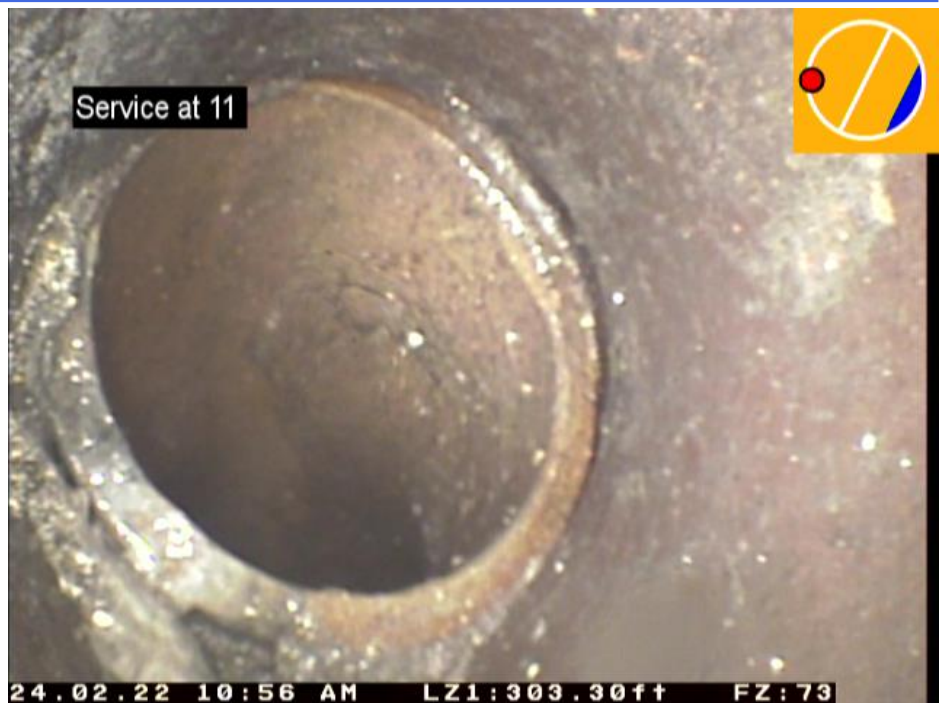
Picture 073

Service at 11

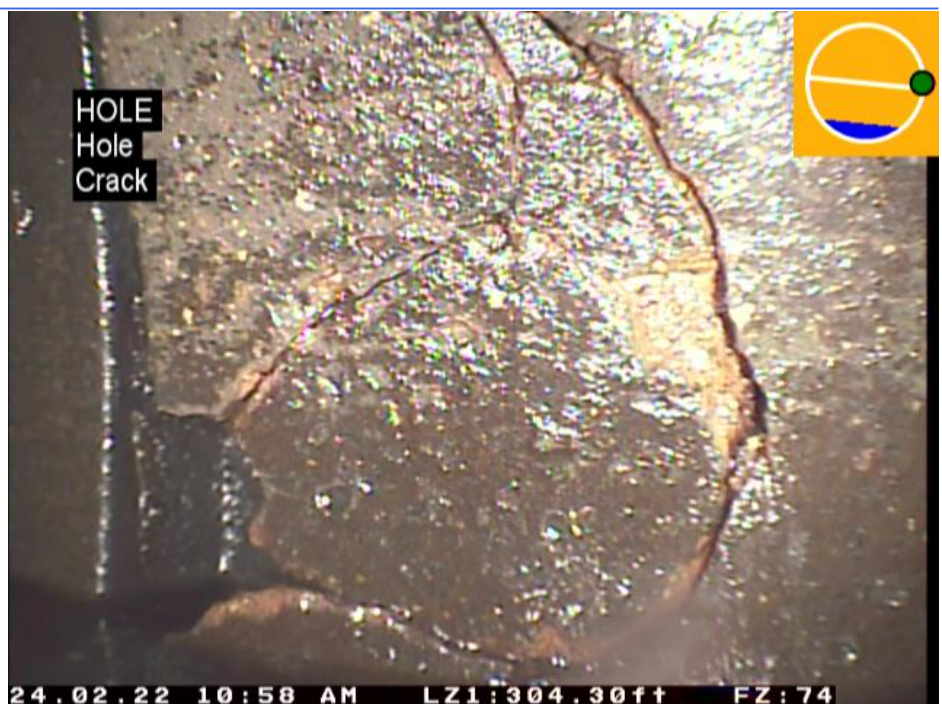
Picture 074

HOLE, Hole, Crack

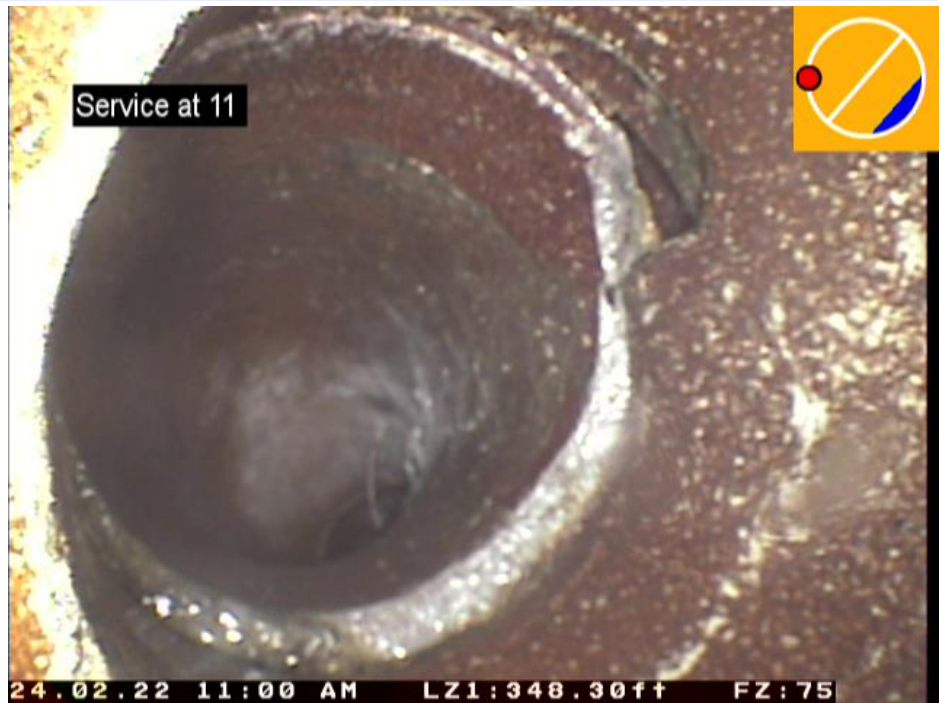
Picture 075

Service at 11

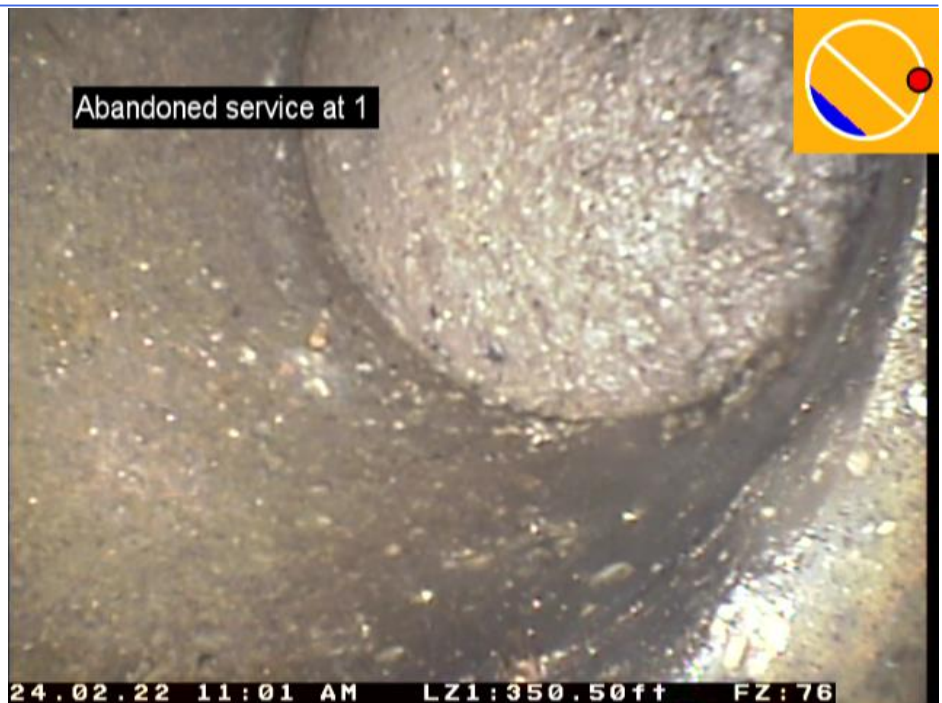
Picture 076

Abandoned service at 1

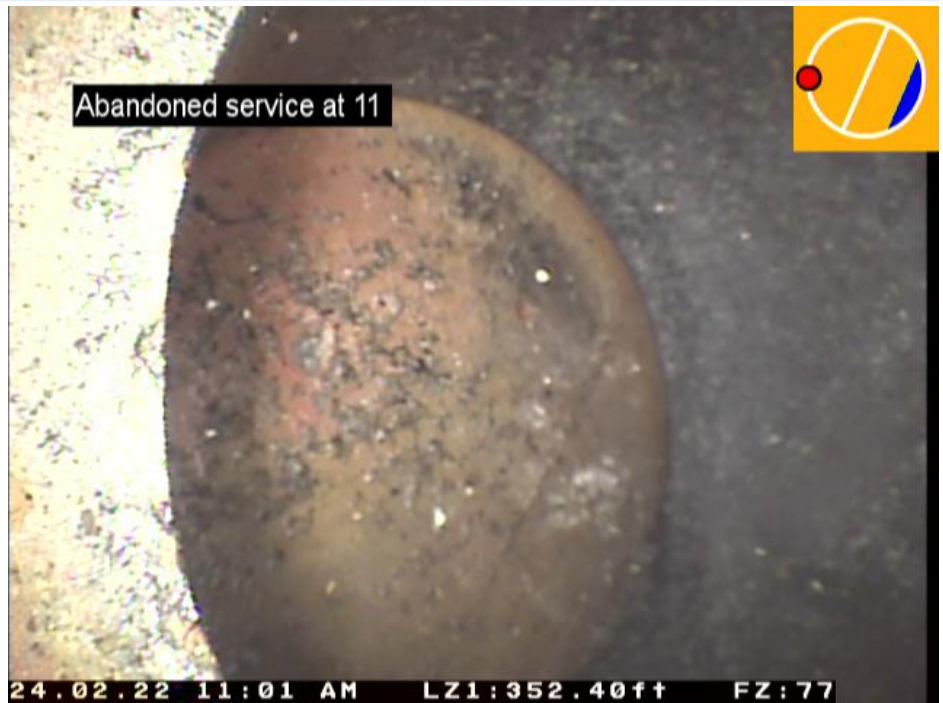
Picture 077

Abandoned service at 11

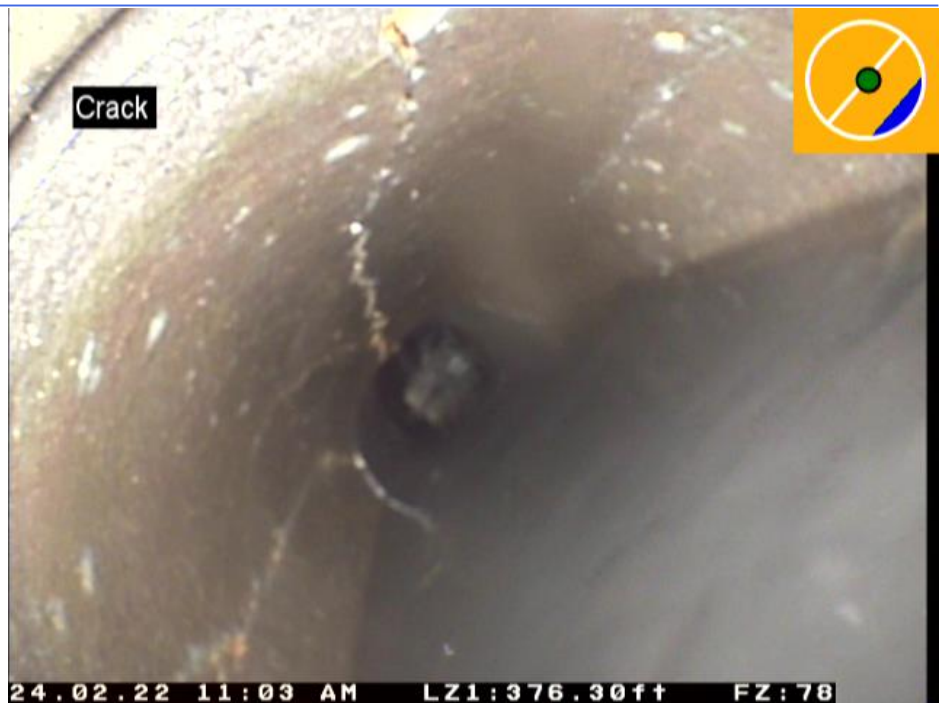
Picture 078

Crack

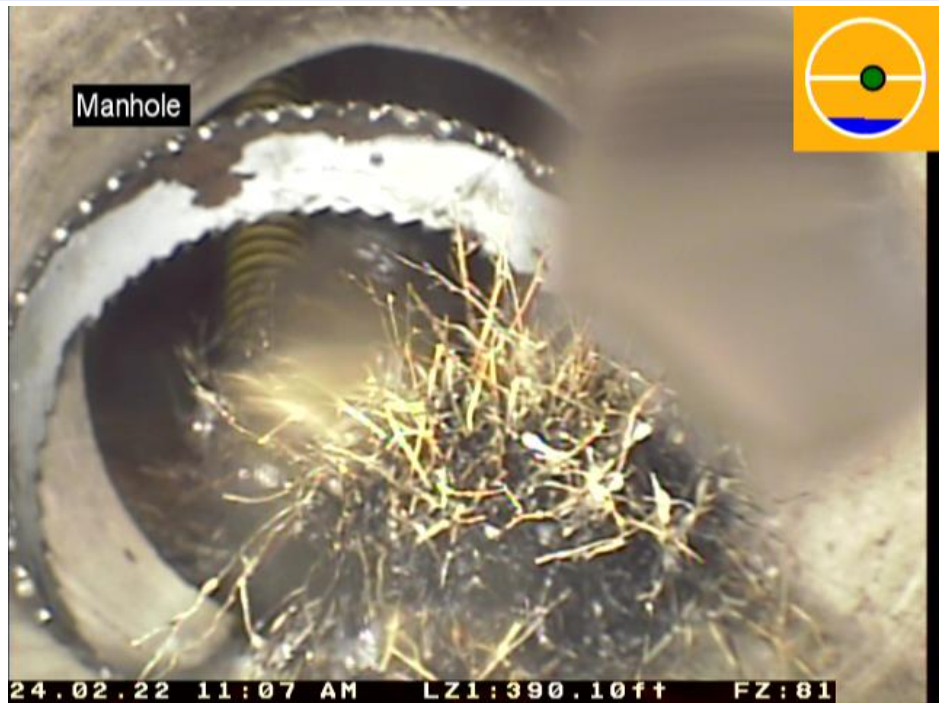
Picture 081

Manhole
