<b>Owner</b>	<b>Customer</b>	<b>Upstream MH</b>	<b>Downstream MH</b>	<b>Date</b>	<b>Time</b>
		2RM04	1RM36	08-16-2019	10:39 AM
<b>Surveyor</b>	<b>Street</b>		<b>City</b>	<b>Weather</b>	
NICK	ILLINOIS		GENEVA	Dry	
<b>Size</b>	<b>Material</b>	<b>Sewer Use</b>	<b>Purpose</b>	<b>Length</b>	
6	Vitrified Clay Pipe		Routine Assessment		
<b>Comments</b>				<b>Pre-Cleaning</b>	<b>TV Length</b>
				Jetting	260.2

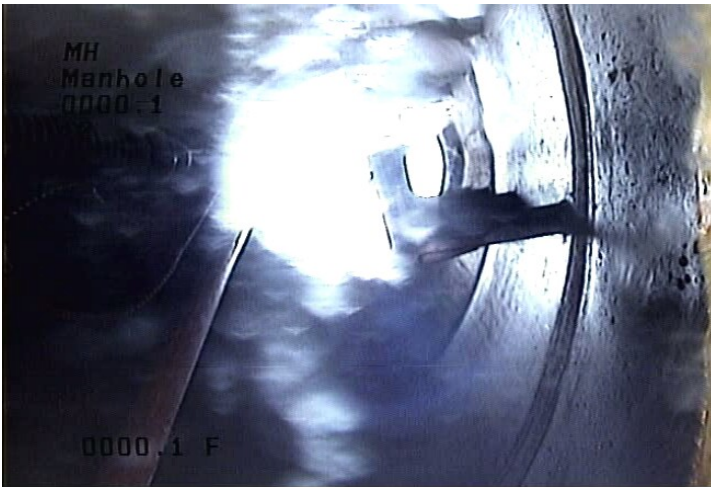
MH - Manhole @ 0.1 ft.

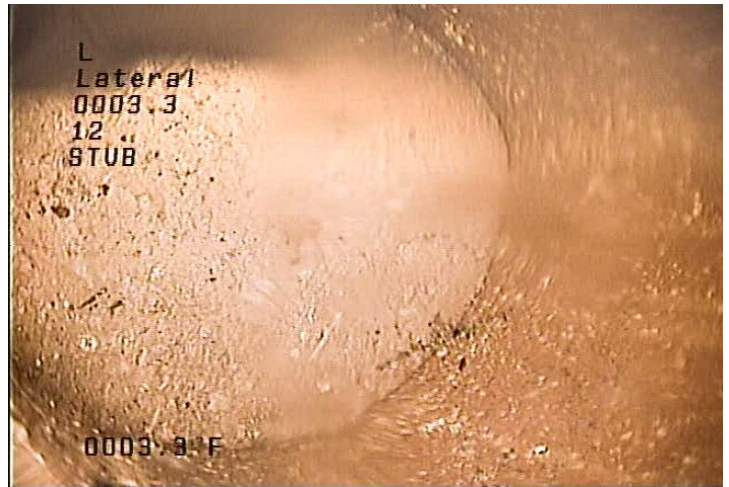
L - Lateral @ 3.3 ft. STUB

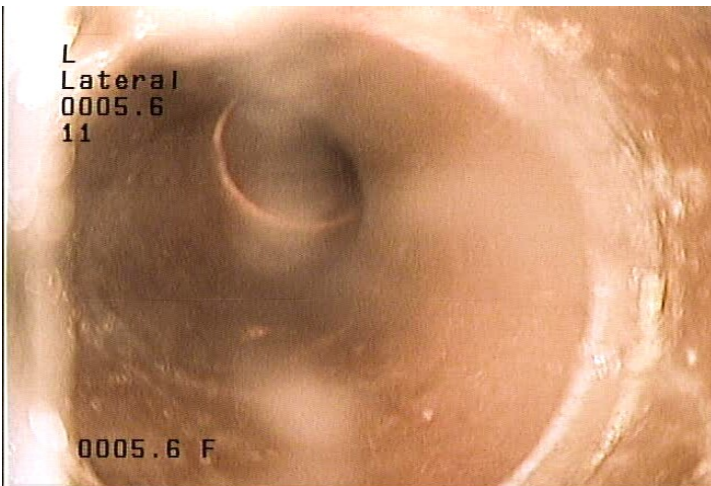
L - Lateral @ 5.6 ft.

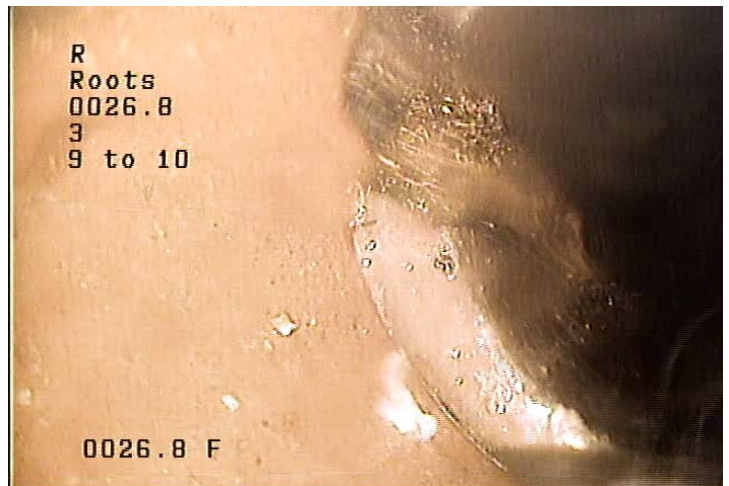
R - Roots @ 26.8 ft.

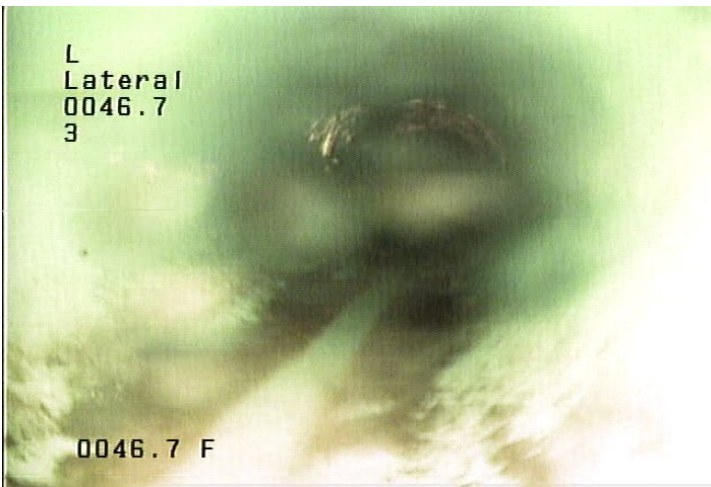
L - Lateral @ 46.7 ft.

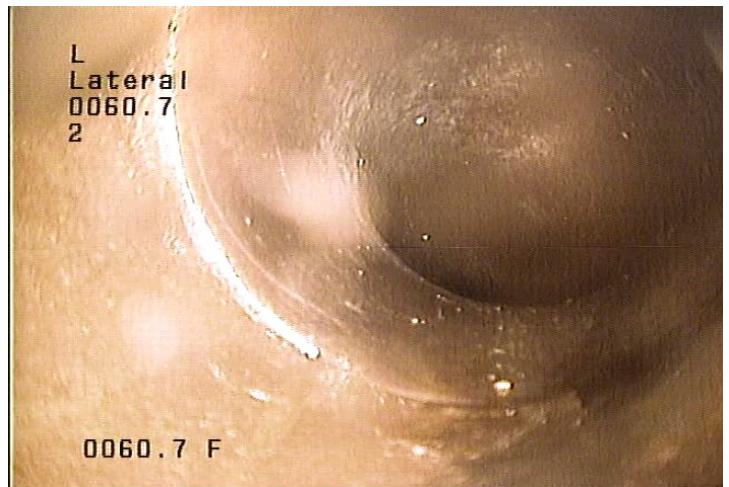
L - Lateral @ 60.7 ft.

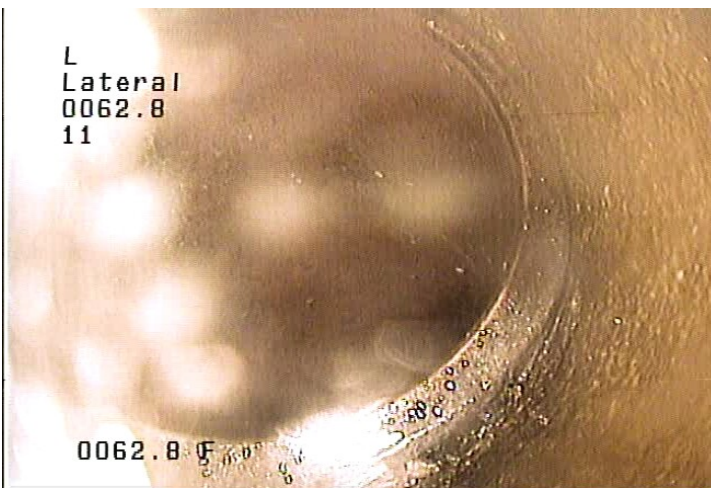
L - Lateral @ 62.8 ft.

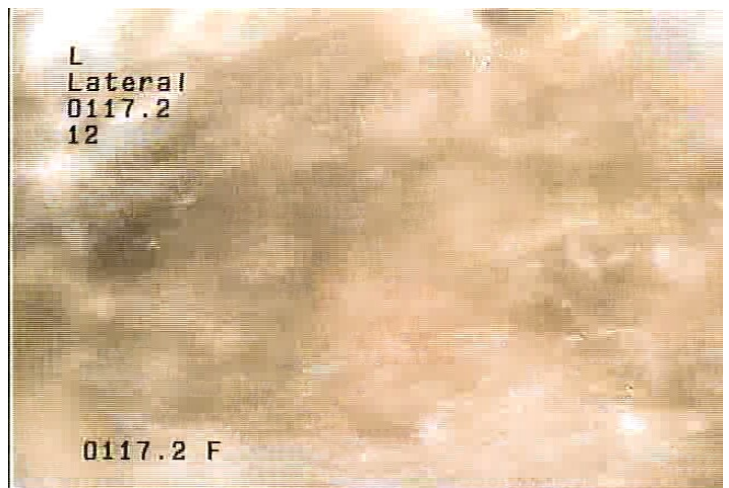
L - Lateral @ 117.2 ft.

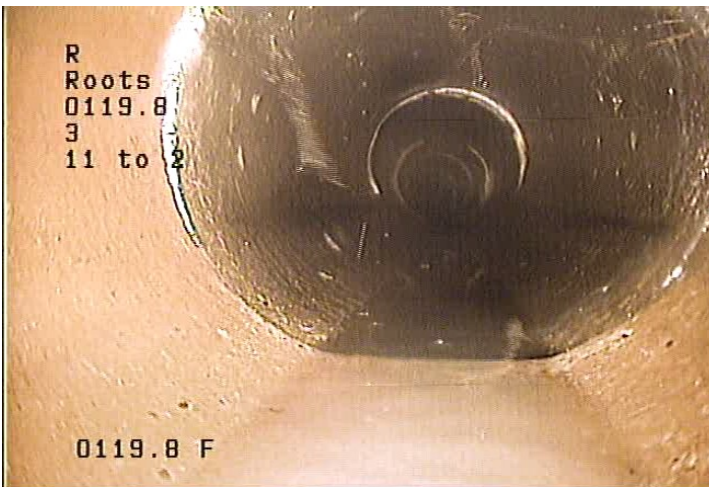
R - Roots @ 119.8 ft.

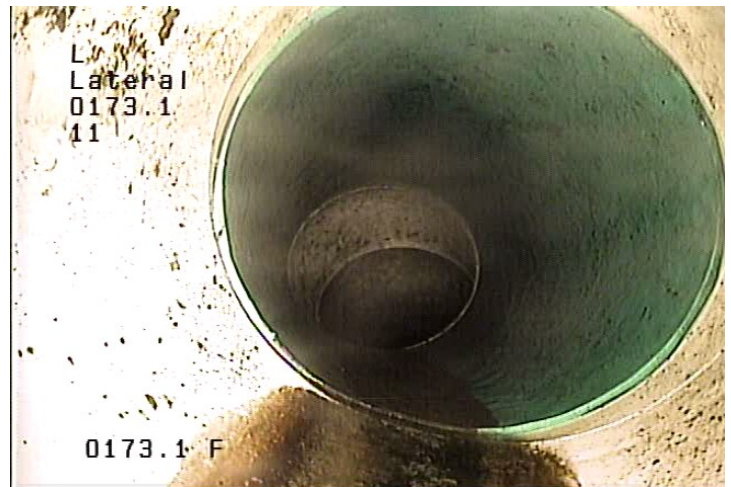
L - Lateral @ 173.1 ft.

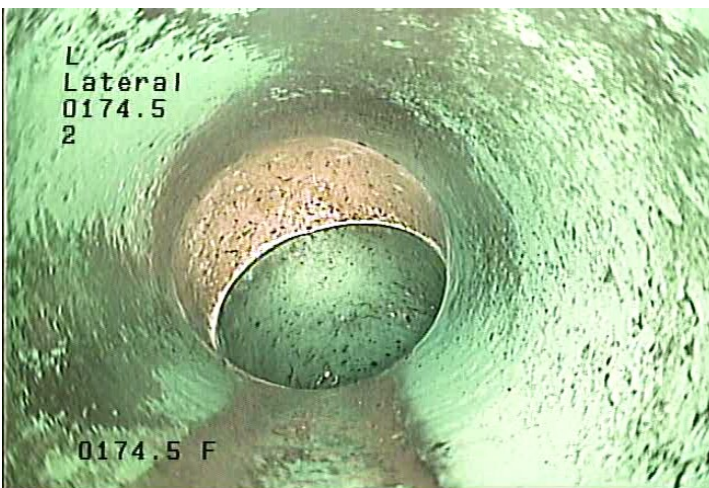
L - Lateral @ 174.5 ft.

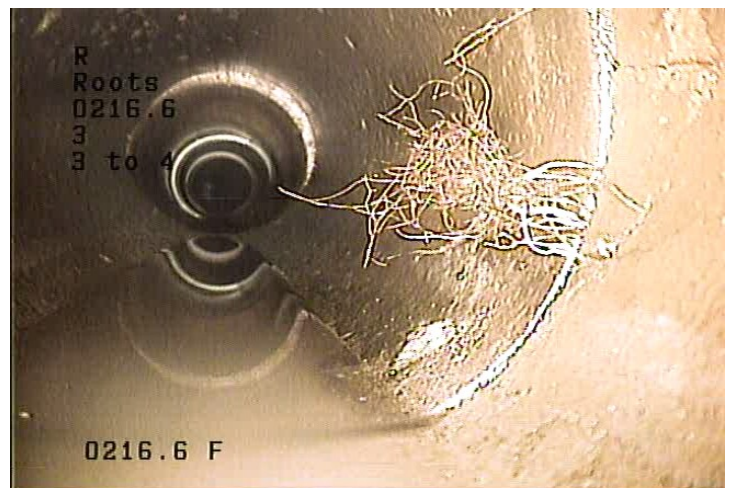
R - Roots @ 216.6 ft.

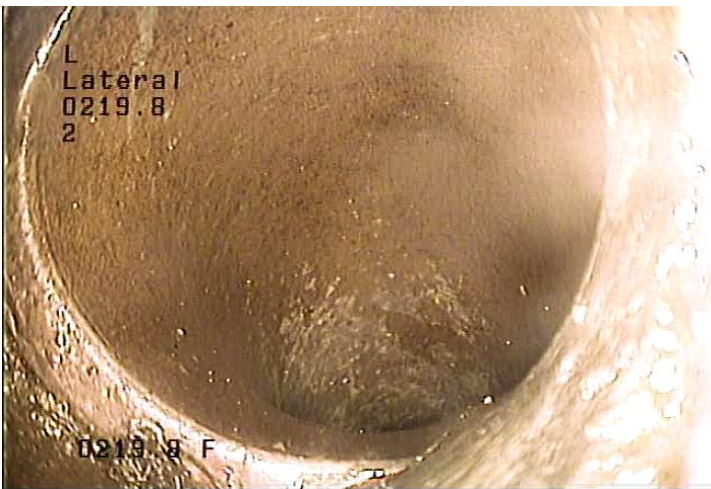
L - Lateral @ 219.8 ft.

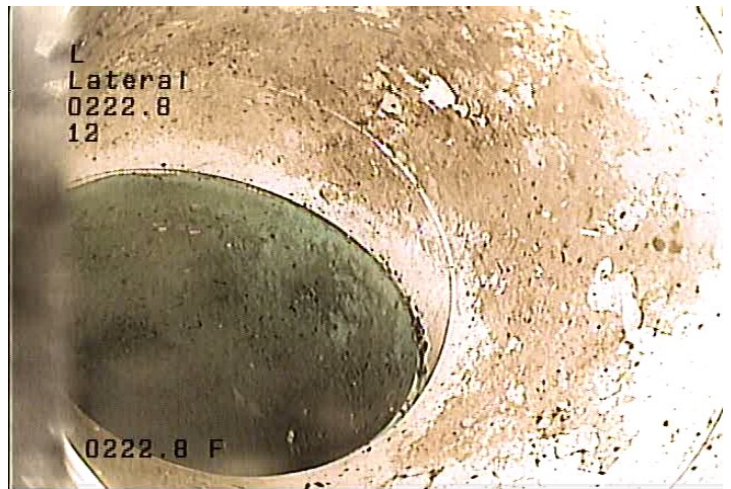
L - Lateral @ 222.8 ft.

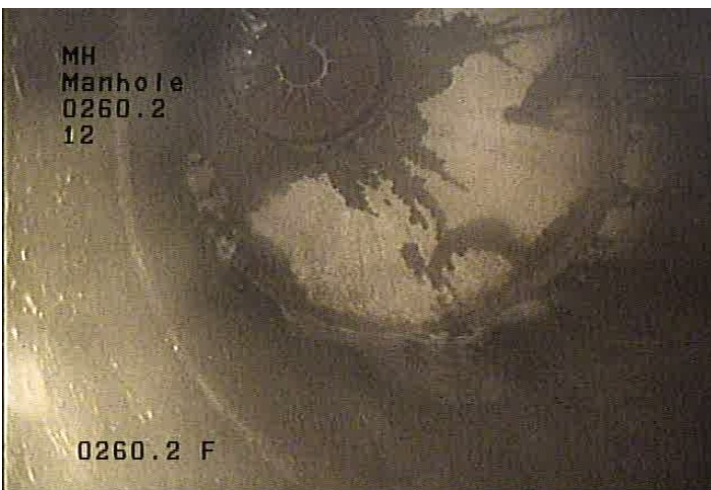
MH - Manhole @ 260.2 ft.
