<b>Owner</b>	<b>Customer</b>	<b>Upstream MH</b>	<b>Downstream MH</b>	<b>Date</b>	<b>Time</b>
		2SM17	2SM21	12-27-2019	9:49 AM
<b>Surveyor</b>	<b>Street</b>		<b>City</b>	<b>Weather</b>	
NICK	2ND		GENEVA	Dry	
<b>Size</b>	<b>Material</b>	<b>Sewer Use</b>	<b>Purpose</b>	<b>Length</b>	
6	Vitrified Clay Pipe	Sanitary	Routine Assessment		
<b>Comments</b>				<b>Pre-Cleaning</b>	<b>TV Length</b>
AFTER ROOT CUTTING.				Jetting	235.3

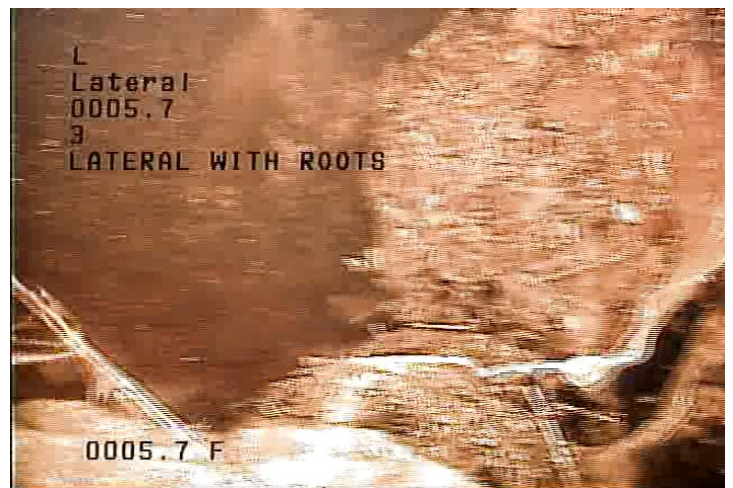
L - Lateral @ 5.7 ft. LATERAL WITH ROOTS

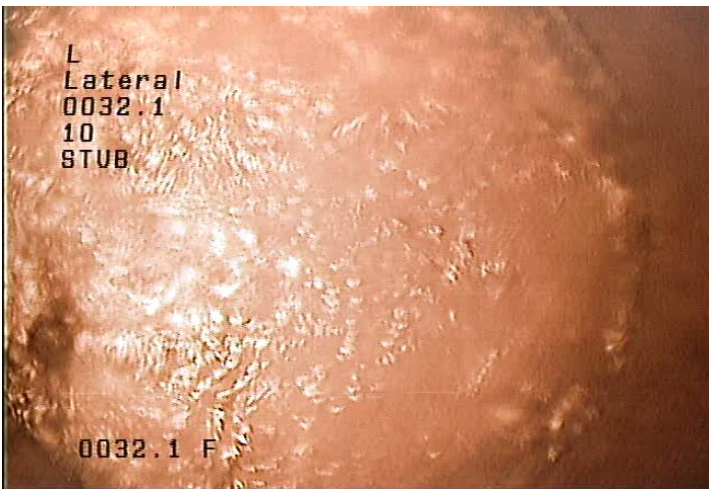
L - Lateral @ 32.1 ft. STUB

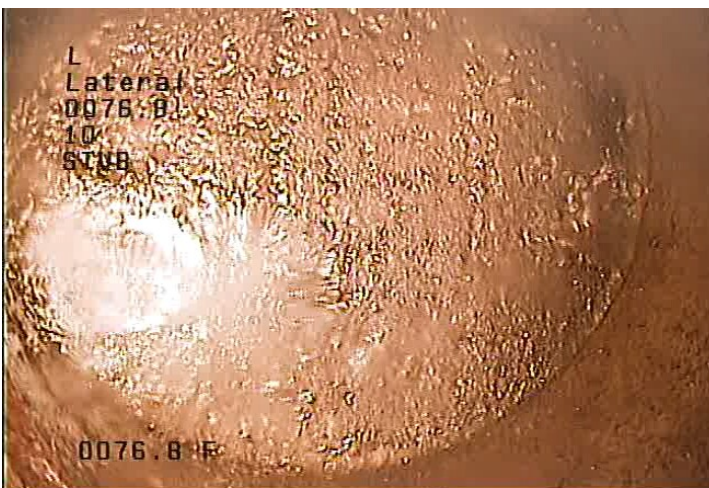
L - Lateral @ 76.8 ft. STUB

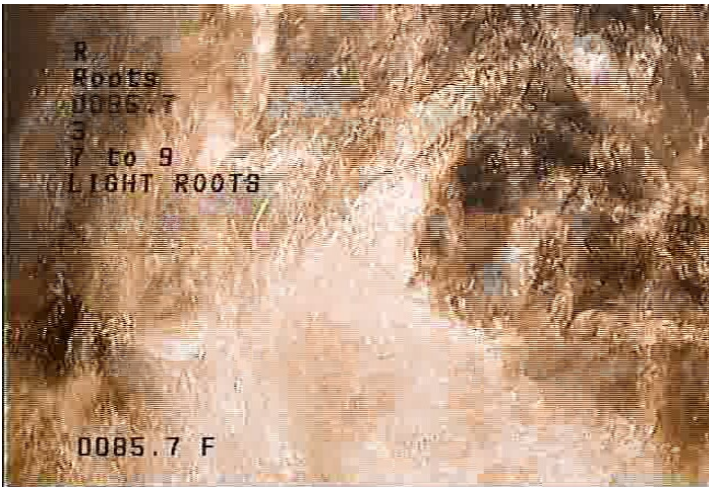
R - Roots @ 85.7 ft. LIGHT ROOTS

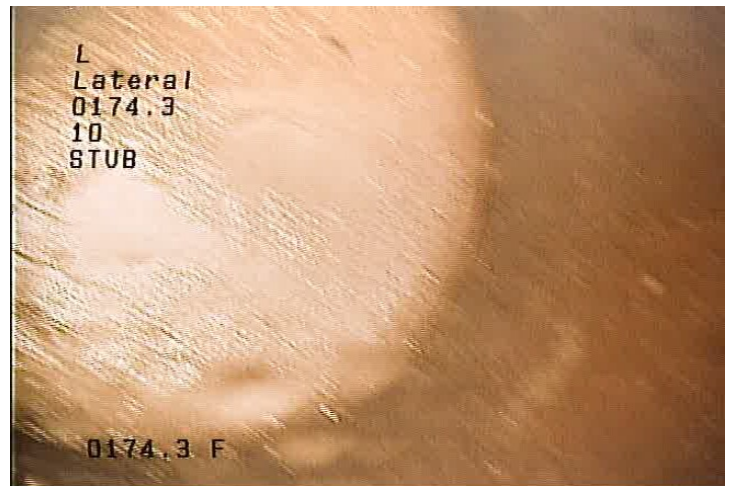
L - Lateral @ 174.3 ft. STUB

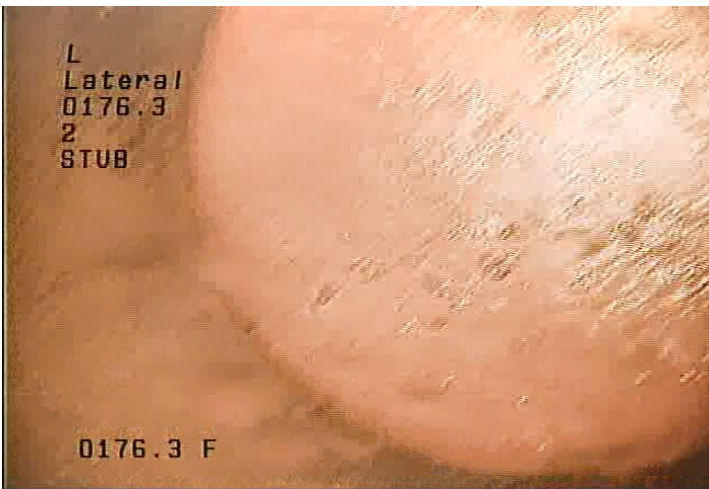
L - Lateral @ 176.3 ft. STUB
