| Upstream MH 3P-M18-S | Downstream MH 3P-M19-S | Size 8 | Material Vitrified Clay Pipe | Total Length | City Geneva |

| Surveyor's Name Jakub Kawa | Certificate Number U 215 06023260 | Street Address Sherman Avenue | Location Details |

| Direction Downstream | Purpose Routine Assessment | Weather Light Rain | Date 20191021 | Time 08:22 | Length Surveyed 113 |

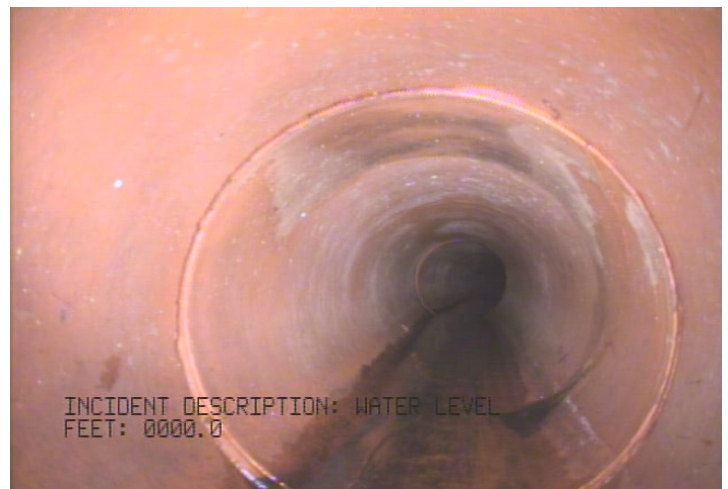
| Distance (Feet) | Code | | Continuous defect | Value | | | Joint | Circumferential Location | | Image Ref. | Struct. Grade | O&M Grade | Remarks | |
|---|---|---|---|---|---|---|---|---|---|---|---|---|---|---|
| 0.0 | MWL | | | | | 5 | | | | | | | | |

MWL - Water Level @ 0.0 ft.

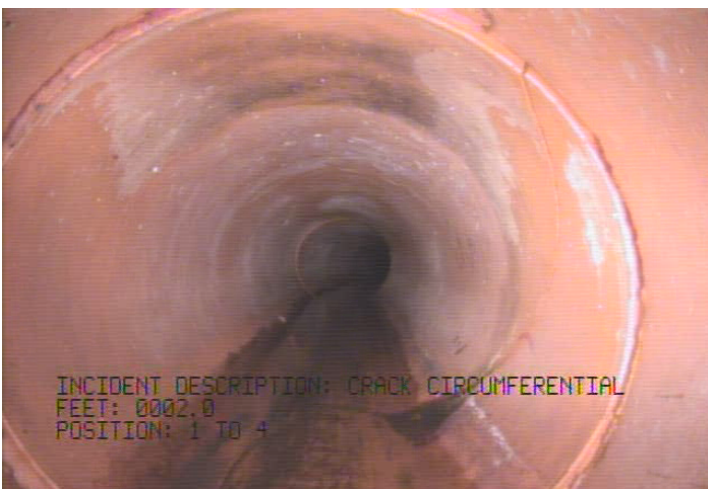
| Distance (Feet) | Code | | Continuous defect | Value | | | Joint | Circumferential Location | | Image Ref. | Struct. Grade | O&M Grade | Remarks | |
|---|---|---|---|---|---|---|---|---|---|---|---|---|---|---|
| 2.0 | CC | | | | | | J | 1 | 7 | | 1 | | | |

CC - Crack Circumferential @ 2.0 ft.

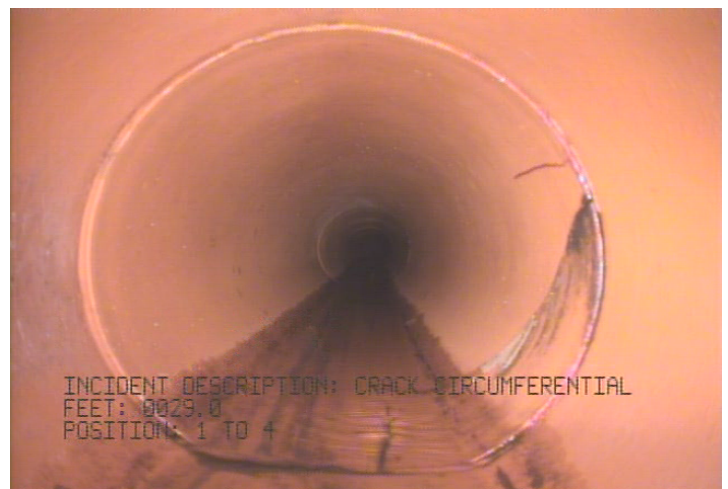
| Distance (Feet) | Code | | Continuous defect | Value | | | Joint | Circumferential Location | | Image Ref. | Struct. Grade | O&M Grade | Remarks | |
|---|---|---|---|---|---|---|---|---|---|---|---|---|---|---|
| 29.0 | CC | | | | | | J | 3 | 6 | | 1 | | | |

CC - Crack Circumferential @ 29.0 ft.

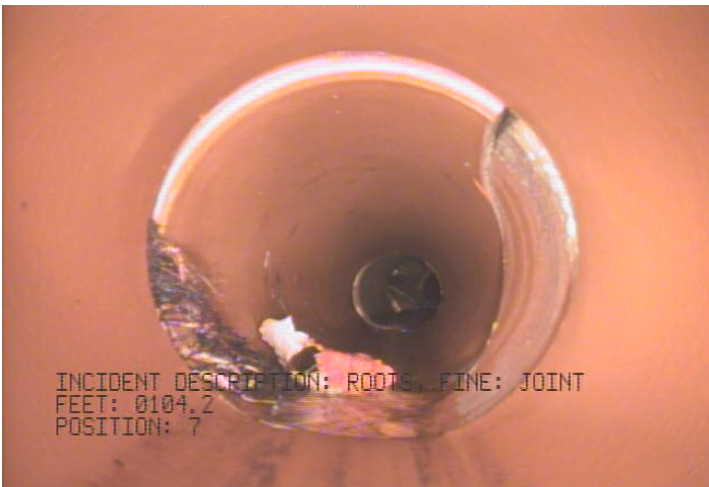
| Distance (Feet) | Code | | Continuous defect | Value | | | Joint | Circumferential Location | | Image Ref. | Struct. Grade | O&M Grade | Remarks | |
|---|---|---|---|---|---|---|---|---|---|---|---|---|---|---|
| 104.2 | RF | | | | | | J | 6 | 8 | | | 1 | | |

RFJ - Roots, Fine: Joint @ 104.2 ft.

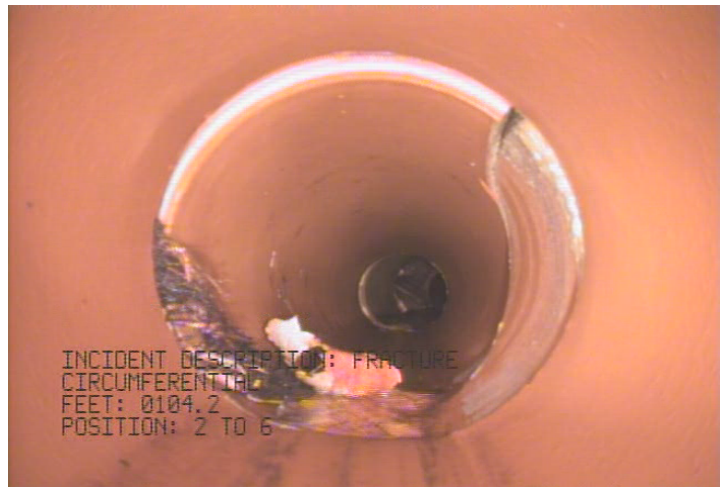
| Distance (Feet) | Code | | Continuous defect | Value | | | Joint | Circumferential Location | | Image Ref. | Struct. Grade | O&M Grade | Remarks | |
|---|---|---|---|---|---|---|---|---|---|---|---|---|---|---|
| 104.2 | FC | | | | | | J | 2 | 6 | | 2 | | | |

FC - Fracture Circumferential @ 104.2 ft.

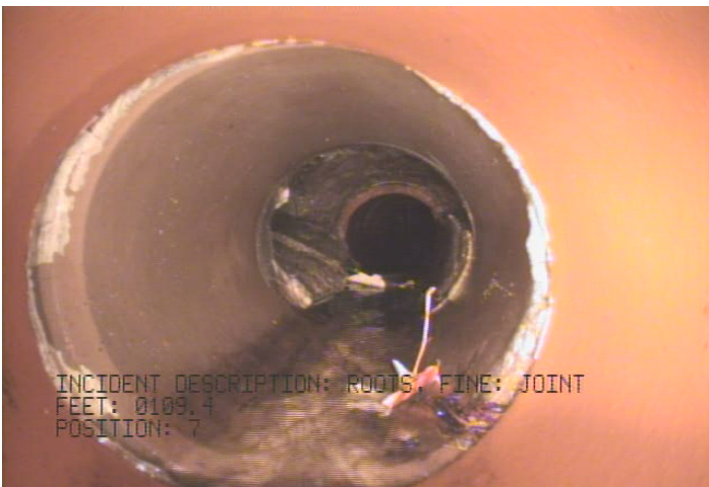
| Distance (Feet) | Code | | Continuous defect | Value | | | Joint | Circumferential Location | | Image Ref. | Struct. Grade | O&M Grade | Remarks | |
|---|---|---|---|---|---|---|---|---|---|---|---|---|---|---|
| 109.4 | RF | | | | | | J | 4 | | | | 1 | | |

RFJ - Roots, Fine: Joint @ 109.4 ft.

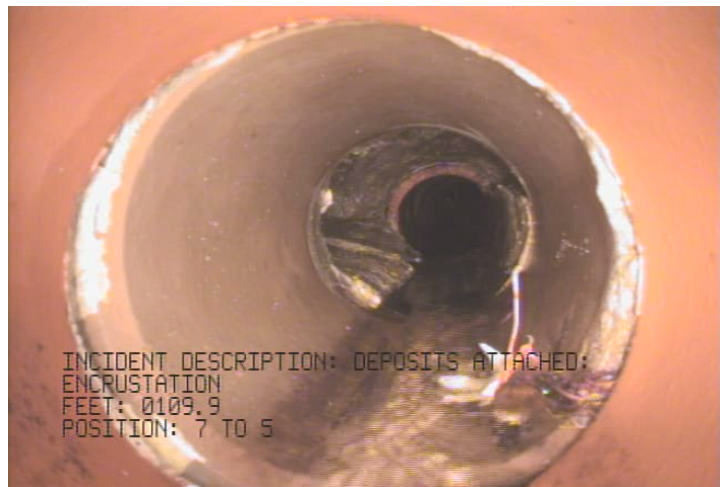
| Distance (Feet) | Code | | Continuous defect | Value | | | Joint | Circumferential Location | | Image Ref. | Struct. Grade | O&M Grade | Remarks | |
|---|---|---|---|---|---|---|---|---|---|---|---|---|---|---|
| 109.4 | DA | E | | | | 5 | J | 8 | 4 | | | 2 | | |

DAE - Deposits Attached: Encrustation @ 109.4 ft.
