<b>Owner</b>	<b>Customer</b>	<b>Upstream MH</b>	<b>Downstream MH</b>	<b>Date</b>	<b>Time</b>
		3UM33	3UM37	05-05-2021	9:22 AM
<b>Surveyor</b>	<b>Street</b>		<b>City</b>	<b>Weather</b>	
NICK	SANDHOLM		GENEVA	Dry	
<b>Size</b>	<b>Material</b>	<b>Sewer Use</b>	<b>Purpose</b>	<b>Length</b>	
8	Vitrified Clay Pipe	Sanitary	Routine Assessment		
<b>Comments</b>				<b>Pre-Cleaning</b>	<b>TV Length</b>
				Jetting	269.3

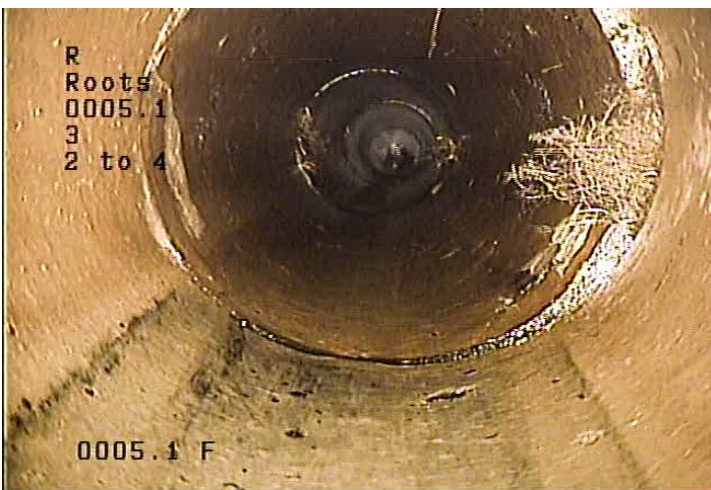
R - Roots @ 5.1 ft.

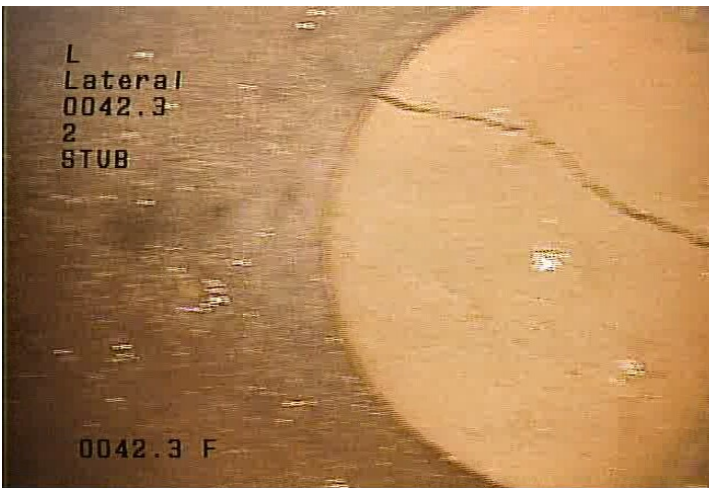
L - Lateral @ 42.3 ft. STUB

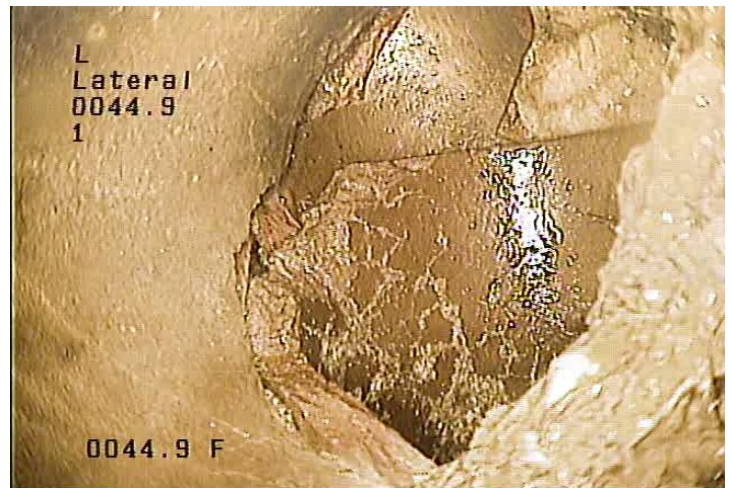
L - Lateral @ 44.9 ft.

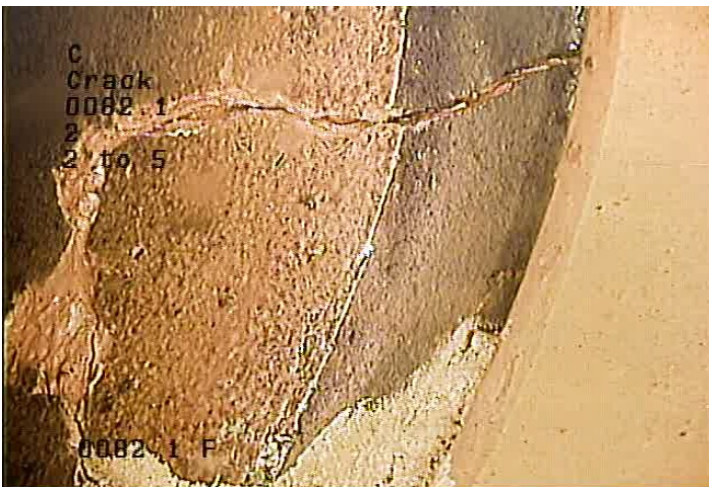
C - Crack @ 82.1 ft.

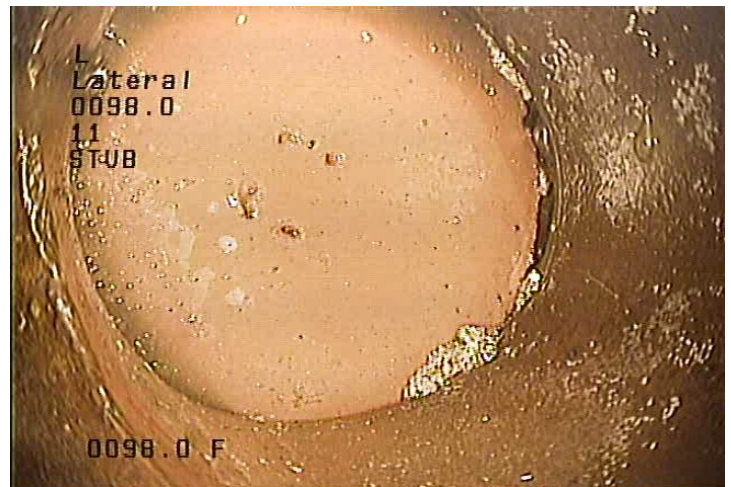
L - Lateral @ 98.0 ft. STUB

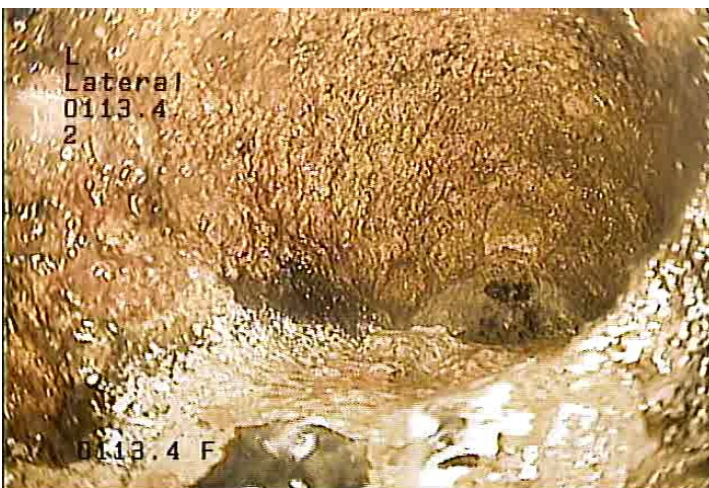
L - Lateral @ 113.4 ft.

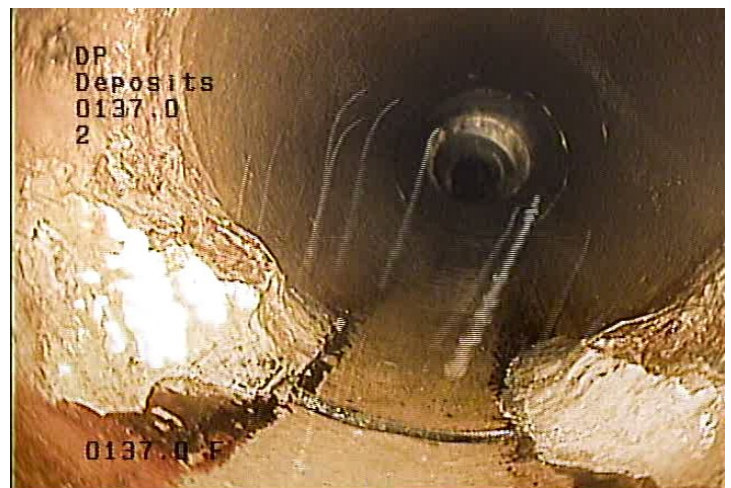
DP - Deposits @ 137.0 ft.

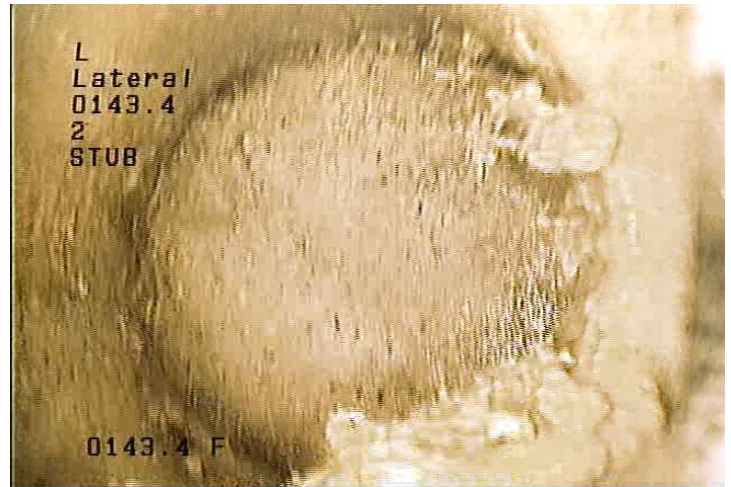
L - Lateral @ 143.4 ft. STUB

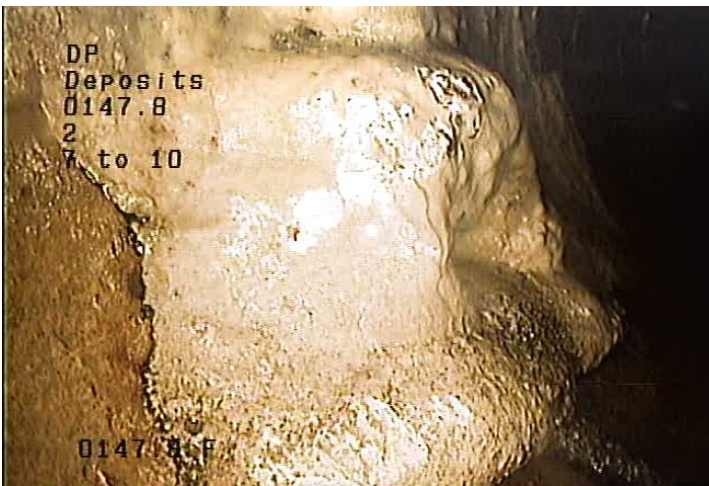
DP - Deposits @ 147.8 ft.

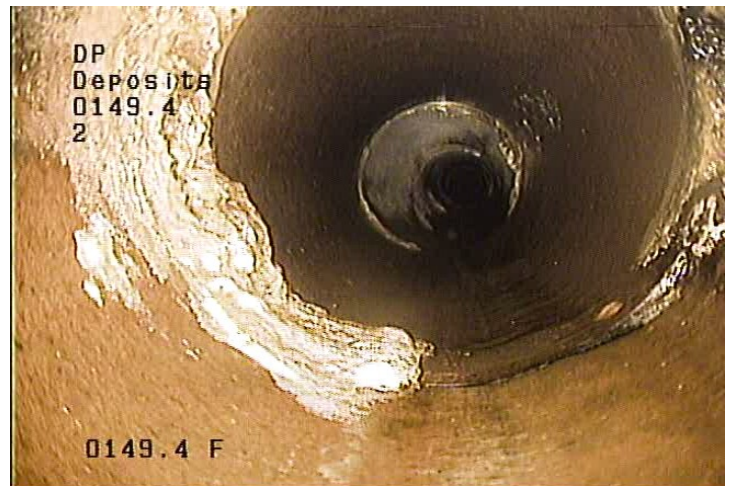
DP - Deposits @ 149.4 ft.

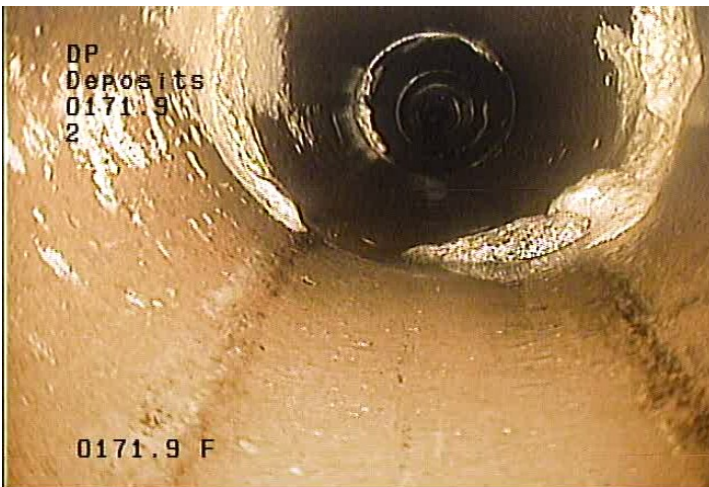
DP - Deposits @ 171.9 ft.

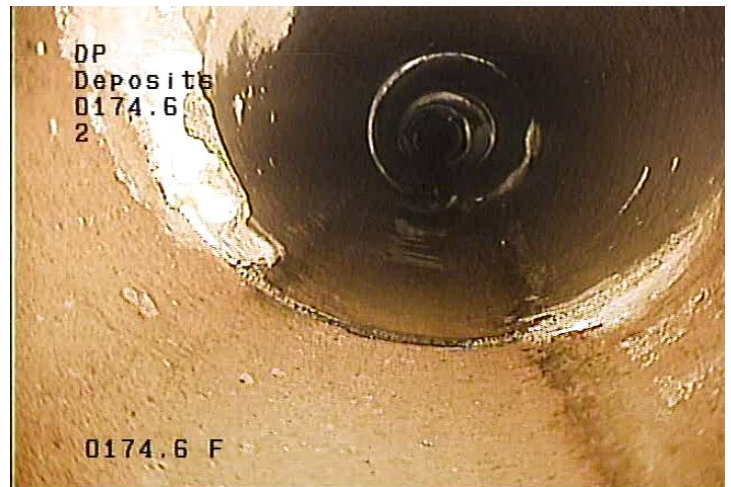
DP - Deposits @ 174.6 ft.

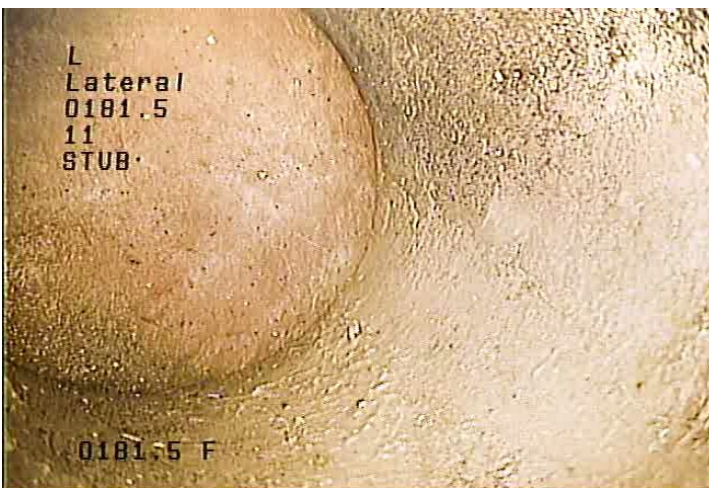
L - Lateral @ 181.5 ft. STUB

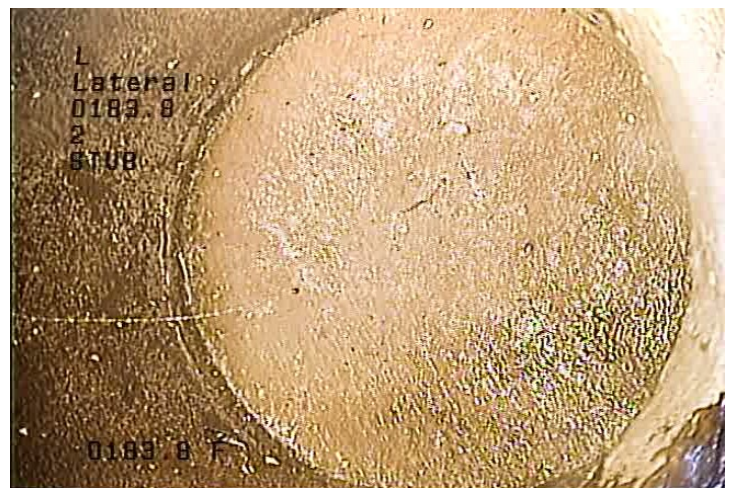
L - Lateral @ 183.8 ft. STUB

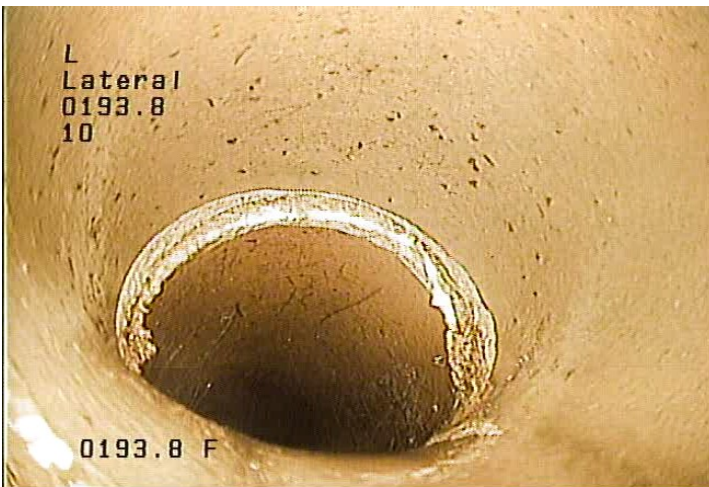
L - Lateral @ 193.8 ft.

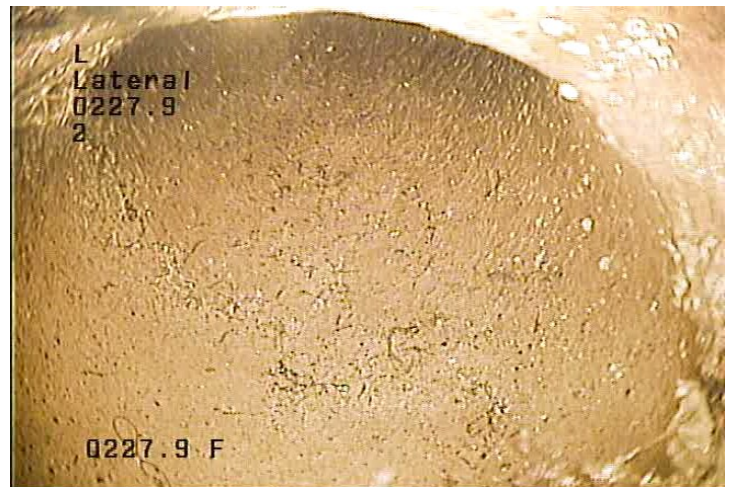
L - Lateral @ 227.9 ft.

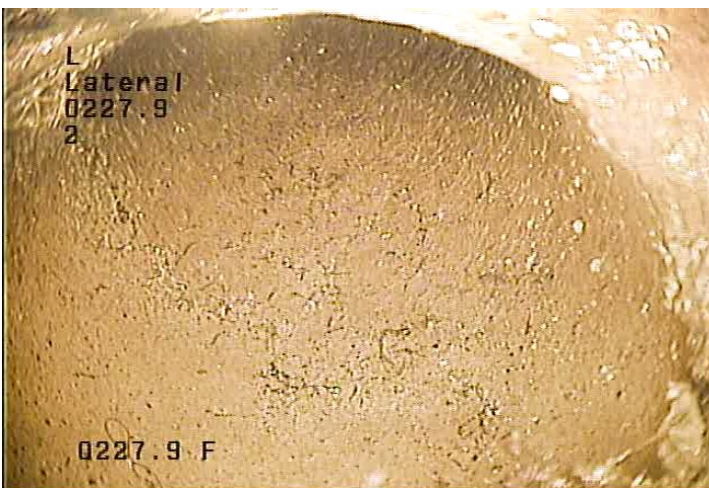
R - Roots @ 227.9 ft.

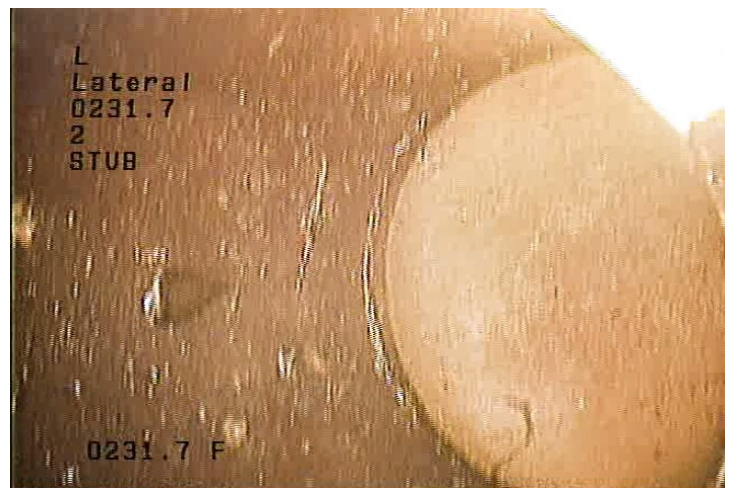
L - Lateral @ 231.7 ft. STUB

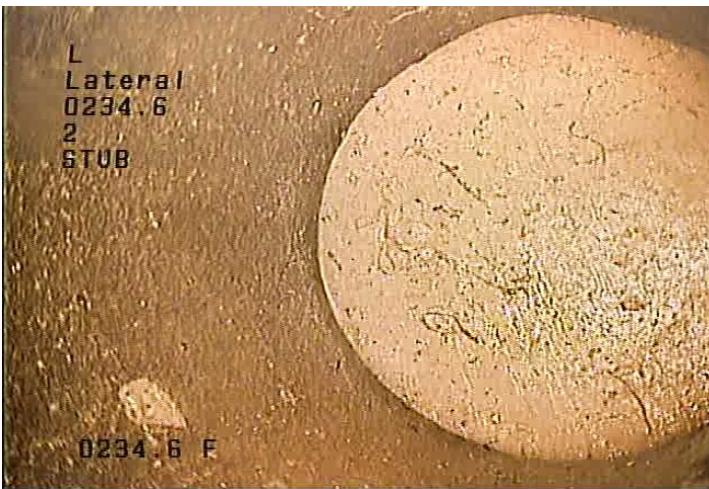
L - Lateral @ 234.6 ft. STUB
