PACP Inspection Report

Project	P/O Number	Reviewed by
Owner	Work Order No.	Certificate No.
Customer		
Purpose of Survey		
COF		
Pressure Value		
Surveyed by 31	Date 9/12/2025	Weather
Certificate No. 1234	Time 10:12	Pre-cleaning No Pre-Cleaning
Inspection Status Complete Inspection		Date Cleaned
Inspection Tech.		Flow Control
Direction of Survey Downstream

Drainage Area	Street	DODSON ST
Pipe Segment Ref. 3VM02-3UM03	City	GENEVA
Location Code		
Location Details

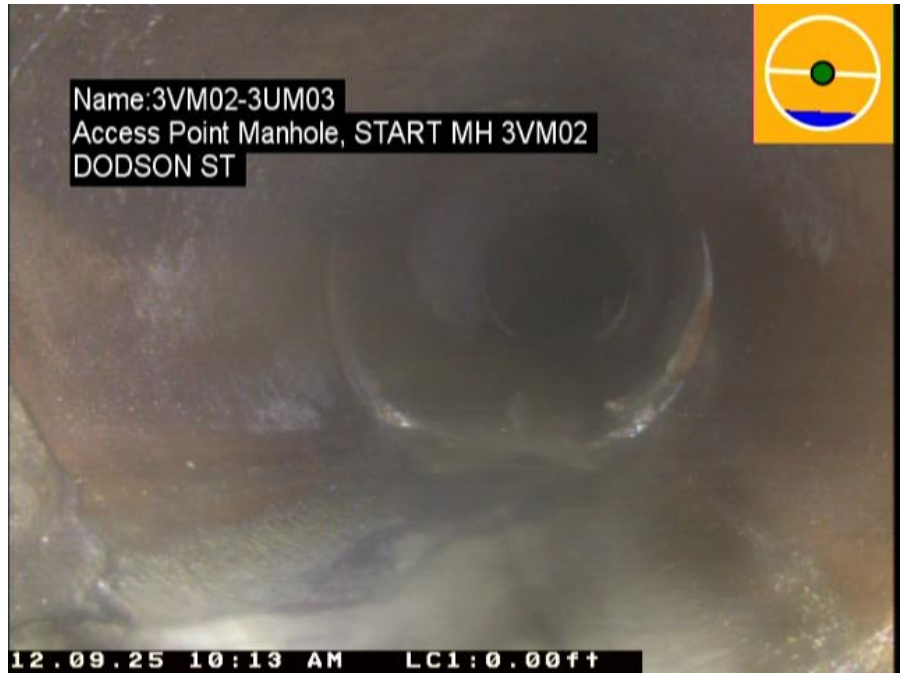
Image Ref. 001

Access Point Manhole, START MH
3VM02 DODSON ST

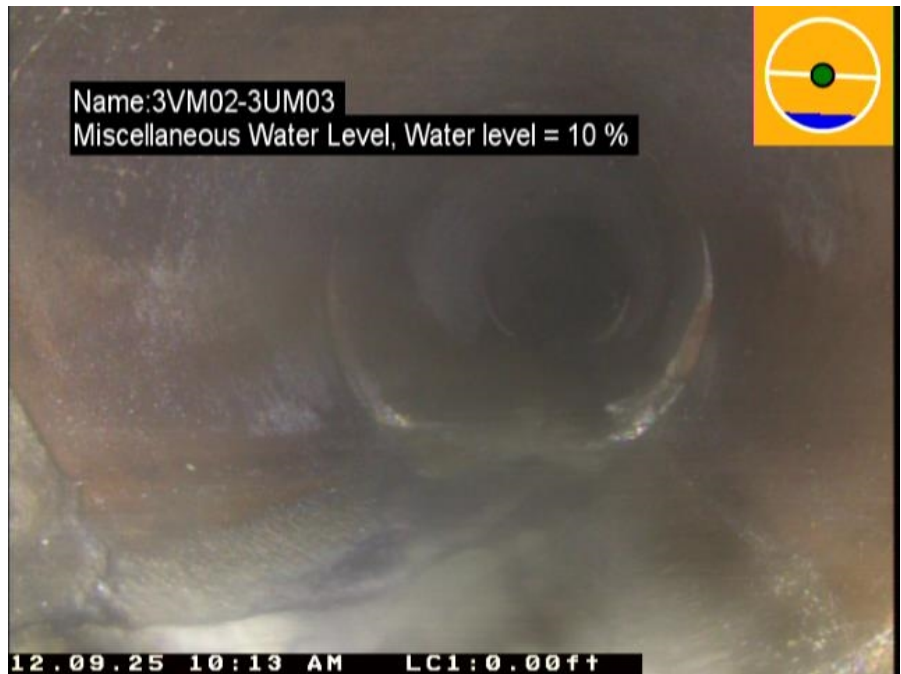
Image Ref. 002

Miscellaneous Water Level, Water
level = 10 %

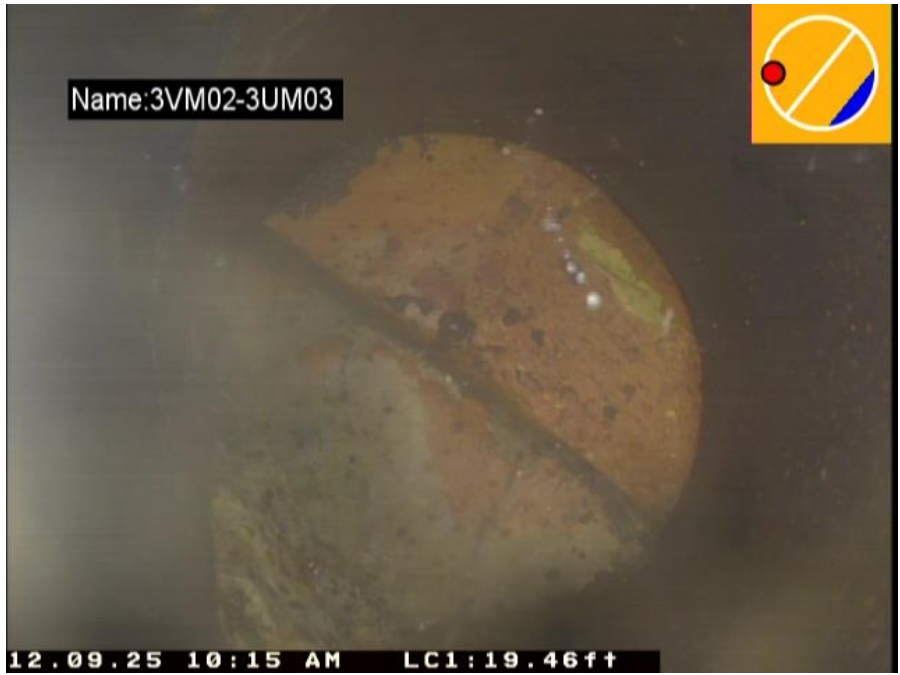
Image Ref. 003

Tap Factory Activity at 10 o'clock,
Diameter = 8 in.

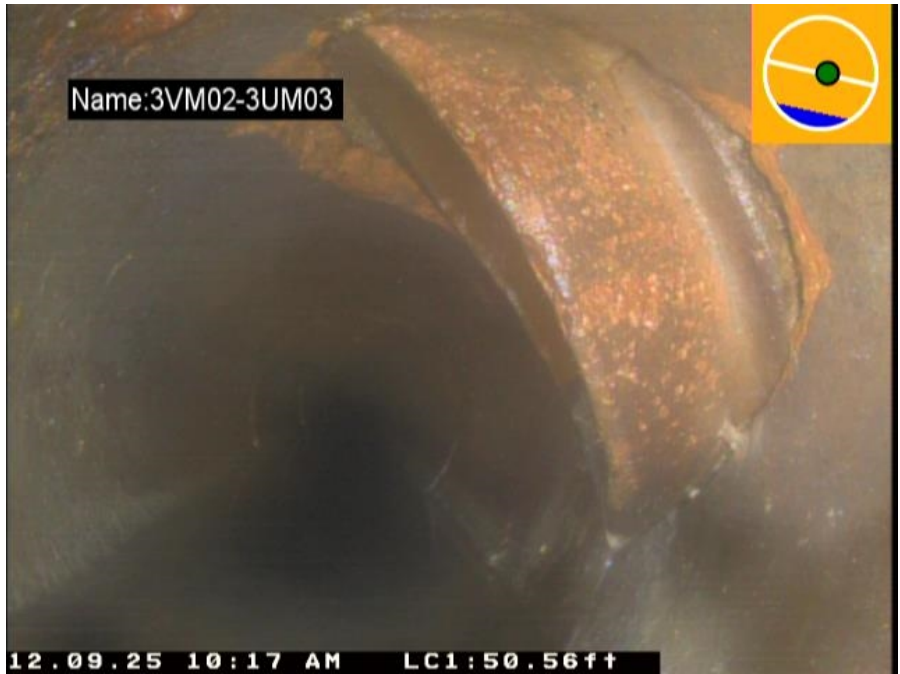
Image Ref. 004

Tap Factory Intruding at 2 o'clock,
Diameter = 8 in., Intrusion = 2 in.,
OM:4

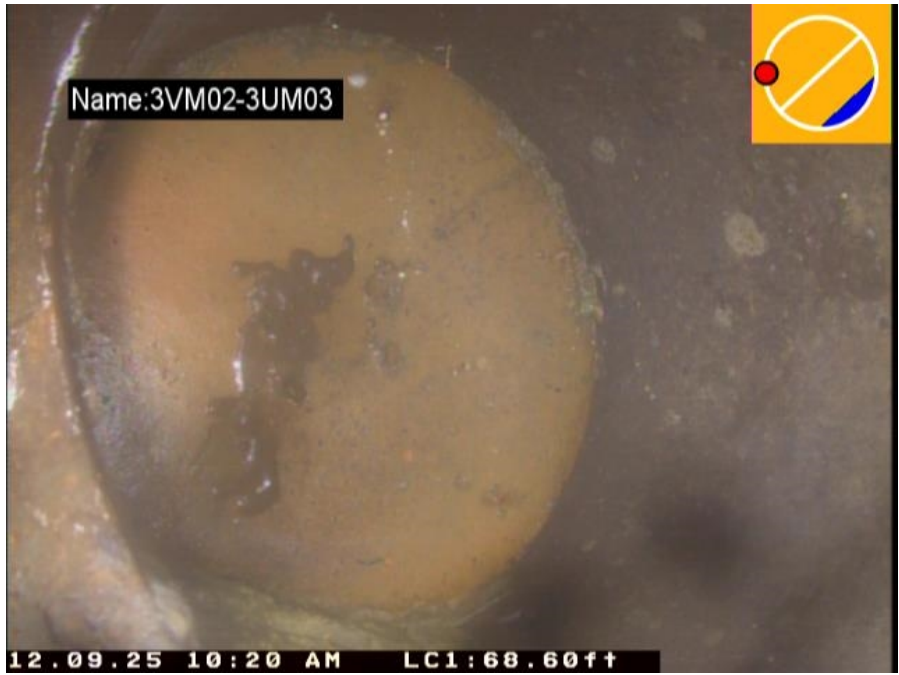
Image Ref.	005
Video	00:05:30
Dist. downstream	68.60 ft
Code	TFA
C. Location	10

Tap Factory Activity at 10 o'clock,
Diameter = 8 in.

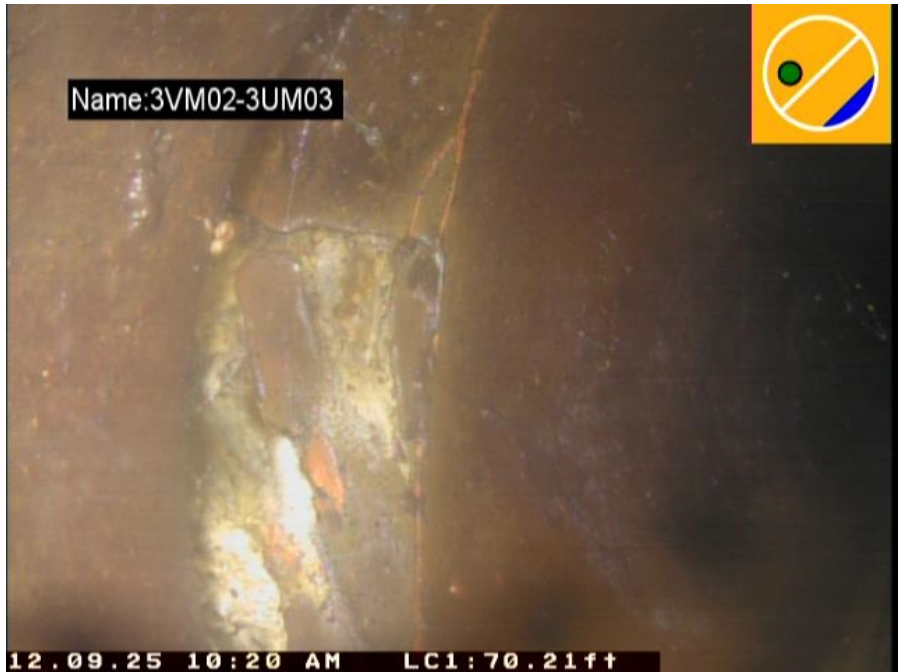
Image Ref.	006
Video	00:07:17
Dist. downstream	70.21 ft
Code	CC
C. Location	06 - 11

Crack Circumferential from 6 to 11
o'clock, Length = 2 in., Width = 0.5
in., S:1

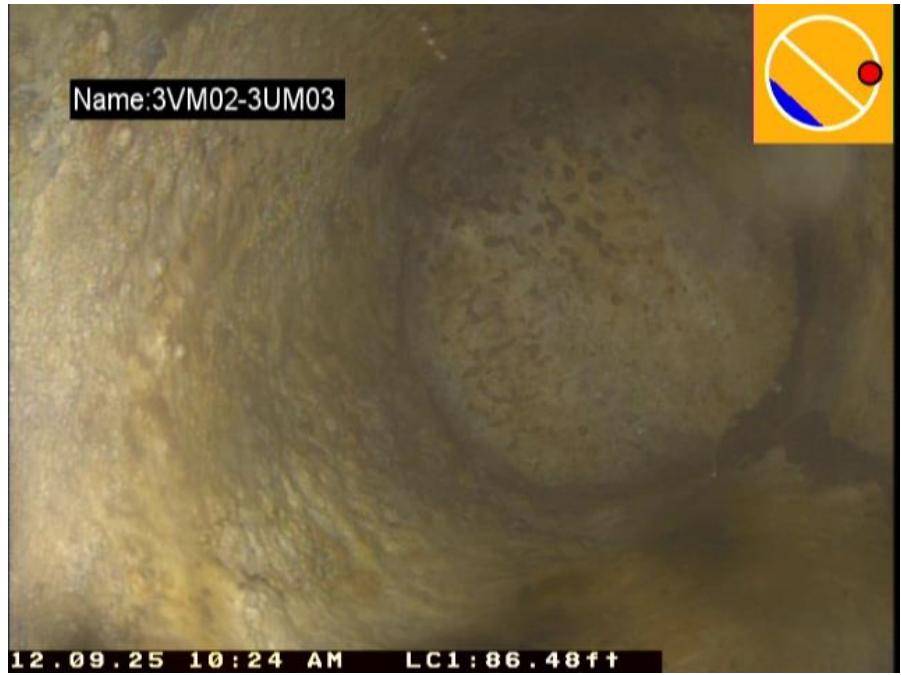
Image Ref. 007

Tap Factory Activity at 2 o'clock,
Diameter = 8 in.

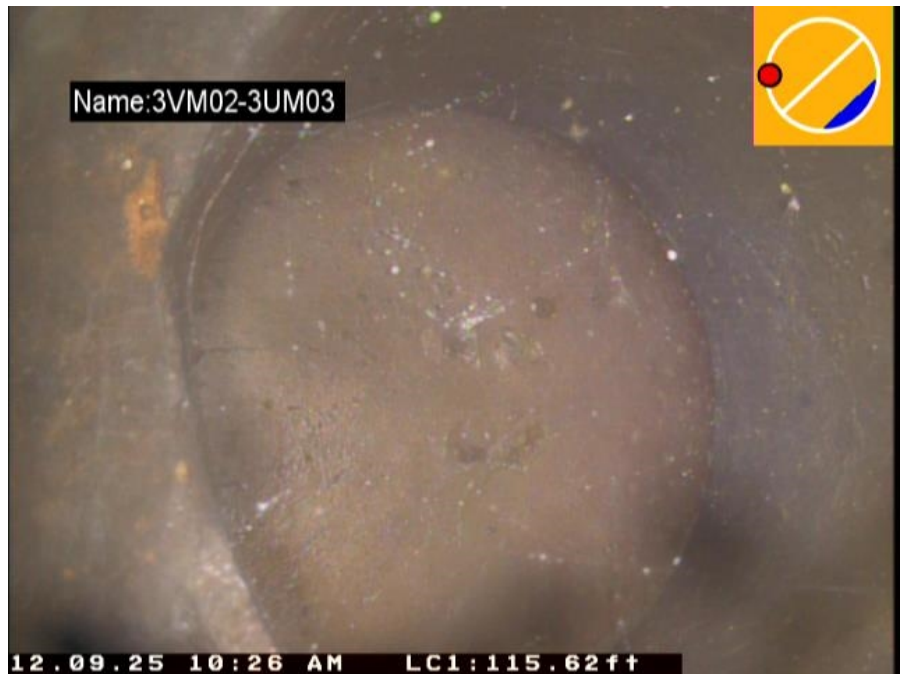
Image Ref. 008

Tap Factory Activity at 10 o'clock,
Diameter = 8 in.

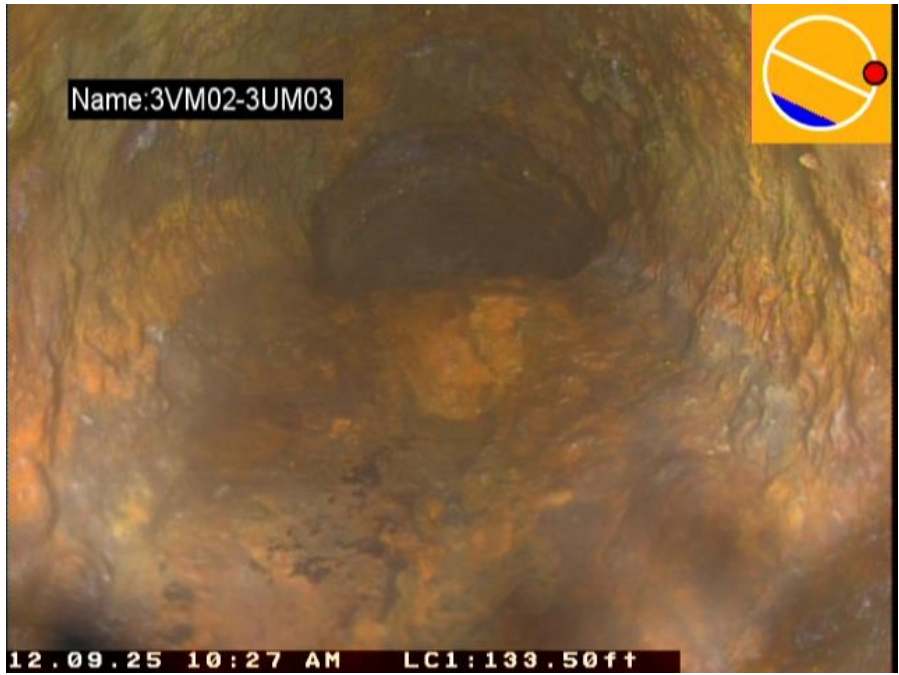
Image Ref. 009

Tap Factory at 2 o'clock, Diameter = 8 in., HEAVY GREASE

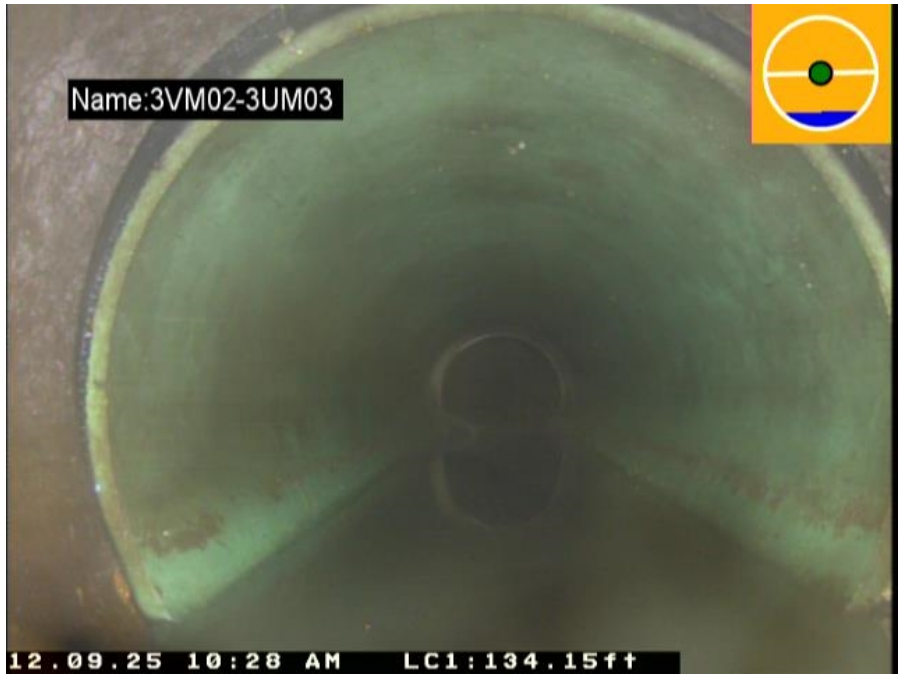
Image Ref. 010

Miscellaneous Material Change,
REPAIR START PVC

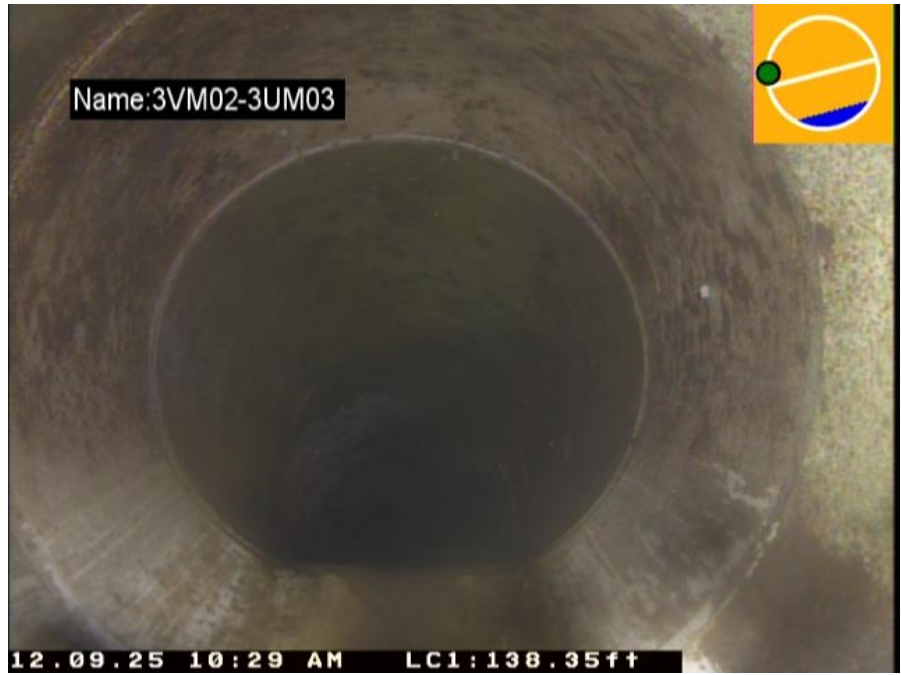
Image Ref. 011

Tap Factory at 10 o'clock, Diameter = 8 in.

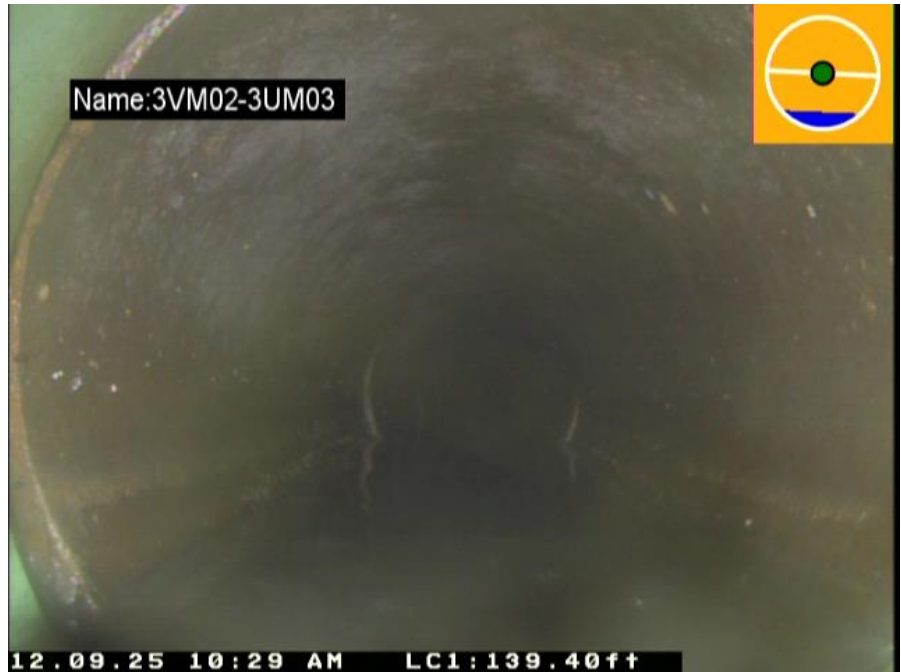
Image Ref. 012

Miscellaneous Material Change, END REPAIR

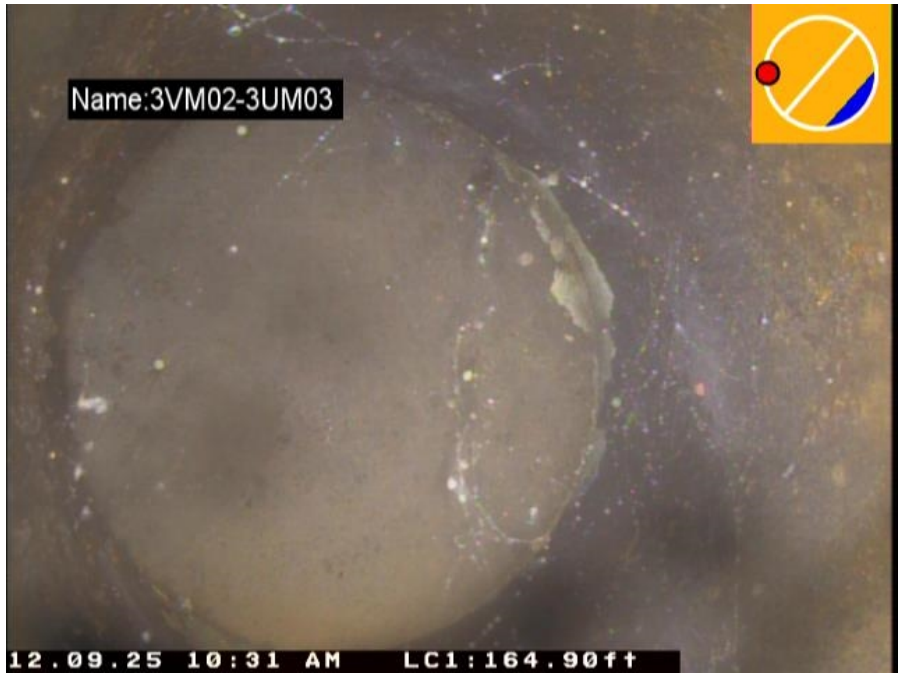
Image Ref. 013

Tap Factory Activity at 10 o'clock,
Diameter = 8 in.

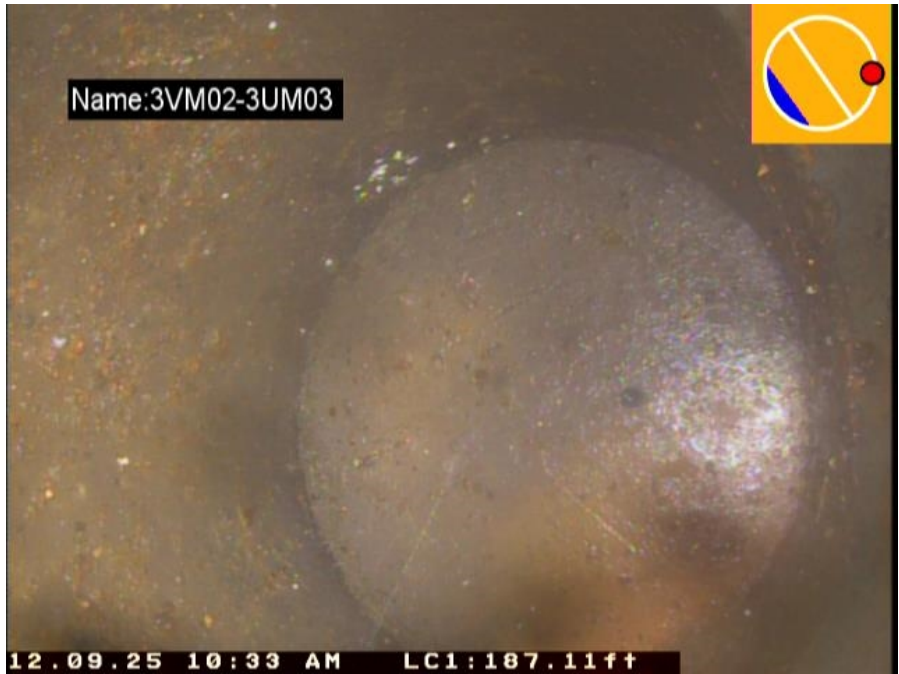
Image Ref. 014

Tap Factory Activity at 2 o'clock,
Diameter = 8 in.

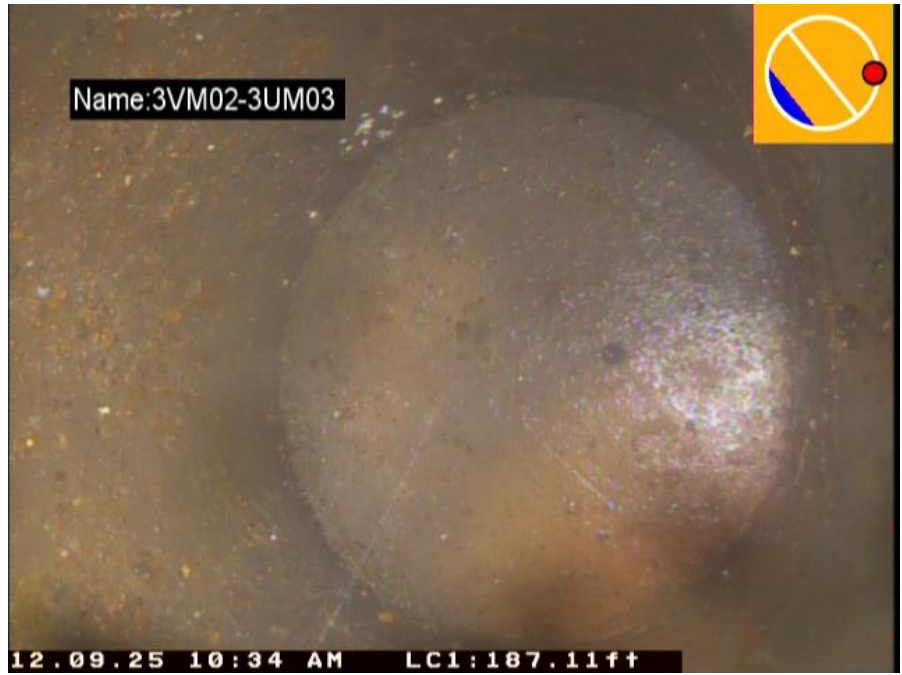
Image Ref. 015

Tap Factory Abandoned at 2 o'clock, Diameter = 8 in.

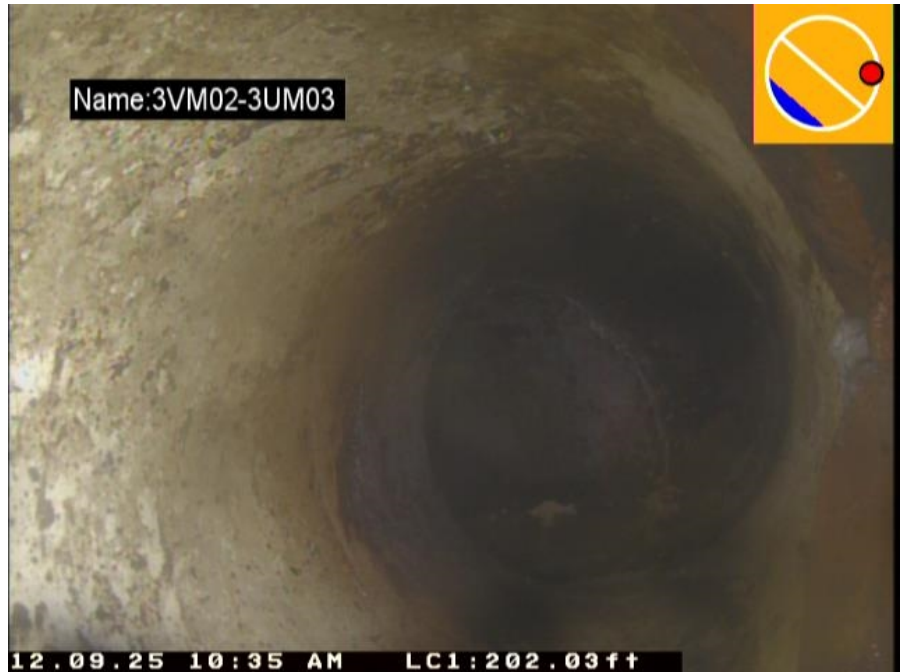
Image Ref. 016

Tap Factory at 2 o'clock, Diameter = 8 in.

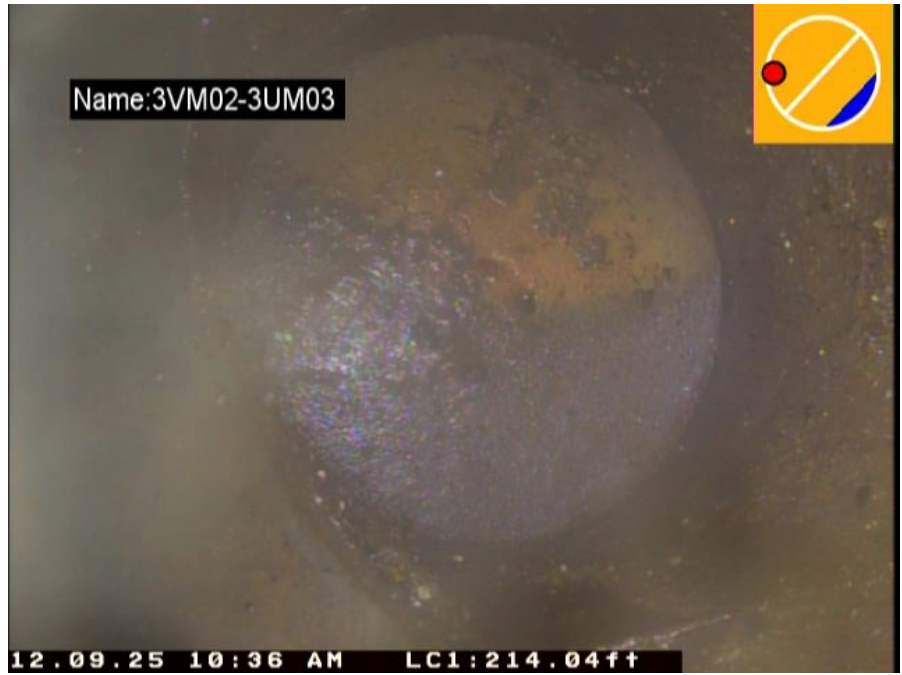
Image Ref. 017

Tap Factory Abandoned at 10 o'clock, Diameter = 8 in.

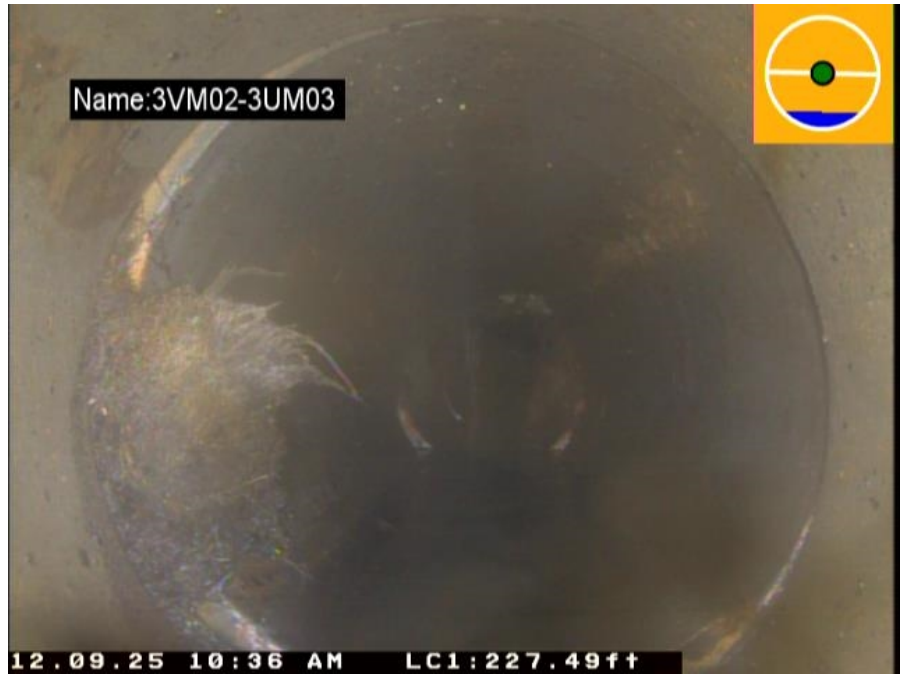
Image Ref. 018

Roots Fine Joint from 7 to 9 o'clock, Joint, OM:1

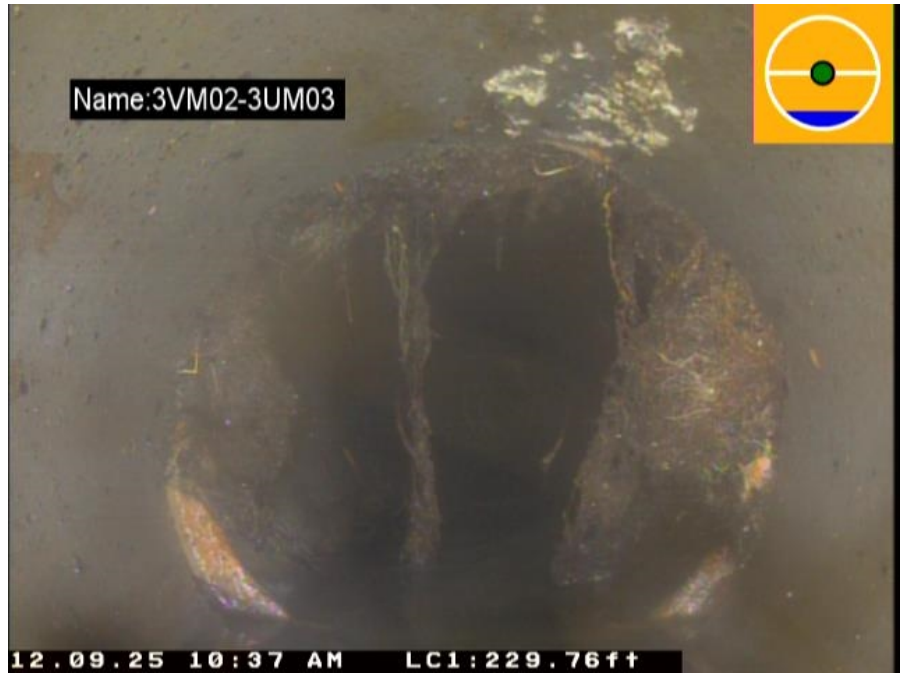
Image Ref. 019

Roots Fine Joint from 9 to 3 o'clock, Joint, OM:1

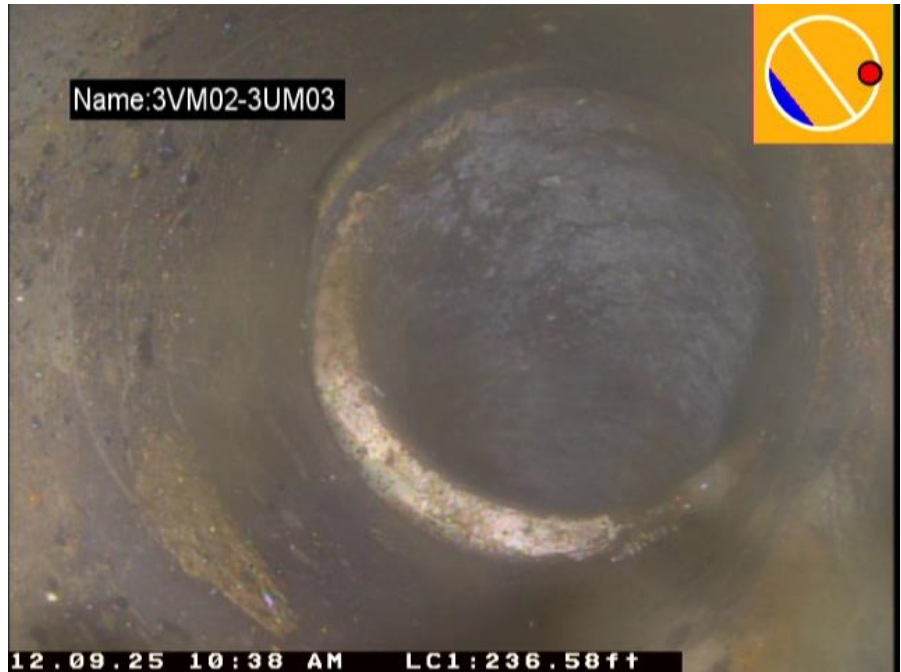
Image Ref. 020

Tap Factory at 2 o'clock, Diameter = 8 in.

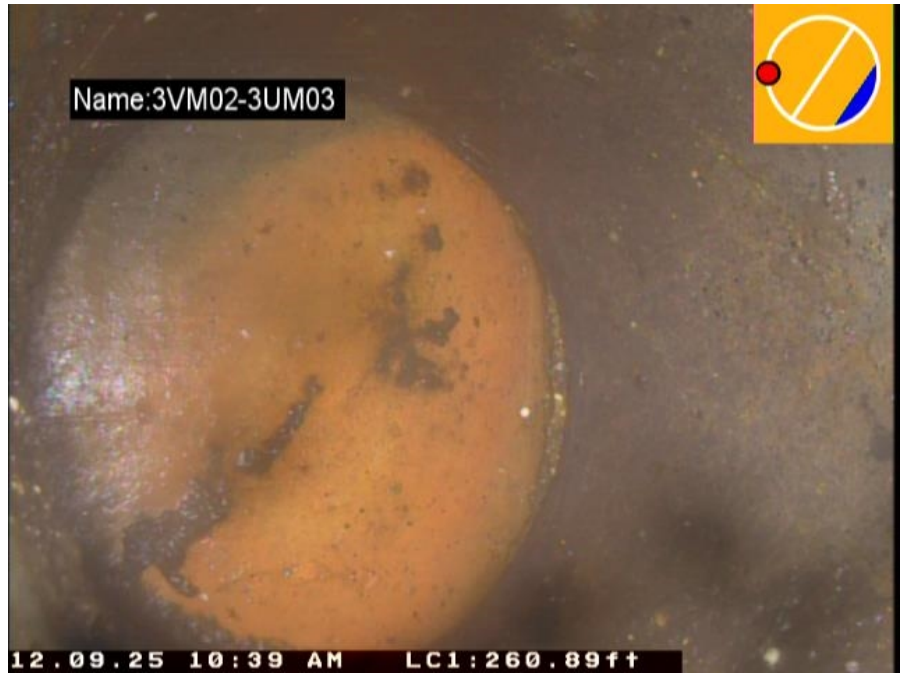
Image Ref. 021

Tap Factory Abandoned at 10 o'clock, Diameter = 8 in.

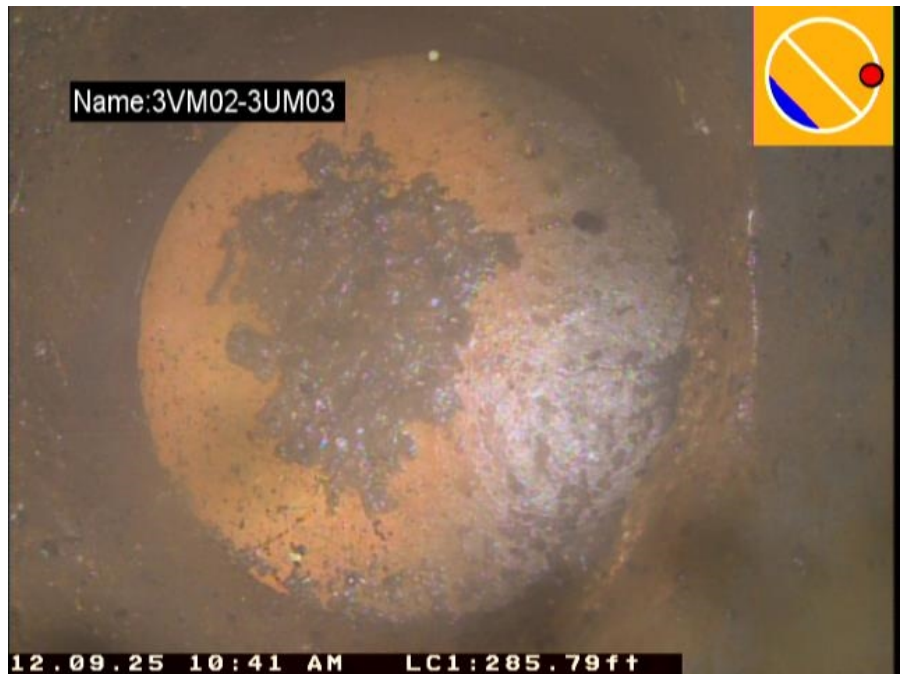
Image Ref. 022

Tap Factory Abandoned at 2 o'clock, Diameter = 8 in.

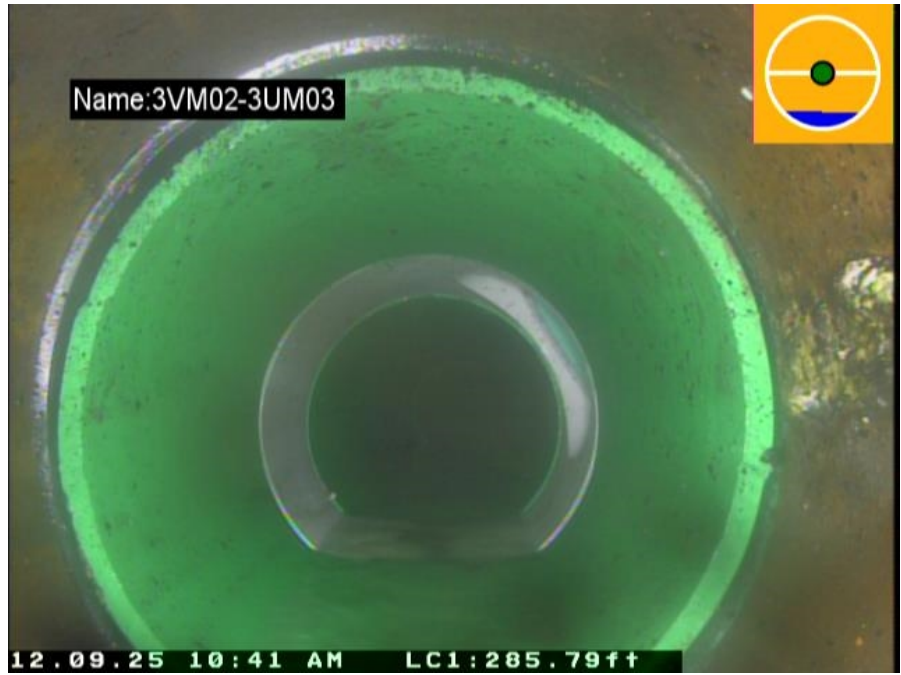
Image Ref. 023

Miscellaneous Material Change,
START REPAIR PVC

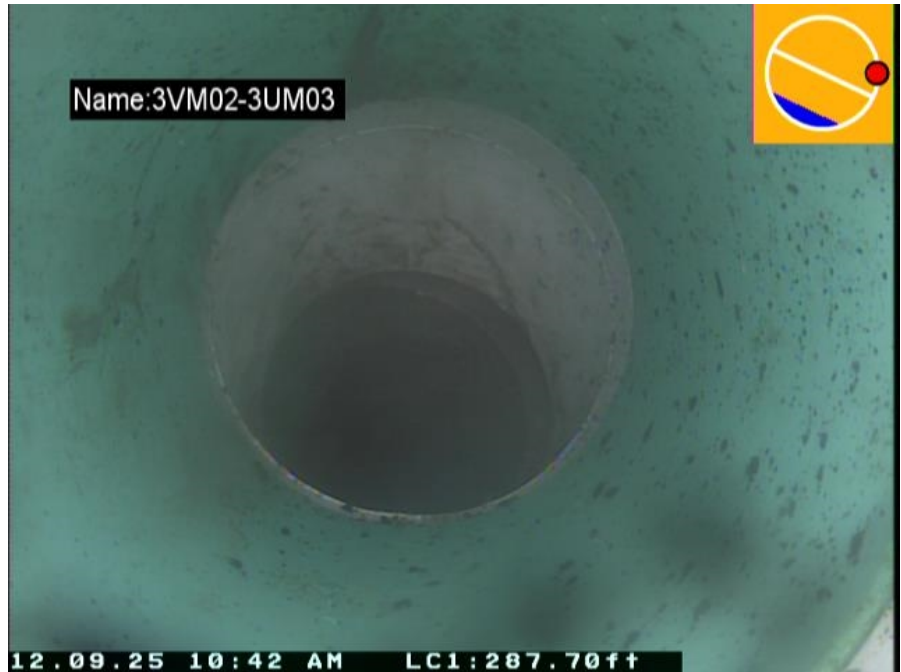
Image Ref. 024

Tap Factory at 2 o'clock, Diameter =
8 in.

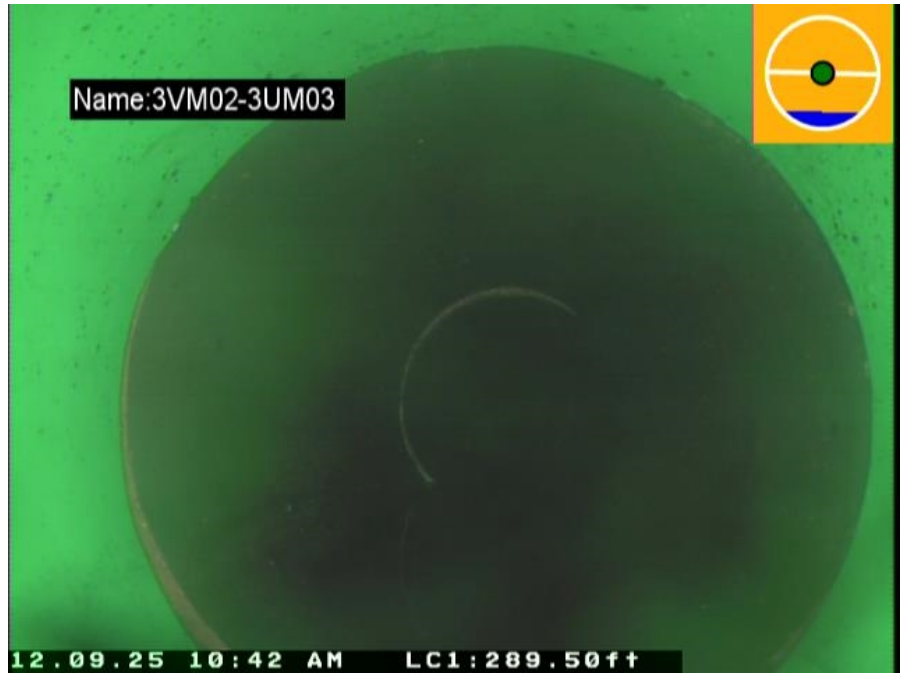
Image Ref. 025

Miscellaneous Material Change,
END REPAIR

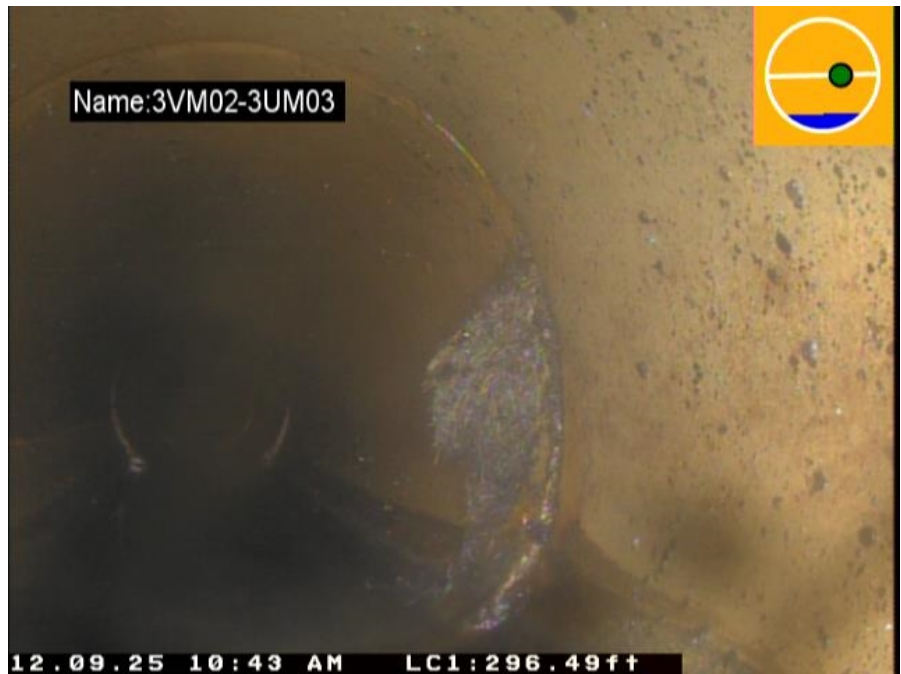
Image Ref. 026

Roots Fine Joint from 1 to 3 o'clock,
Joint, OM:1

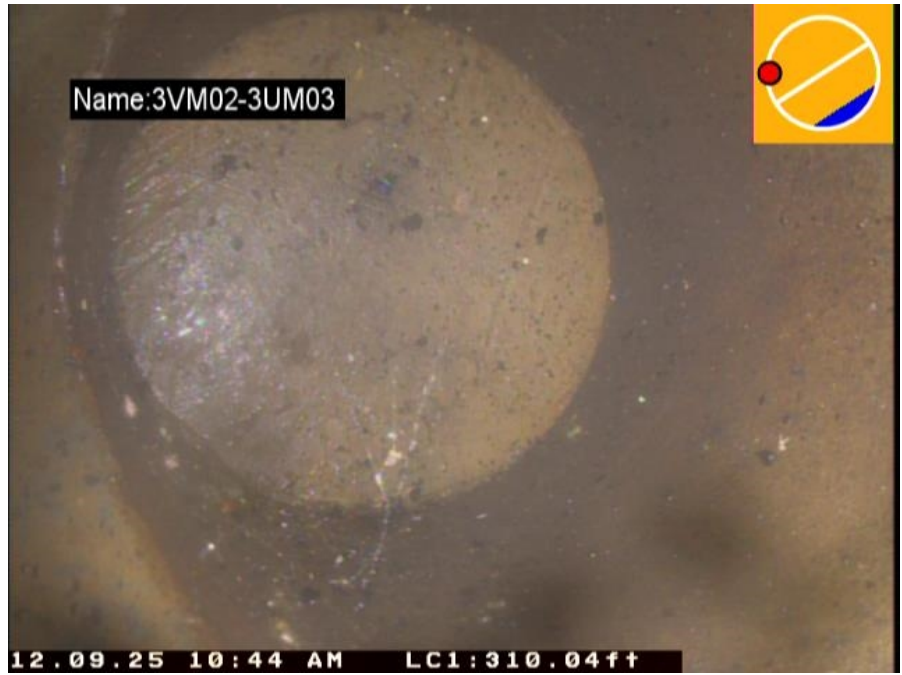
Image Ref. 027

Tap Factory Abandoned at 10 o'clock, Diameter = 8 in.

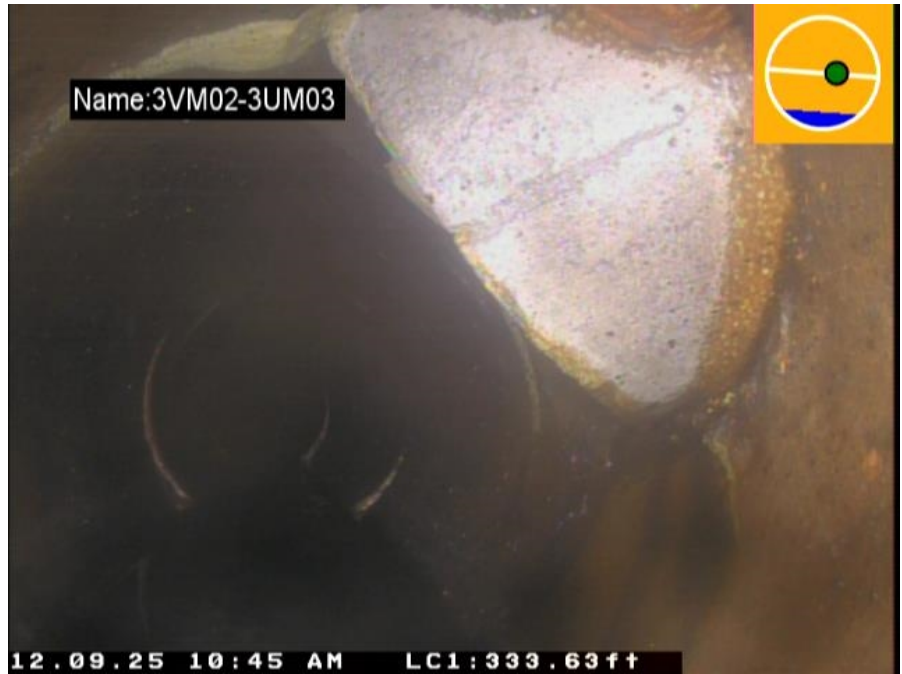
Image Ref. 028

Tap Factory Intruding at 2 o'clock, Diameter = 8 in., Intrusion = 2 in., OM:4

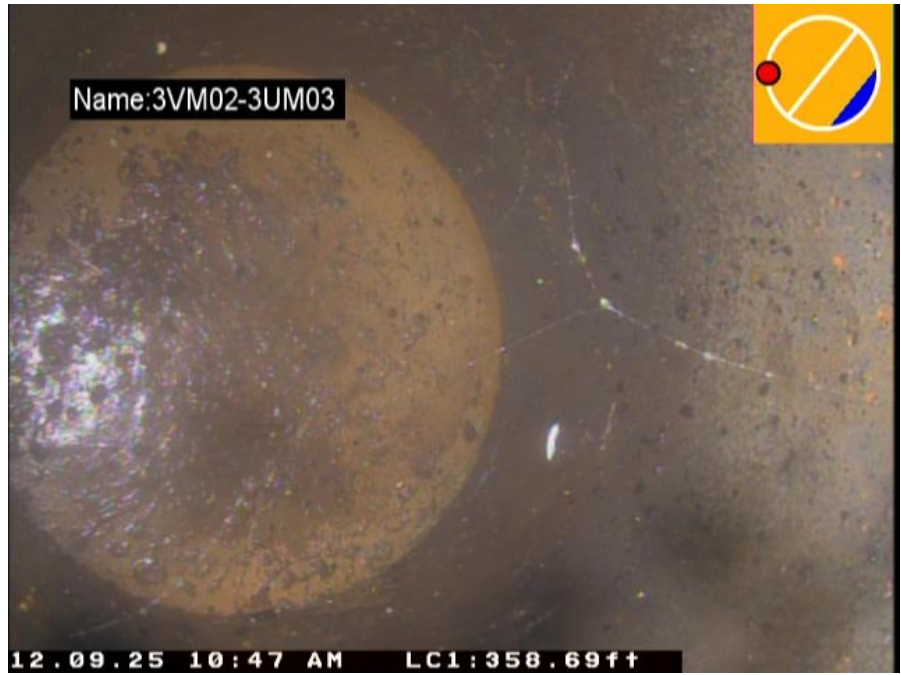
Image Ref.	029
Video	00:25:28
Dist. downstream	358.69 ft
Code	TFB
C. Location	11

Tap Factory Abandoned at 11 o'clock, Diameter = 8 in.

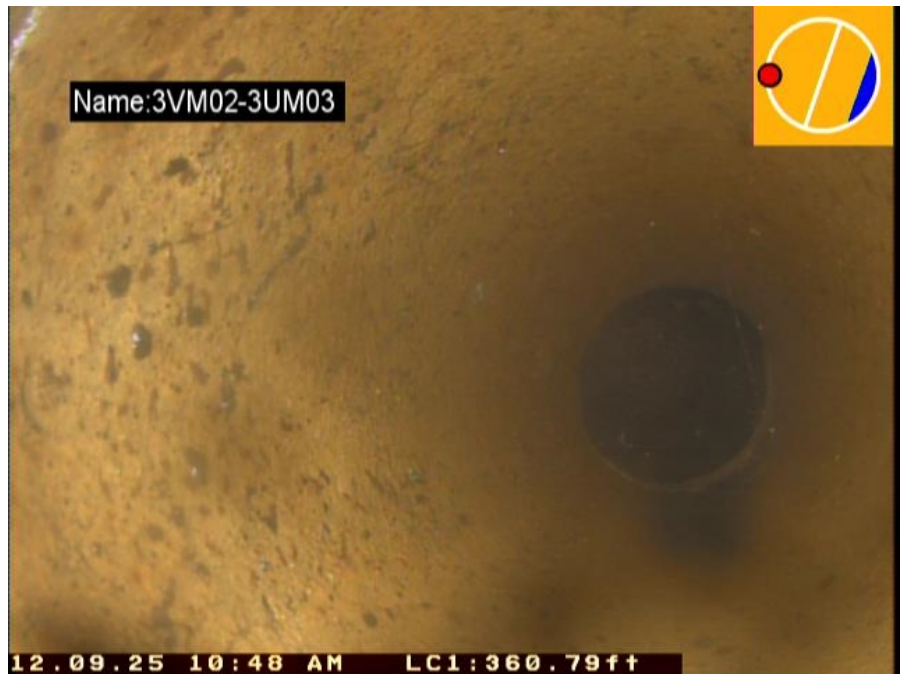
Image Ref.	030
Video	00:26:01
Dist. downstream	360.86 ft
Code	TF
C. Location	12

Tap Factory at 12 o'clock, Diameter = 8 in.

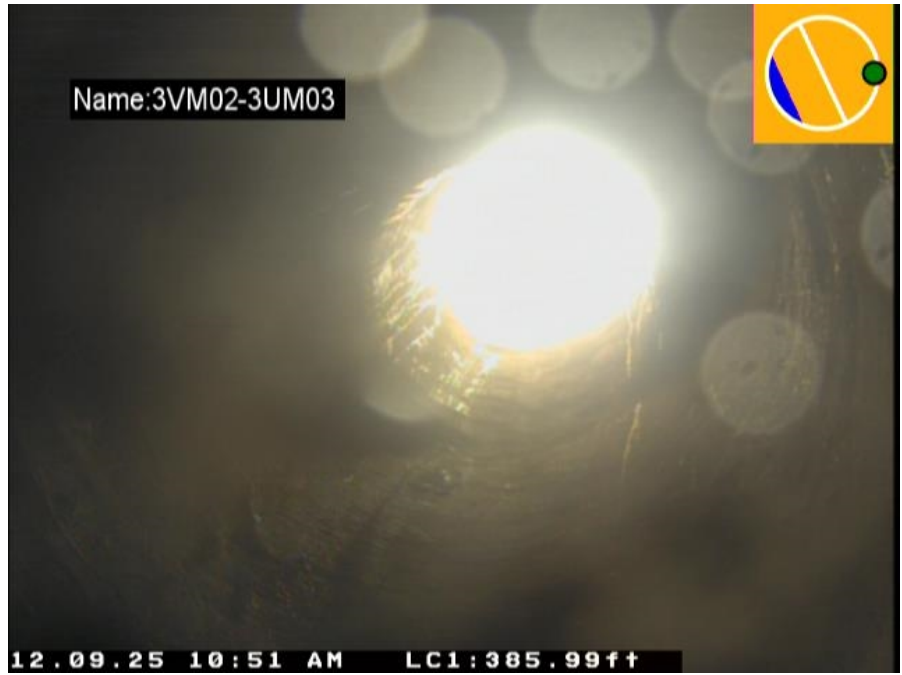
Image Ref. 031

Access Point Manhole, END RUN
3UM03 DODSON
