<b>Owner</b>	<b>Customer</b>	<b>Upstream MH</b>	<b>Downstream MH</b>	<b>Date</b>	<b>Time</b>
		3VM37	3VM38	01-13-2021	9:42 AM
<b>Surveyor</b>	<b>Street</b>		<b>City</b>	<b>Weather</b>	
NICK	SIMPSON		GENEVA	Dry	
<b>Size</b>	<b>Material</b>	<b>Sewer Use</b>	<b>Purpose</b>	<b>Length</b>	
8	Vitrified Clay Pipe	Sanitary	Routine Assessment		
<b>Comments</b>				<b>Pre-Cleaning</b>	<b>TV Length</b>
				Jetting	13.8

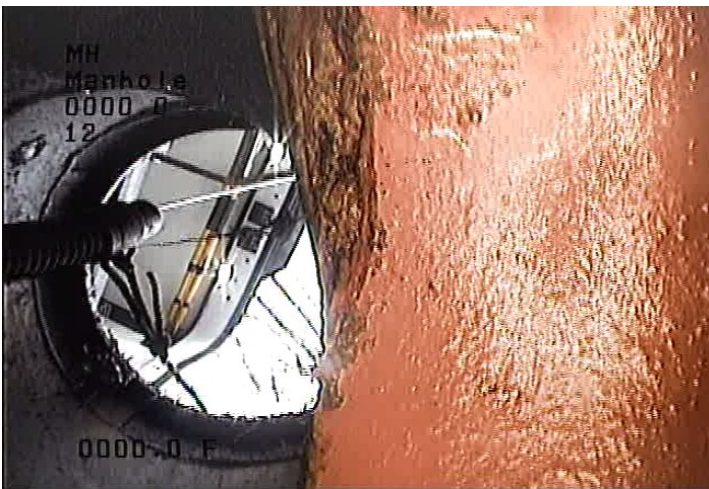
MH - Manhole @ 0.0 ft.

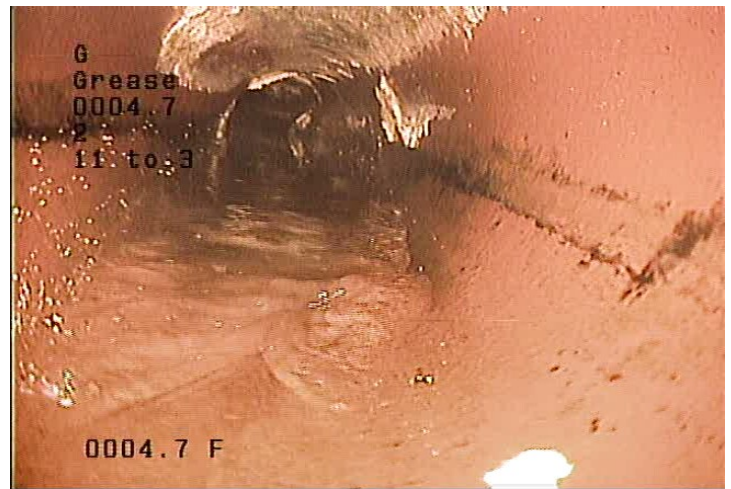
G - Grease @ 4.7 ft.

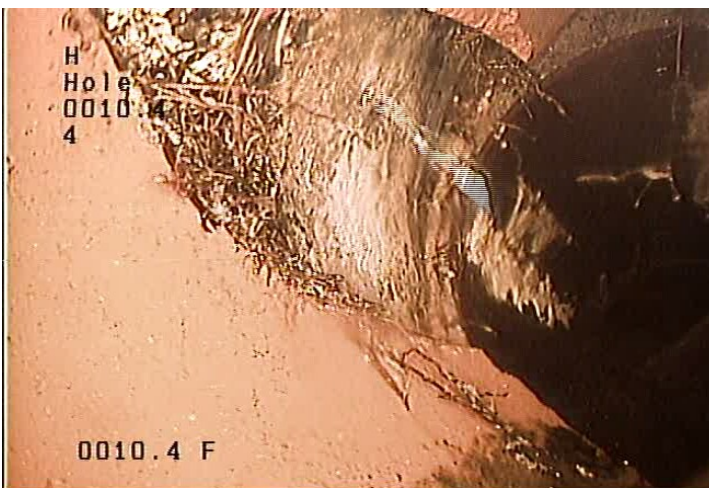
H - Hole @ 10.4 ft.

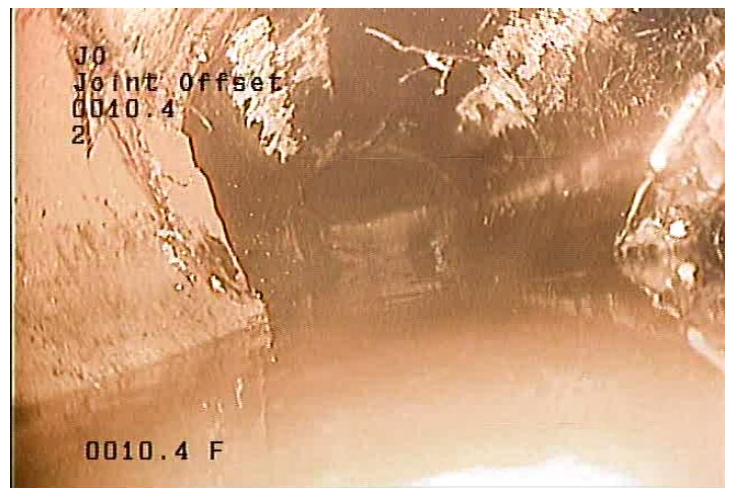
JO - Joint Offset @ 10.4 ft.

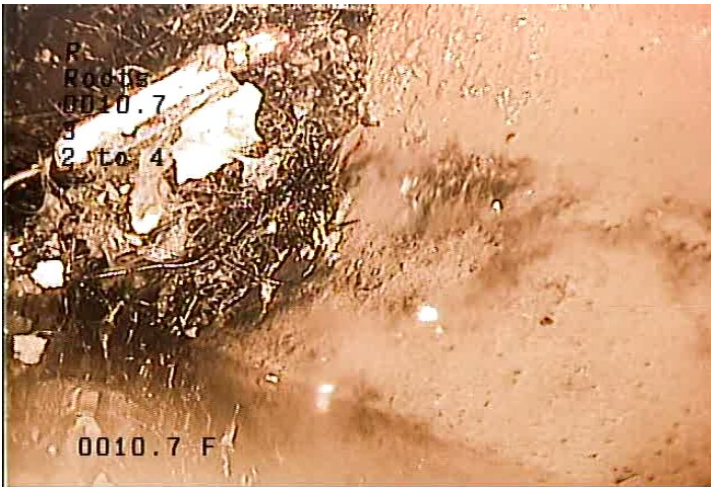
R - Roots @ 10.7 ft.

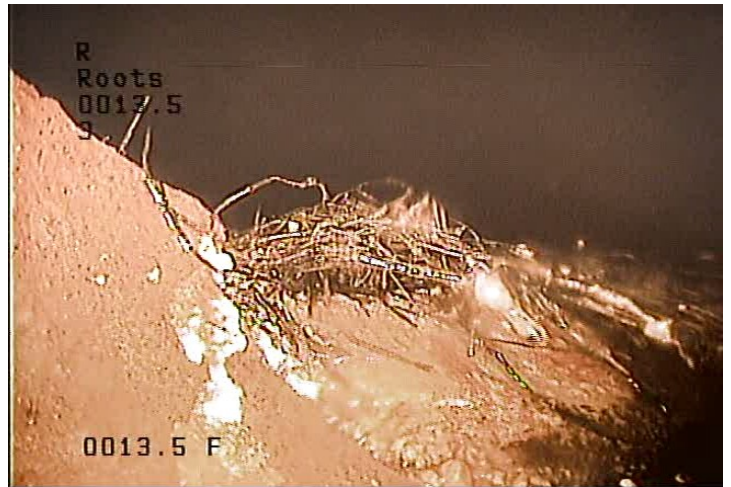
R - Roots @ 13.5 ft.

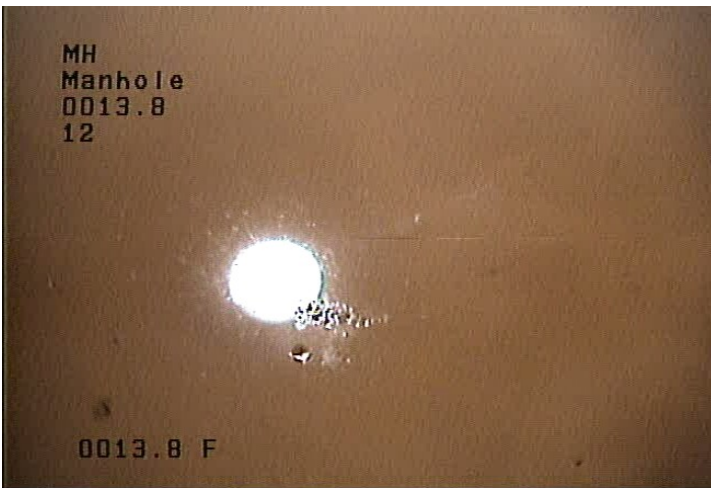
MH - Manhole @ 13.8 ft.
