Owner	Customer	Upstream MH	Downstream MH	Date	Time
		4NM17	4NM22	08-13-2018	12:23 PM
Surveyor	Street		City	Weather	
john	South		GENEVA	Dry	
Size	Material	Sewer Use	Purpose		Length
8	Vitrified Clay Pipe		Routine Assessment		
Comments				Pre-Cleaning	TV Length
root cut				Jetting	345.2

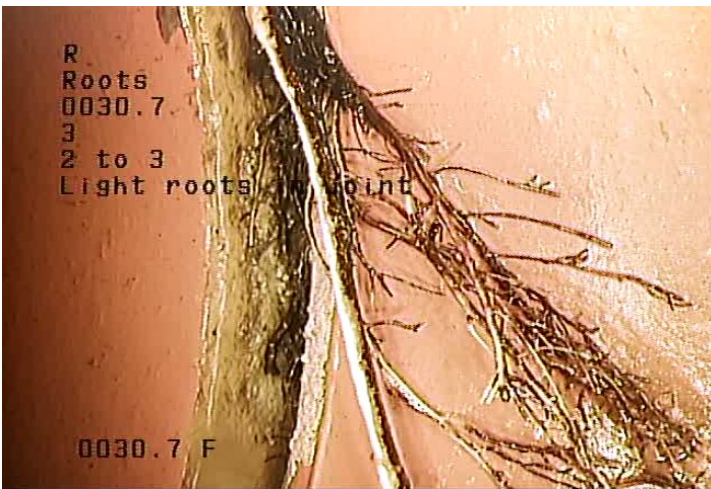
R - Roots @ 30.7 ft. Light roots in joint

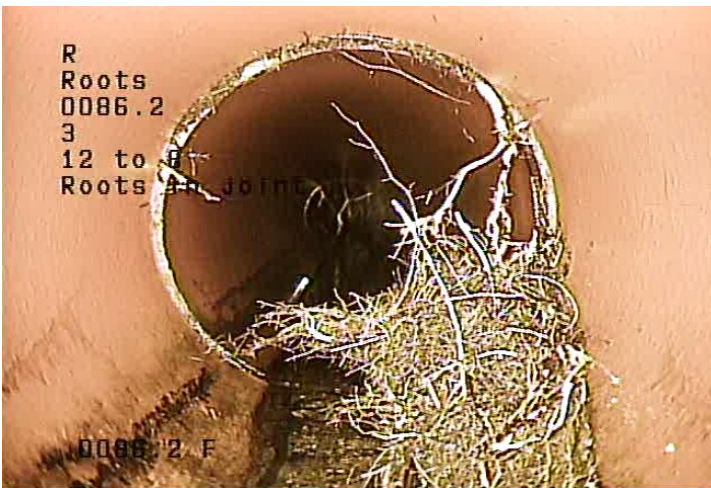
R - Roots @ 86.2 ft. Roots in joint

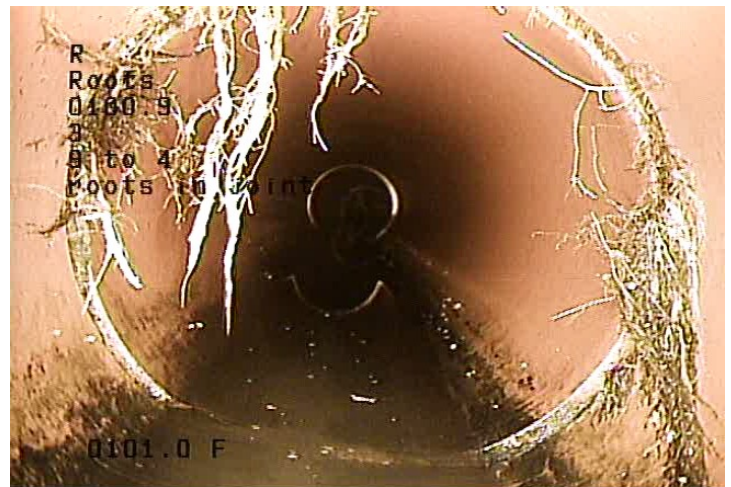
R - Roots @ 100.9 ft. roots in joint

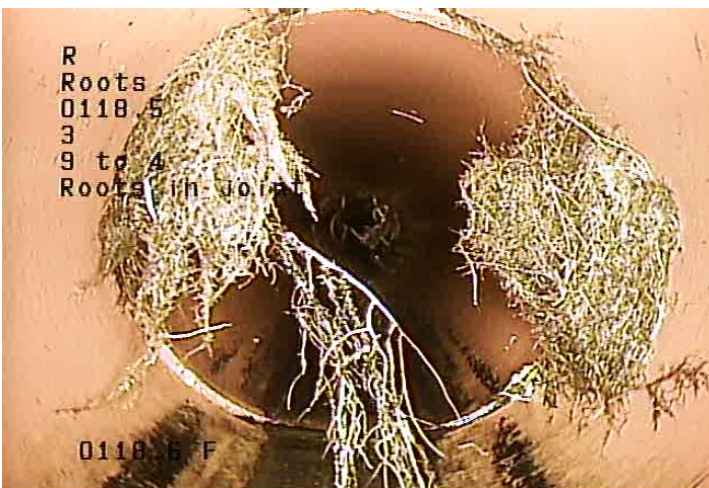
R - Roots @ 118.5 ft. Roots in joint

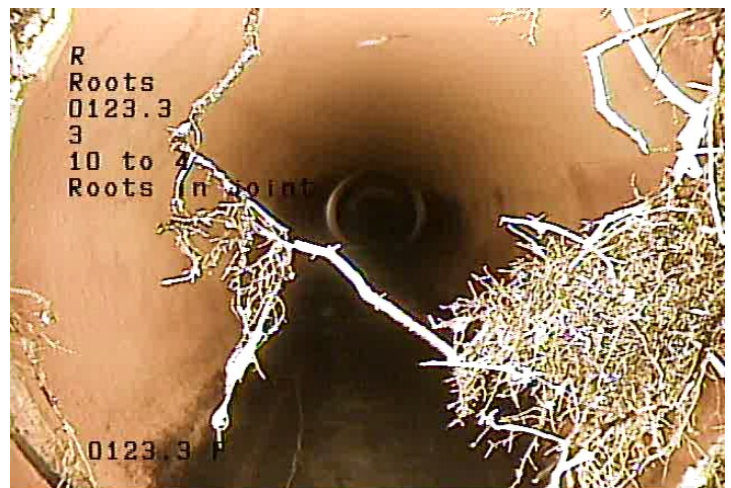
R - Roots @ 123.3 ft. Roots in joint

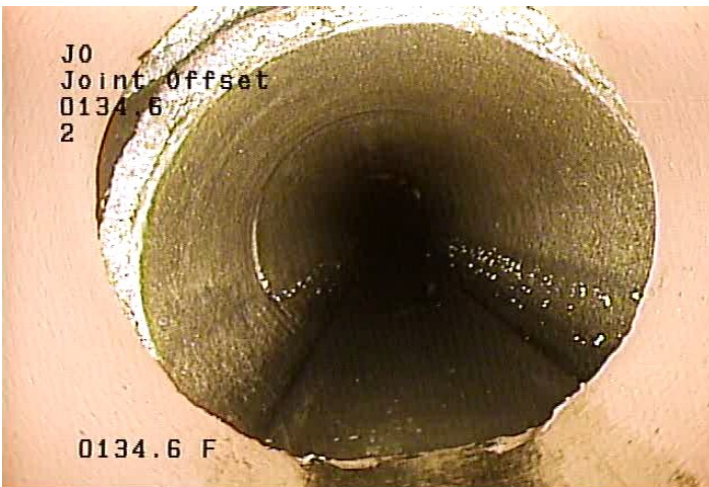
JO - Joint Offset @ 134.6 ft.

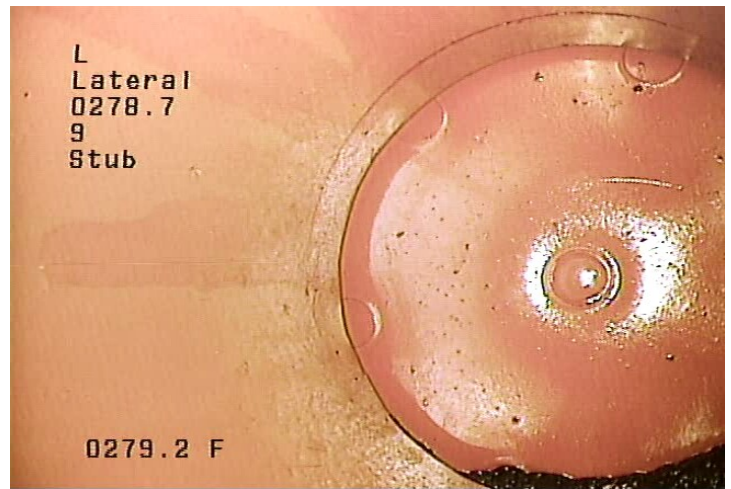
L - Lateral @ 278.7 ft. Stub

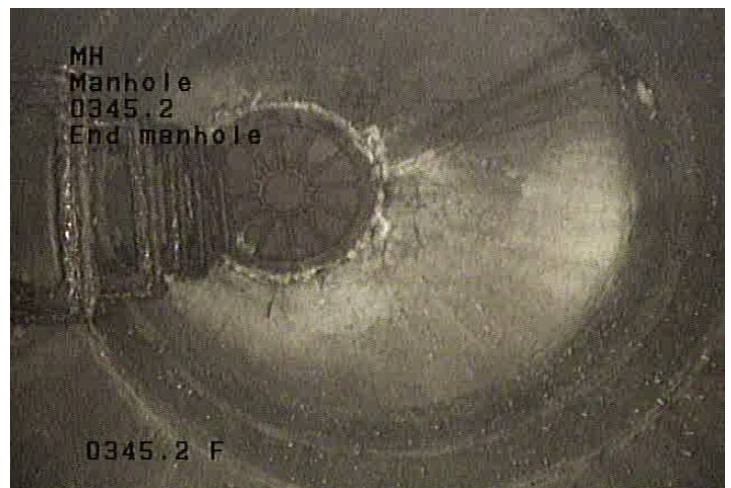
MH - Manhole @ 345.2 ft. End manhole
