<b>Owner</b>	<b>Customer</b>	<b>Upstream MH</b>	<b>Downstream MH</b>	<b>Date</b>	<b>Time</b>
		4UM09	4UM02	06-14-2021	12:50 PM
<b>Surveyor</b>	<b>Street</b>	<b>City</b>	<b>Weather</b>		
JEREMY	NEBRASKA	GENEVA	Dry		
<b>Size</b>	<b>Material</b>	<b>Sewer Use</b>	<b>Purpose</b>	<b>Length</b>	
6	Vitrified Clay Pipe	Sanitary	Routine Assessment		
<b>Comments</b>				<b>Pre-Cleaning</b>	<b>TV Length</b>
				Jetting	256.6

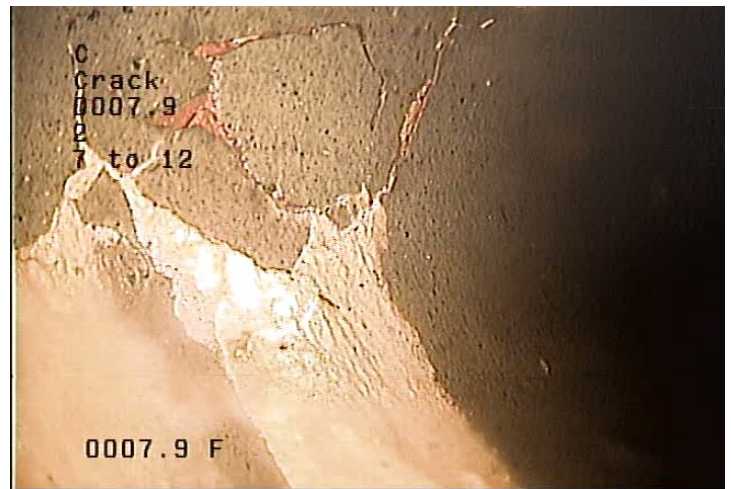
7.9	C	Crack	7 to 12	2

C - Crack @ 7.9 ft.

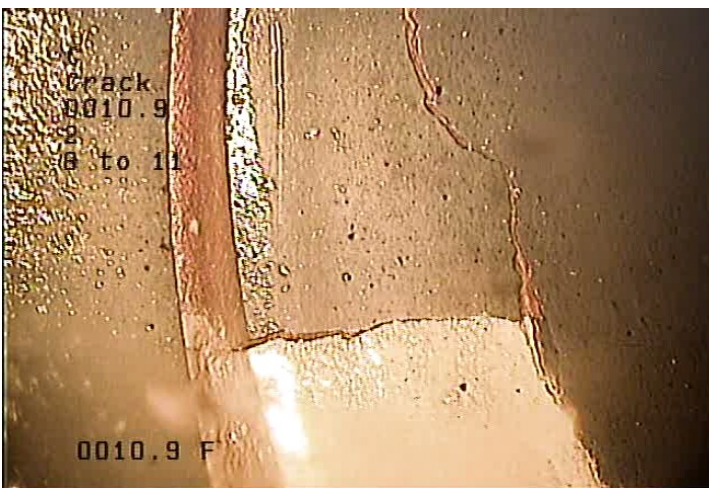
10.9	C	Crack	8 to 11	2

C - Crack @ 10.9 ft.

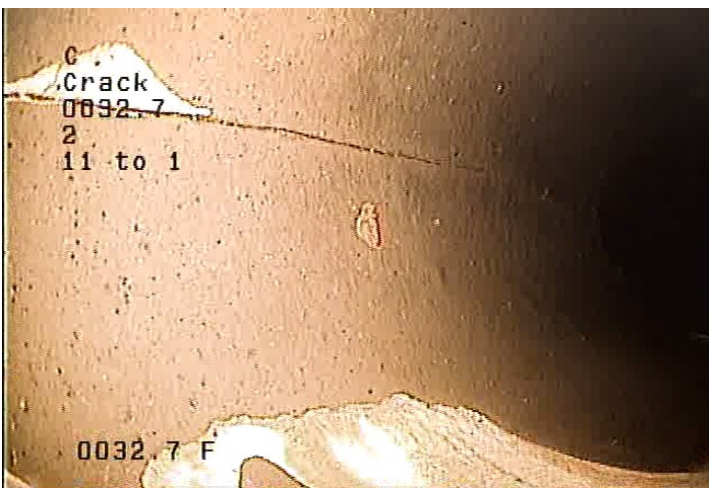
32.7	C	Crack	11 to 1	2

C - Crack @ 32.7 ft.

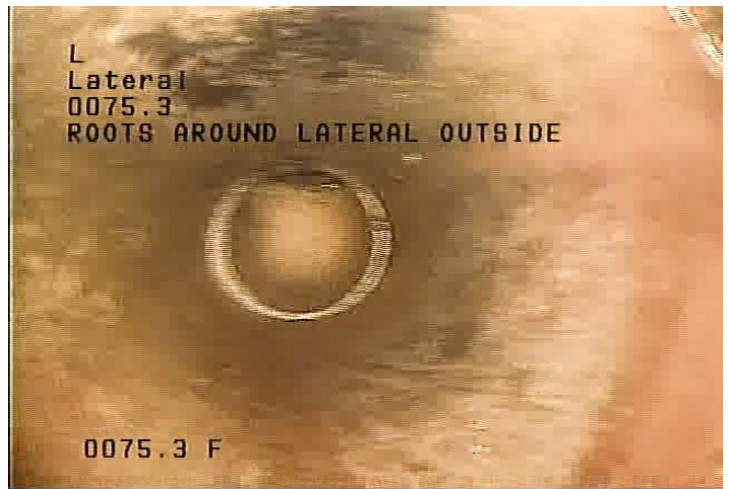
75.3	L	Lateral			ROOTS AROUND LATERAL OUTSIDE OFFSET IN LATERAL WITH ROOTS

L - Lateral @ 75.3 ft. ROOTS AROUND LATERAL OUTSIDE

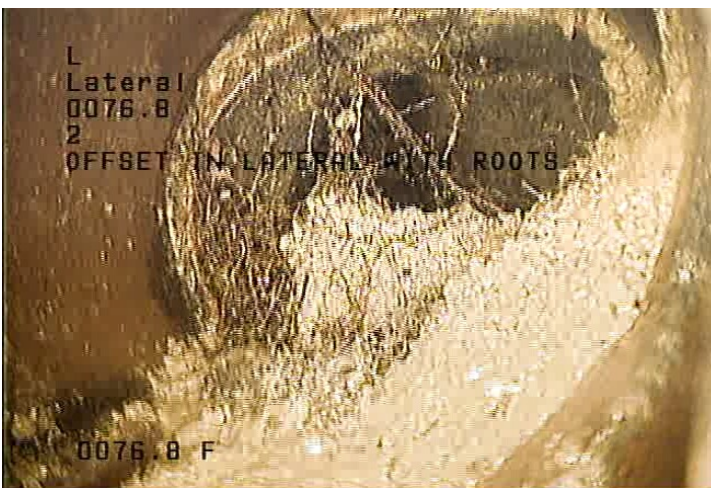
76.8	L	Lateral	2

L - Lateral @ 76.8 ft. OFFSET IN LATERAL WITH ROOTS

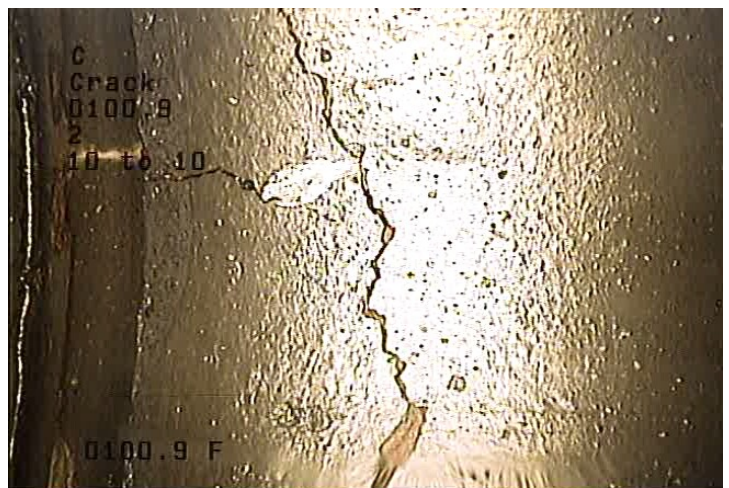
100.9	C	Crack	10 to 10	2

C - Crack @ 100.9 ft.

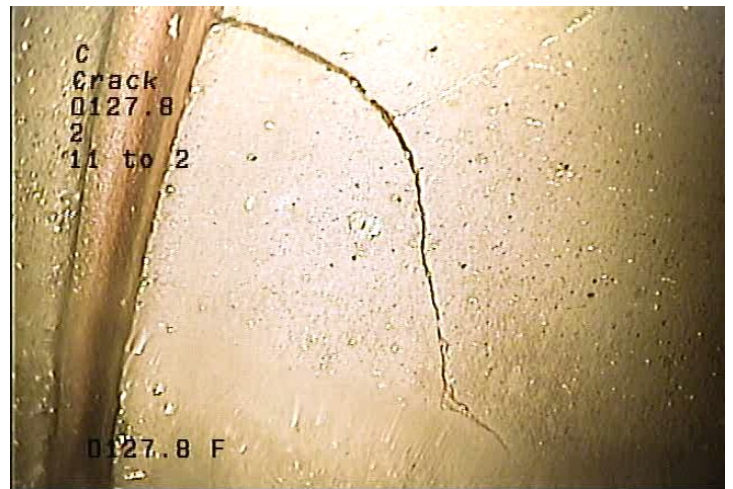
127.8	C	Crack	11 to 2	2

C - Crack @ 127.8 ft.
