<b>Owner</b>	<b>Customer</b>	<b>Upstream MH</b>	<b>Downstream MH</b>	<b>Date</b>	<b>Time</b>
		4UM14	4UM09	05-27-2021	1:49 PM
<b>Surveyor</b>	<b>Street</b>		<b>City</b>	<b>Weather</b>	
NICK	NEBRASKA		GENEVA	Dry	
<b>Size</b>	<b>Material</b>	<b>Sewer Use</b>	<b>Purpose</b>	<b>Length</b>	
8	Vitrified Clay Pipe	Sanitary	Routine Assessment		
<b>Comments</b>				<b>Pre-Cleaning</b>	<b>TV Length</b>
				Jetting	136.4

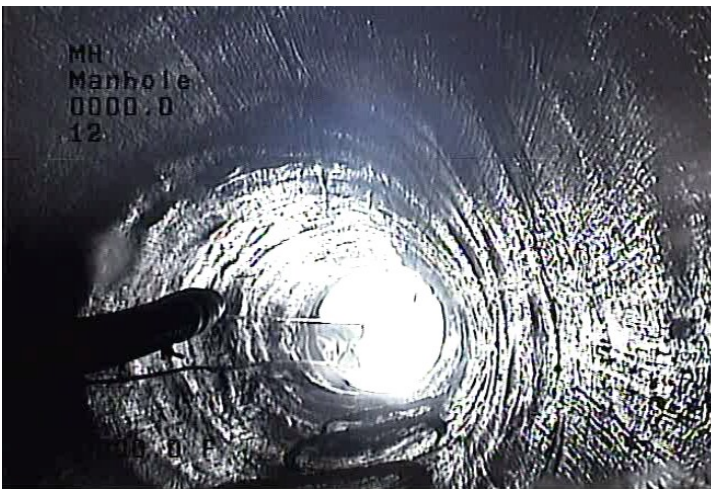
MH - Manhole @ 0.0 ft.

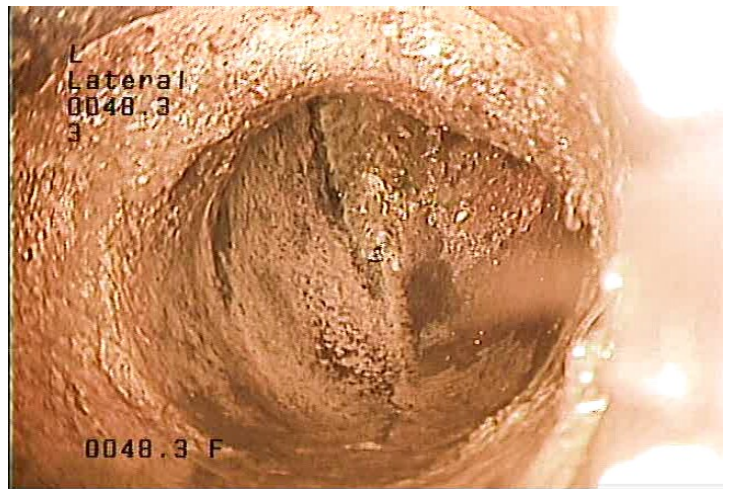
L - Lateral @ 48.3 ft.

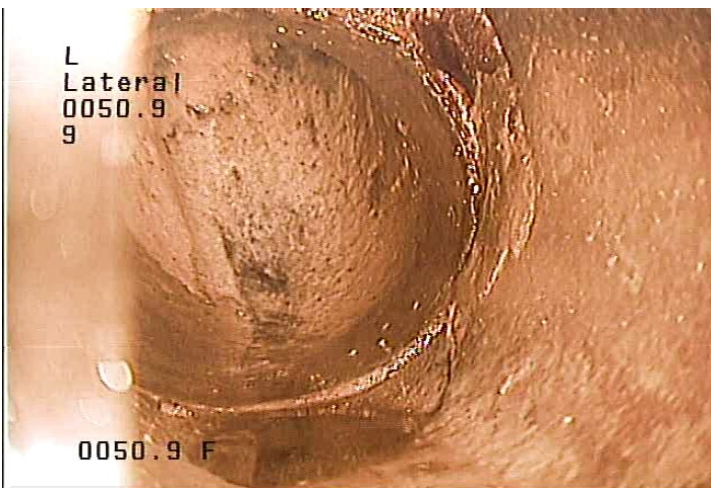
L - Lateral @ 50.9 ft.

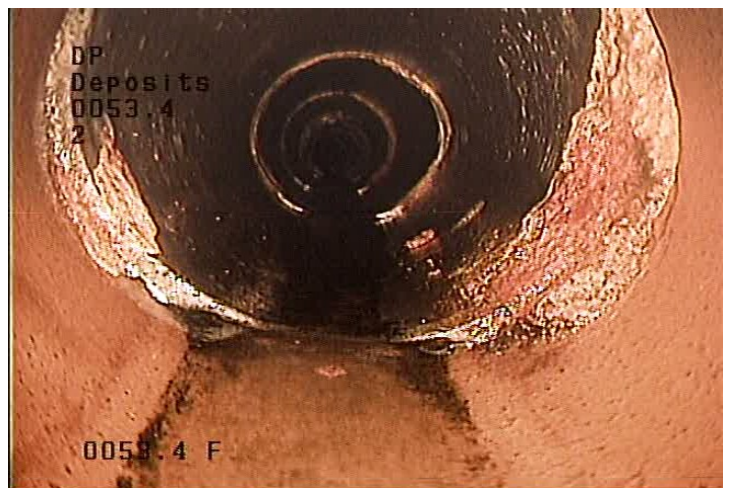
DP - Deposits @ 53.4 ft.

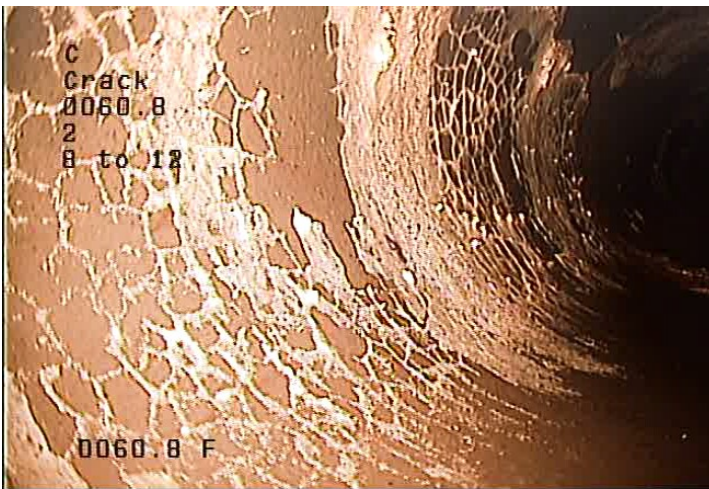
C - Crack @ 60.8 ft.

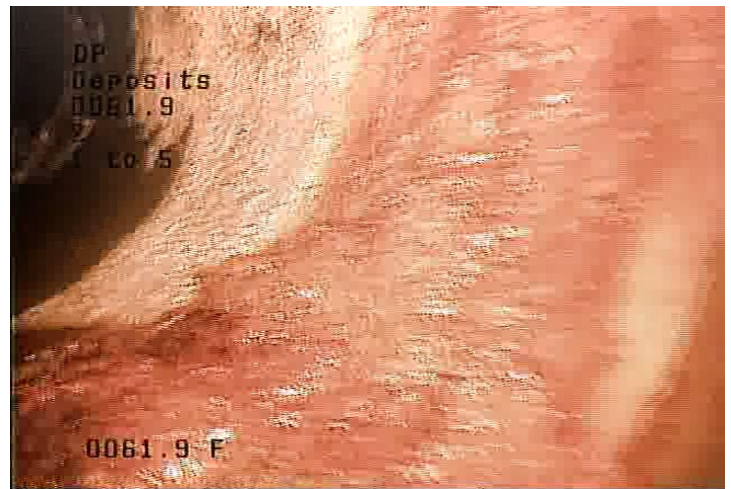
DP - Deposits @ 61.9 ft.

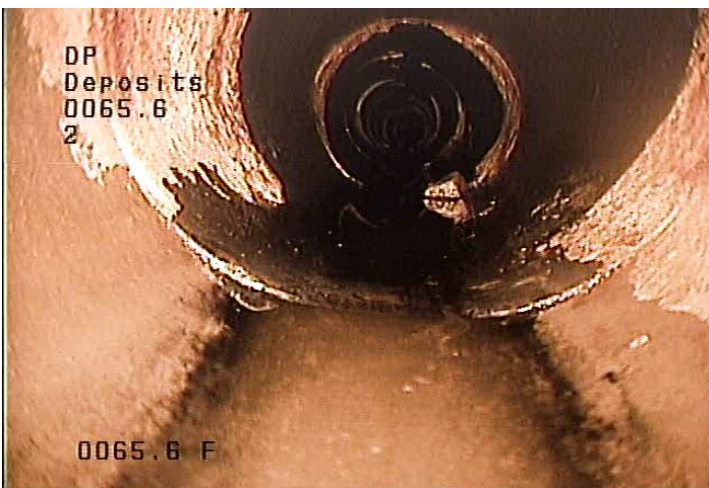
DP - Deposits @ 65.6 ft.

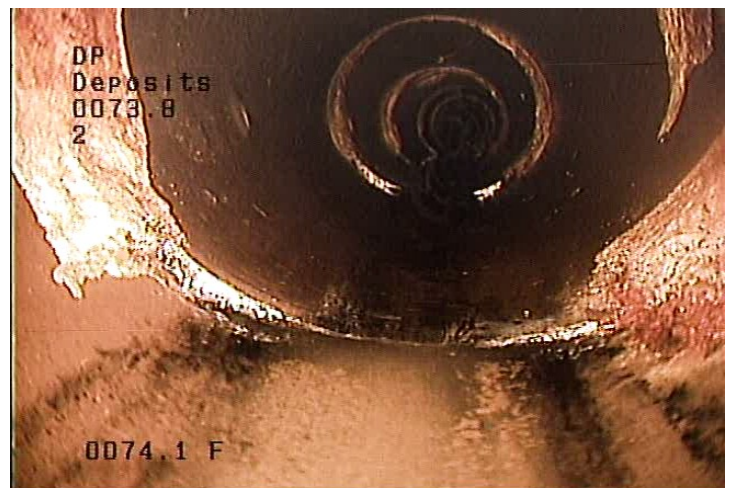
DP - Deposits @ 73.8 ft.

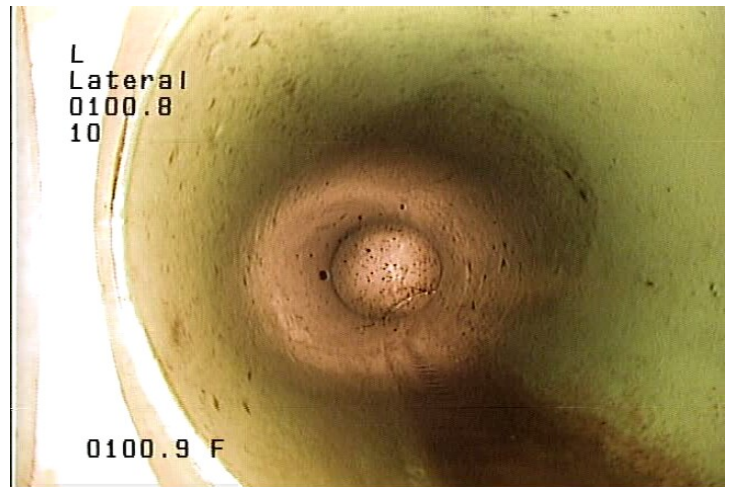
L - Lateral @ 100.8 ft.

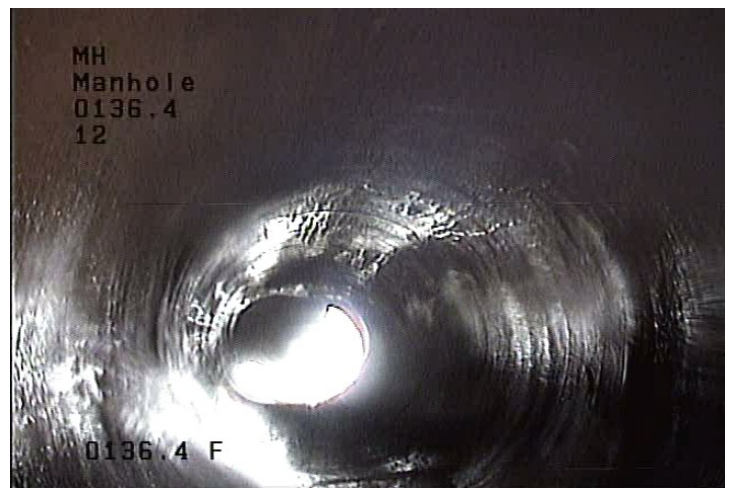
MH - Manhole @ 136.4 ft.
