<b>Owner</b>	<b>Customer</b>	<b>Upstream MH</b>	<b>Downstream MH</b>	<b>Date</b>	<b>Time</b>
		4VM12	4VM14	01-13-2021	1:41 PM
<b>Surveyor</b>	<b>Street</b>		<b>City</b>	<b>Weather</b>	
NICK	CAROLINE		GENEVA	Dry	
<b>Size</b>	<b>Material</b>	<b>Sewer Use</b>	<b>Purpose</b>	<b>Length</b>	
8	Vitrified Clay Pipe	Sanitary	Routine Assessment		
<b>Comments</b>				<b>Pre-Cleaning</b>	<b>TV Length</b>
				Jetting	210.1

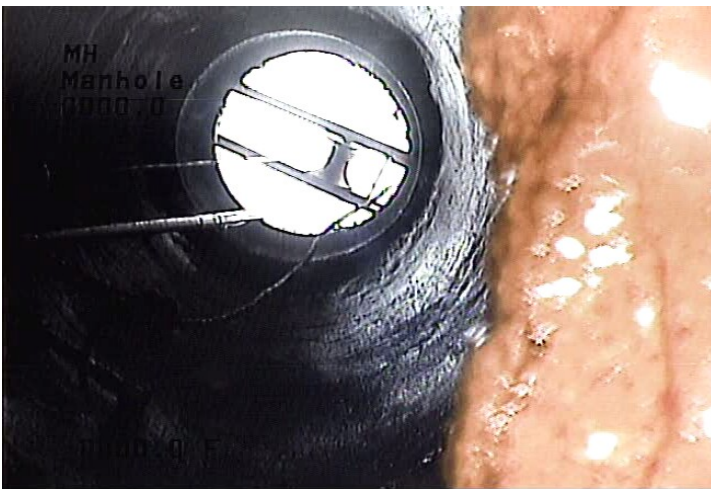
MH - Manhole @ 0.0 ft.

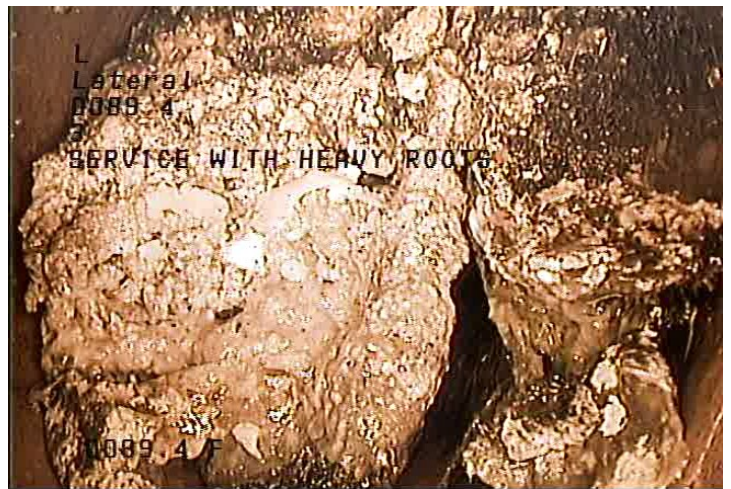
L - Lateral @ 89.4 ft. SERVICE WITH HEAVY ROOTS.

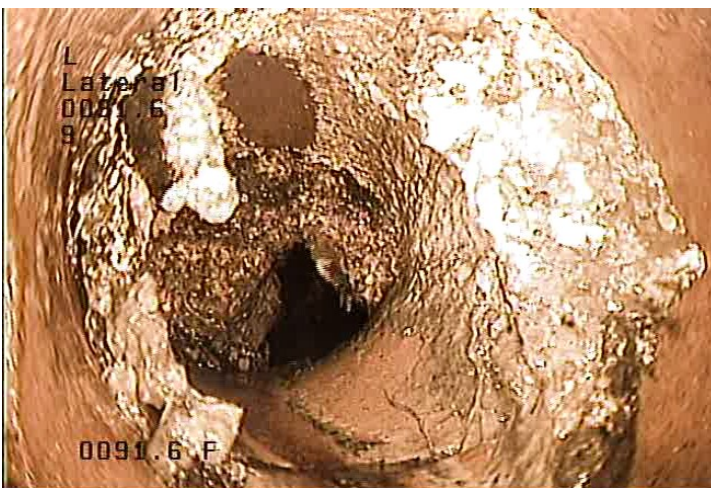
L - Lateral @ 91.6 ft.

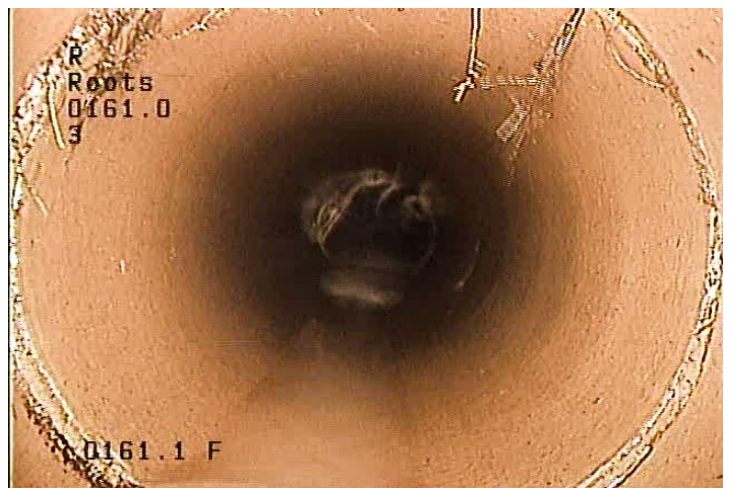
R - Roots @ 161.0 ft.

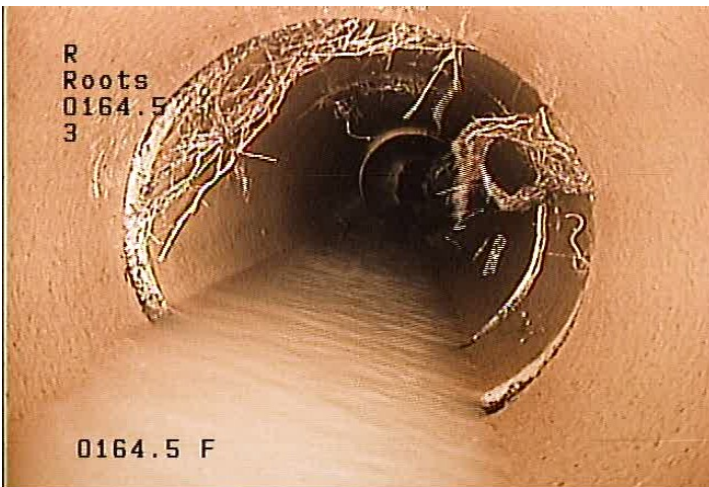
R - Roots @ 164.5 ft.

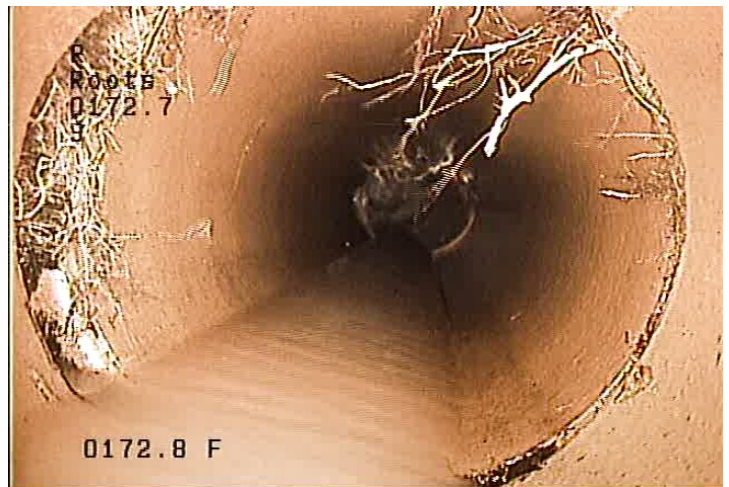
R - Roots @ 172.7 ft.

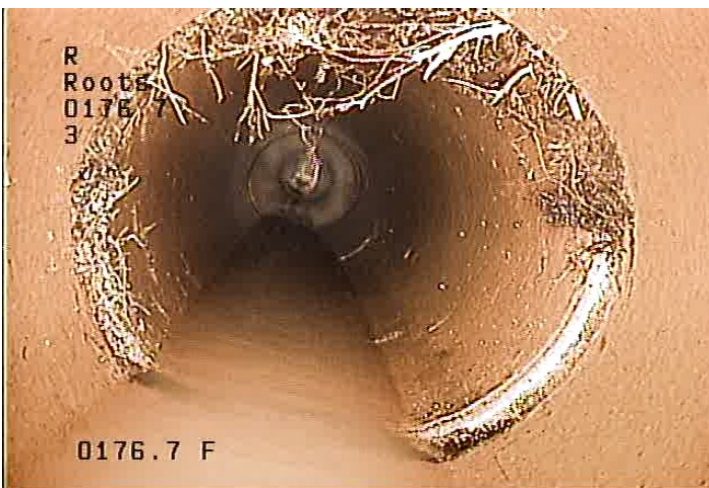
R - Roots @ 176.7 ft.

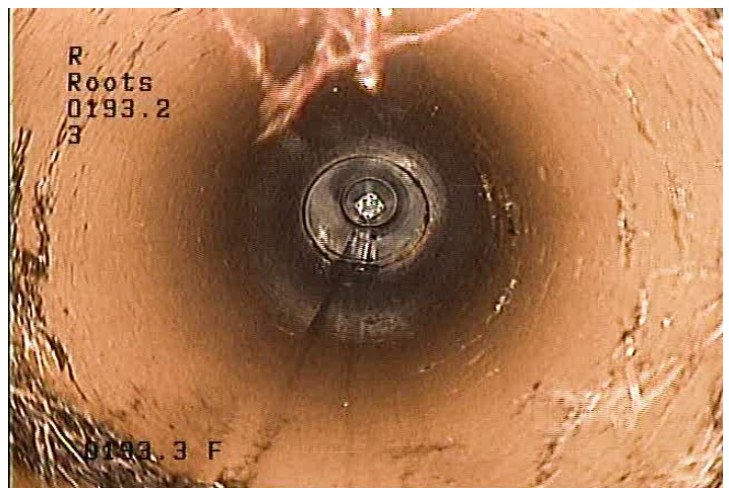
R - Roots @ 193.2 ft.

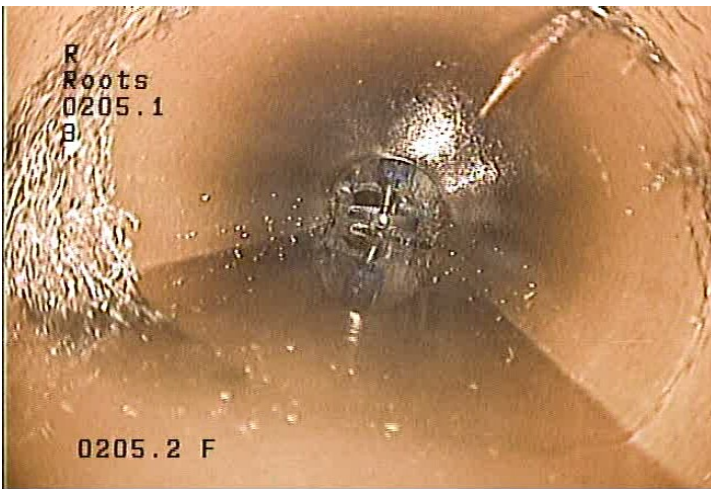
R - Roots @ 205.1 ft.

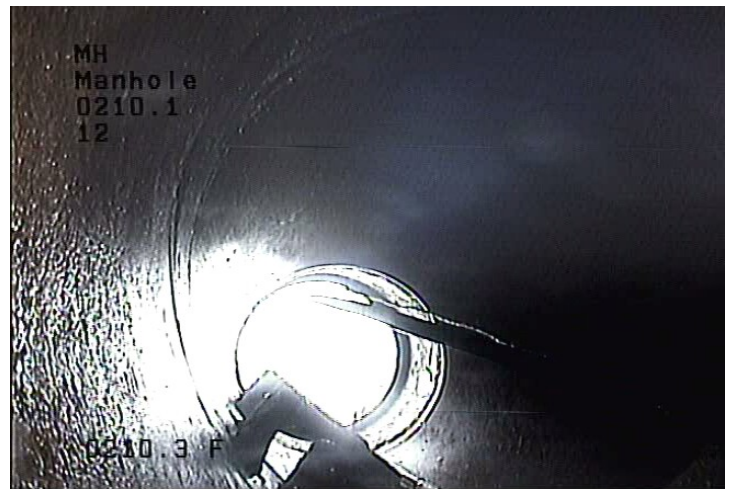
MH - Manhole @ 210.1 ft.
