<b>Owner</b>	<b>Customer</b>	<b>Upstream MH</b>	<b>Downstream MH</b>	<b>Date</b>	<b>Time</b>
		4VM14	4VM20	01-14-2021	8:07 AM
<b>Surveyor</b>	<b>Street</b>		<b>City</b>	<b>Weather</b>	
NICK	CAROLINE		GENEVA	Dry	
<b>Size</b>	<b>Material</b>	<b>Sewer Use</b>	<b>Purpose</b>	<b>Length</b>	
8	Vitrified Clay Pipe	Sanitary	Routine Assessment		
<b>Comments</b>				<b>Pre-Cleaning</b>	<b>TV Length</b>
				Jetting	203

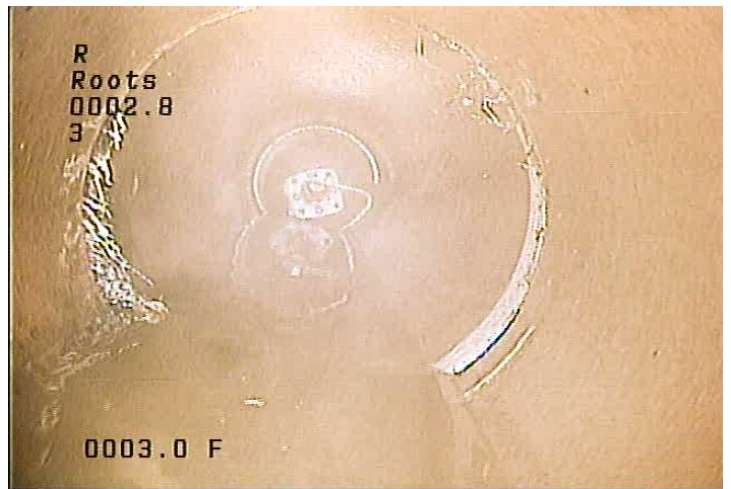
R - Roots @ 2.8 ft.

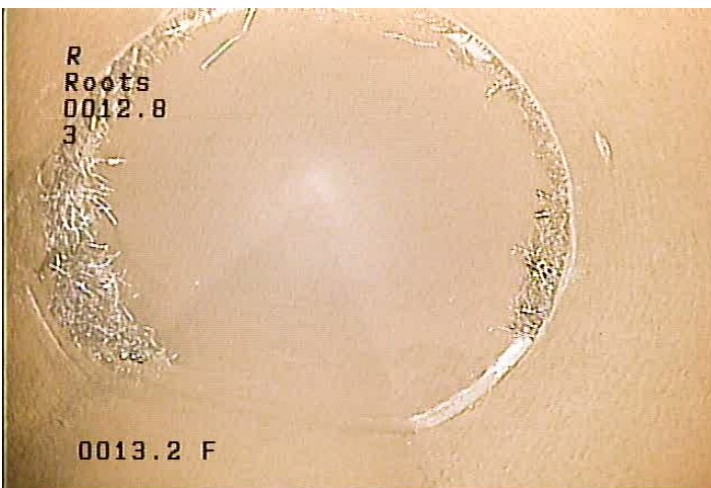
R - Roots @ 12.8 ft.

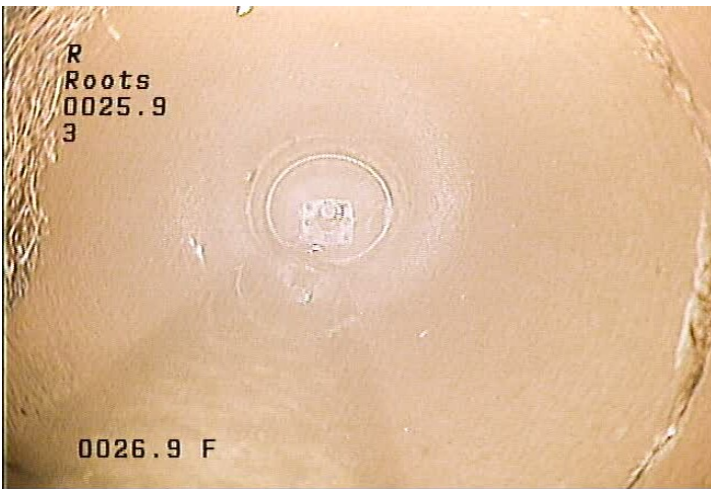
R - Roots @ 25.9 ft.

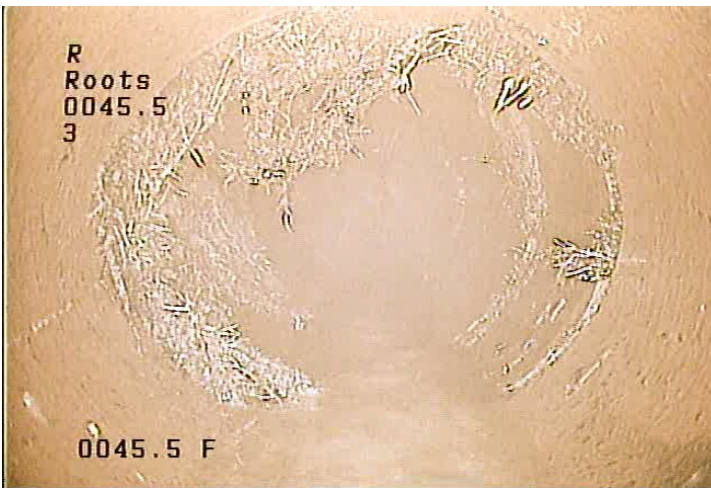
R - Roots @ 45.5 ft.

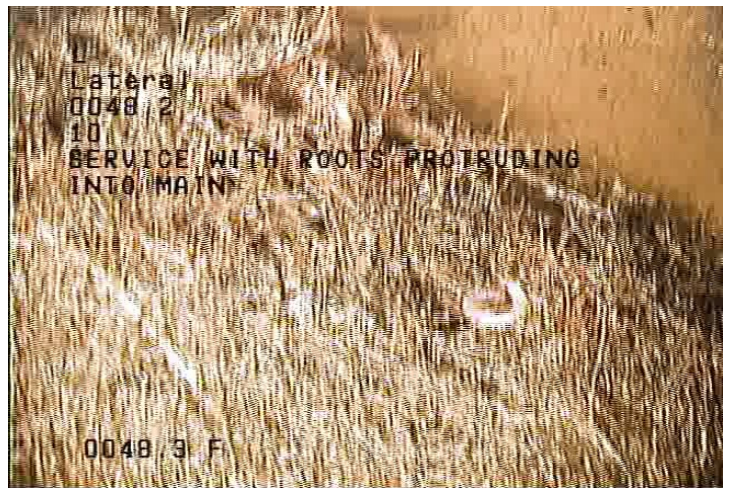
L - Lateral @ 48.2 ft. SERVICE WITH ROOTS PROTRUDING INTO MAIN

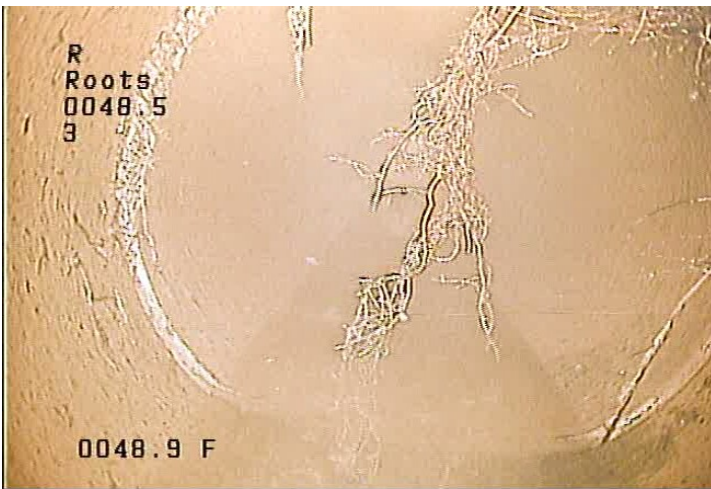
R - Roots @ 48.5 ft.

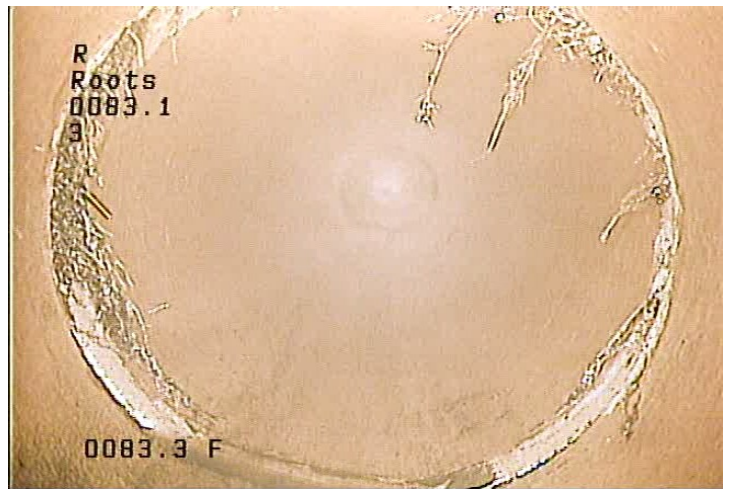
R - Roots @ 83.1 ft.

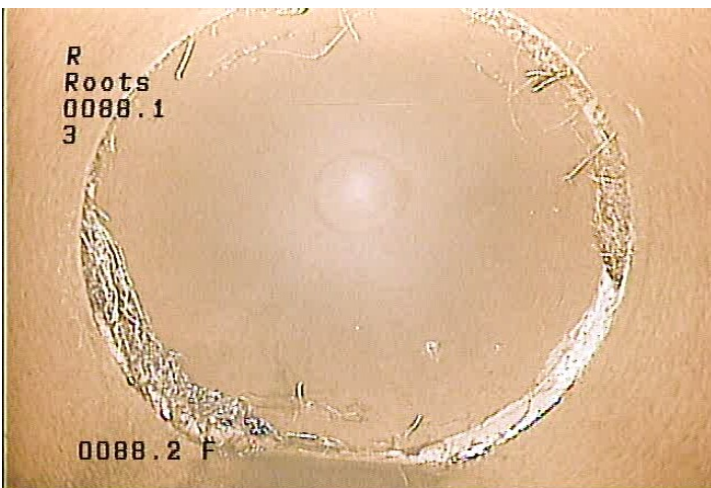
R - Roots @ 88.1 ft.

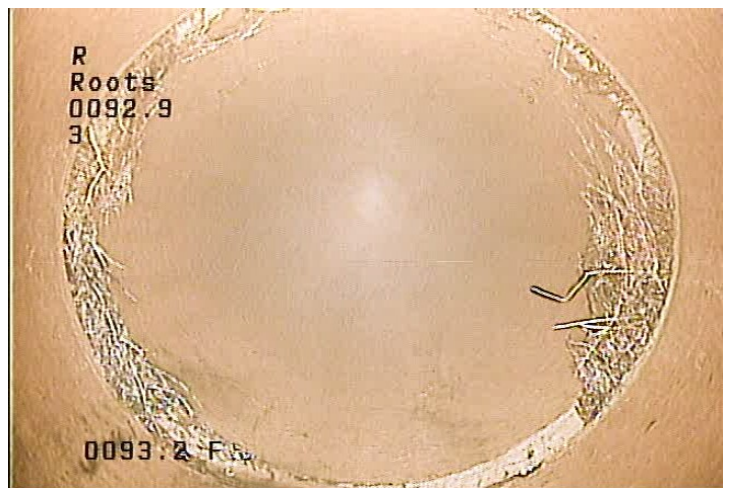
R - Roots @ 92.9 ft.

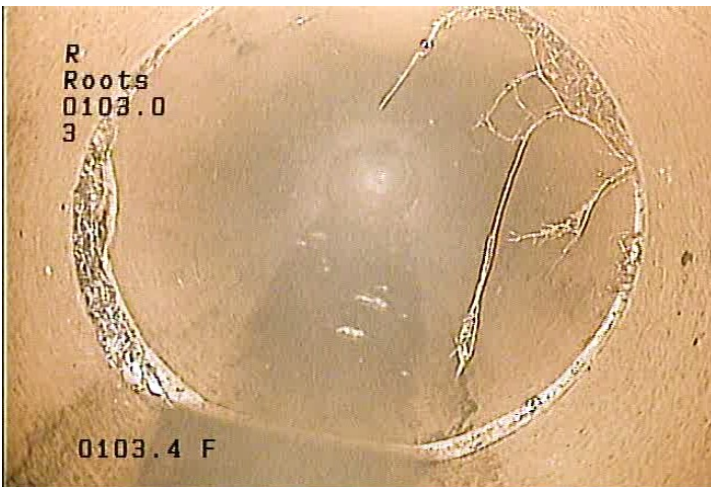
R - Roots @ 103.0 ft.

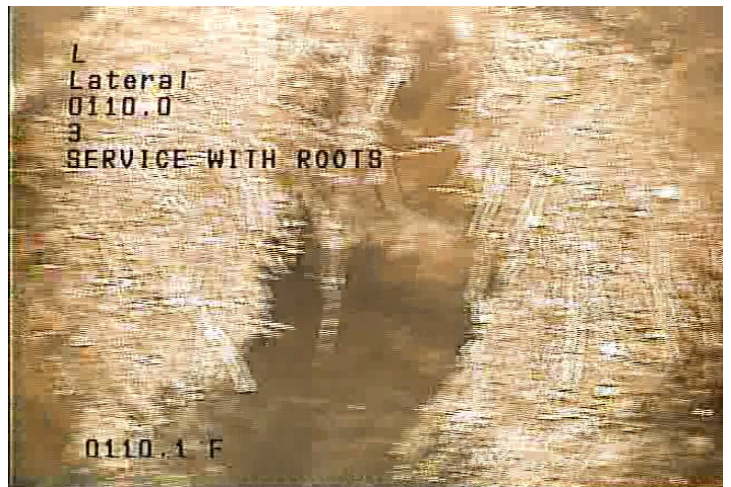
L - Lateral @ 110.0 ft. SERVICE WITH ROOTS
