<b>Drainage Area</b>	<b>Street</b>	SIMPSON
<b>Pipe Segment Ref.</b> 3VM43-4VM06	<b>City</b>	GENEVA
<b>Location Code</b>		
<b>Location Details</b>

# PACP Inspection Report

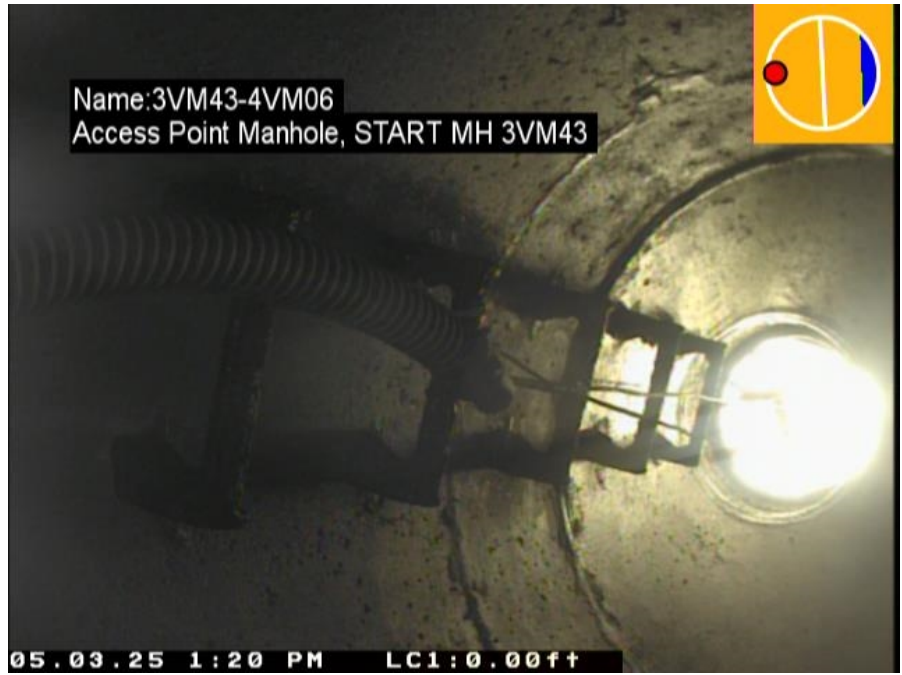
**Image Ref.** 001

Access Point Manhole, START MH  
3VM43

**Video** 00:00:00  
**Dist. downstream** 0.00 ft  
**Code** AMH  
**C. Location**

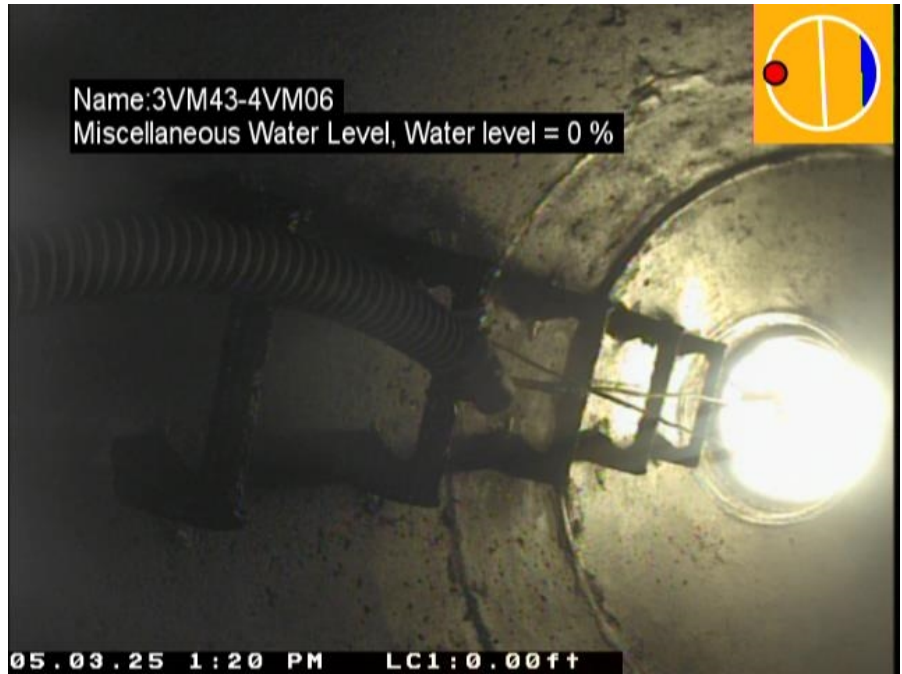
**Image Ref.** 002

Miscellaneous Water Level, Water  
level = 0 %

**Video** 00:00:03  
**Dist. downstream** 0.00 ft  
**Code** MWL  
**C. Location**

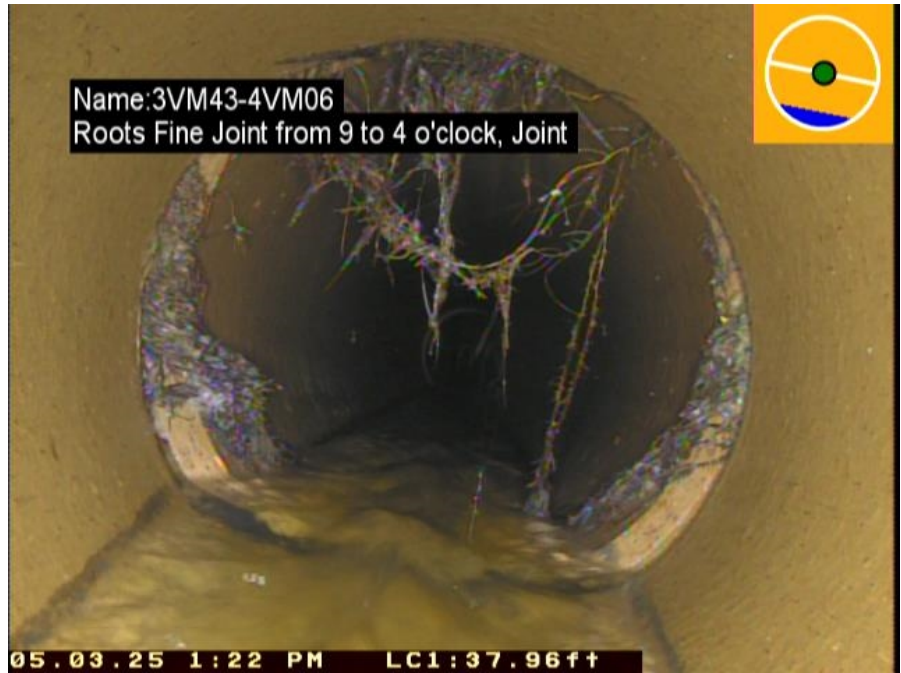
**Image Ref.** 003

Roots Fine Joint from 9 to 4 o'clock, Joint

Video 00:01:39  
Dist. downstream 37.95 ft  
Code **RFJ**  
C. Location 09 - 04

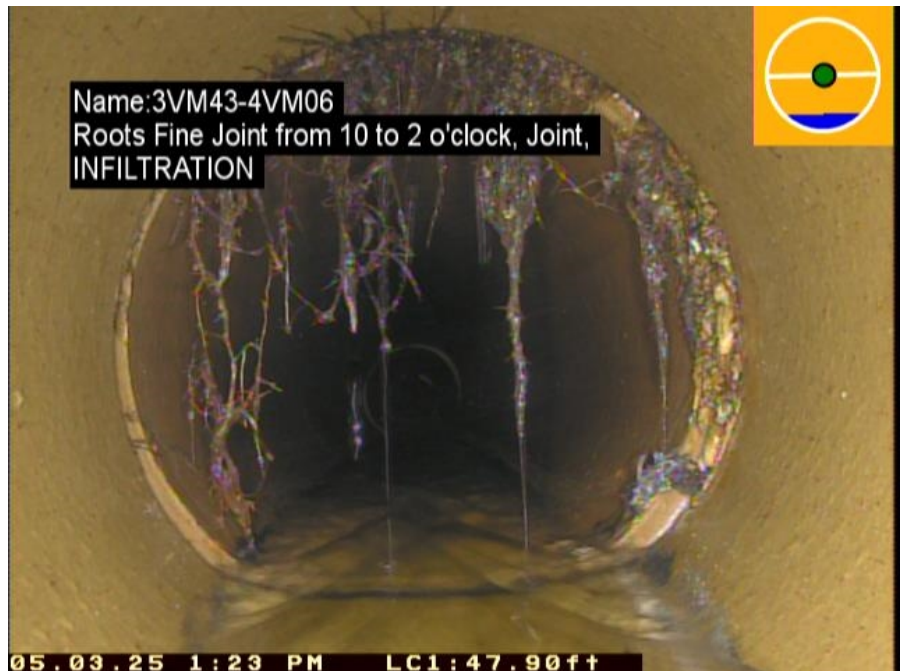
**Image Ref.** 004

Roots Fine Joint from 10 to 2 o'clock, Joint, INFILTRATION

Video 00:02:03  
Dist. downstream 47.90 ft  
Code **RFJ**  
C. Location 10 - 02

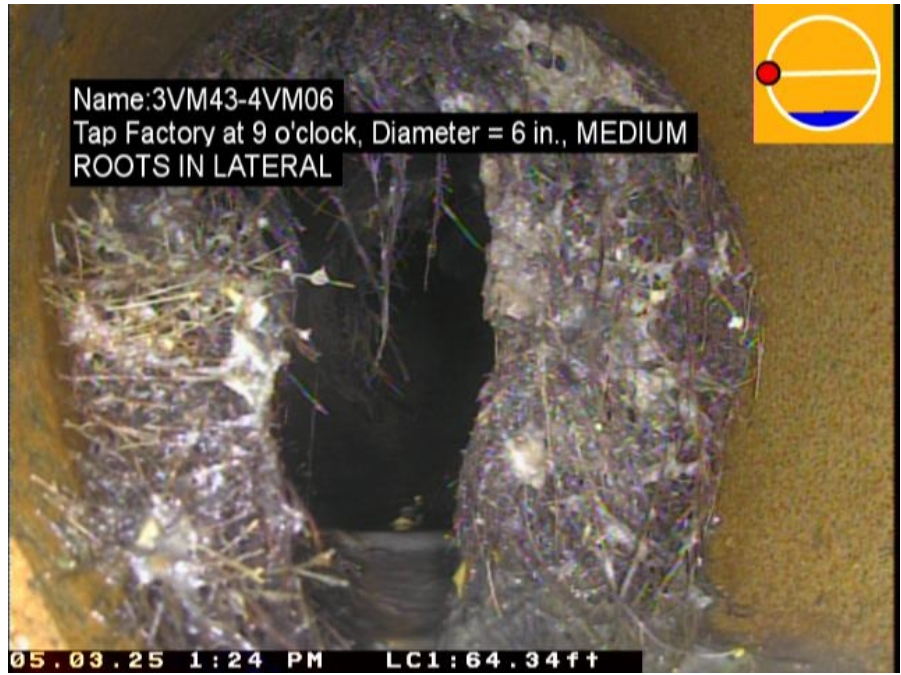
**Image Ref.** 005

Tap Factory at 9 o'clock, Diameter = 6 in., MEDIUM ROOTS IN LATERAL

**Video** 00:02:38  
**Dist. downstream** 64.33 ft  
**Code** TF  
**C. Location** 09

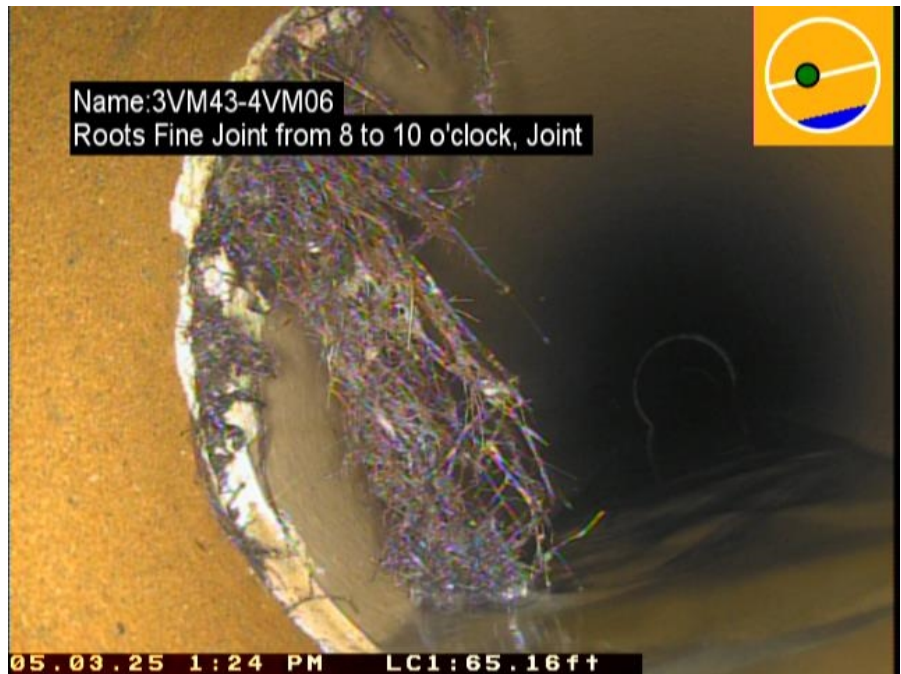
**Image Ref.** 006

Roots Fine Joint from 8 to 10 o'clock, Joint

**Video** 00:02:54  
**Dist. downstream** 65.15 ft  
**Code** RFJ  
**C. Location** 08 - 10

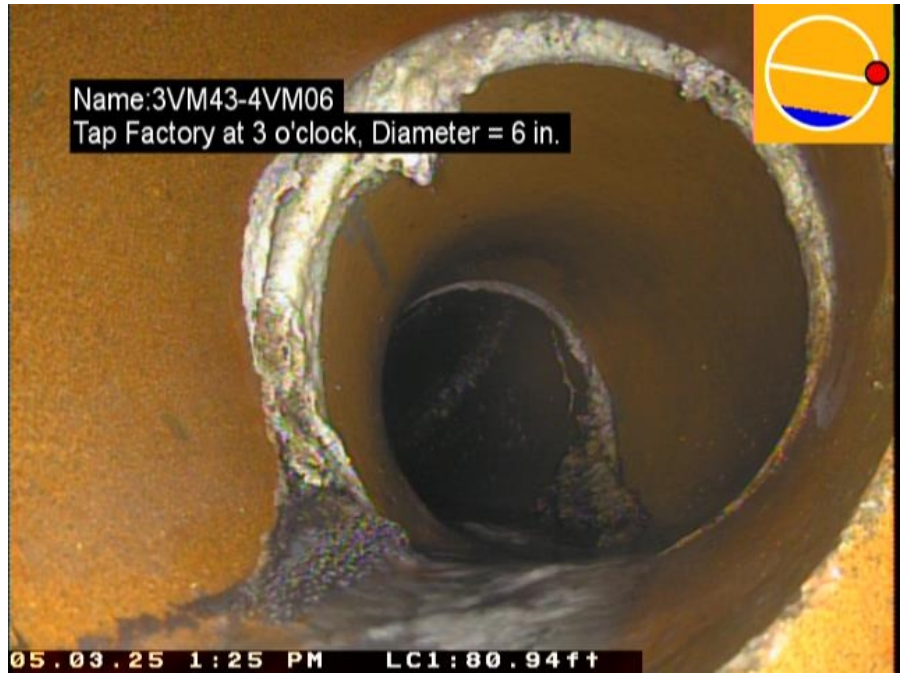
**Image Ref.** 007

Tap Factory at 3 o'clock, Diameter = 6 in.

Video 00:03:28  
 Dist. downstream 80.93 ft  
 Code TF  
 C. Location 03

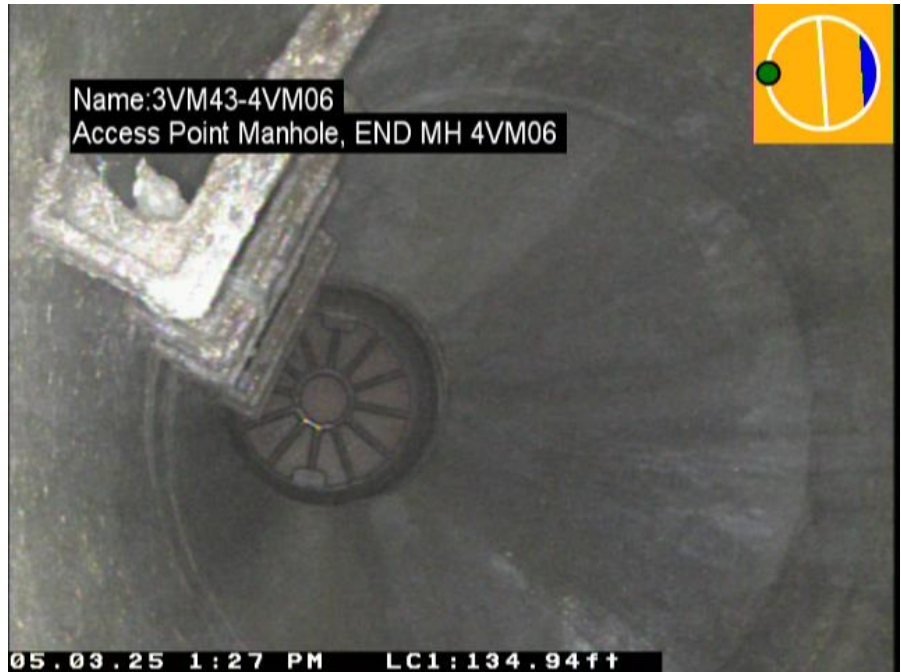
**Image Ref.** 008

Access Point Manhole, END MH 4VM06

Video 00:05:13  
 Dist. downstream 134.94 ft  
 Code AMH  
 C. Location
