Surveyors name
Certificate Number
System Owner
Survey Customer
Drainage Area
Sheet

P/O No.
Pipeline Segment Reference
Date
Time
Location (Street Name and number)
Locality

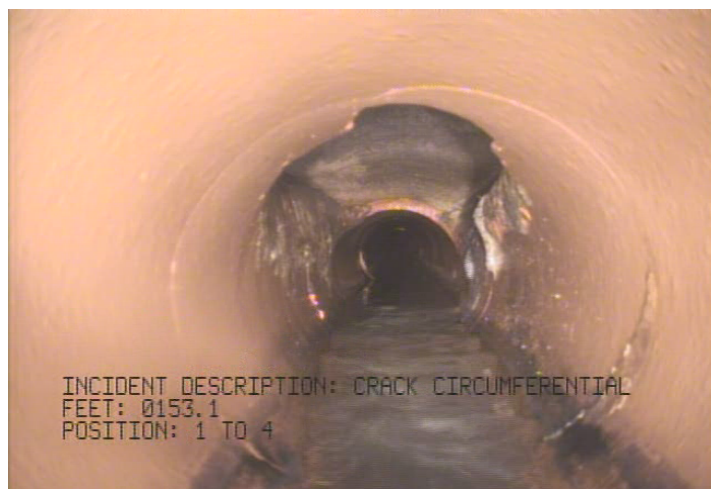
CC - Crack Circumferential @ 153.1 ft.

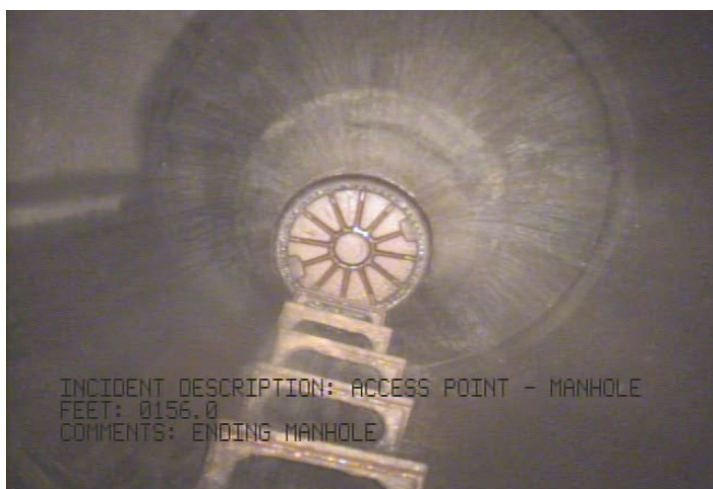
AMH - Access Point - Manhole @ 156.0 ft.
 Ending Manhole 3P-M20-S
