Surveyors name
Certificate Number
System Owner
Survey Customer
Drainage Area
Sheet

P/O No.
Pipeline Segment Reference
Date
Time
Location (Street Name and number)
Locality

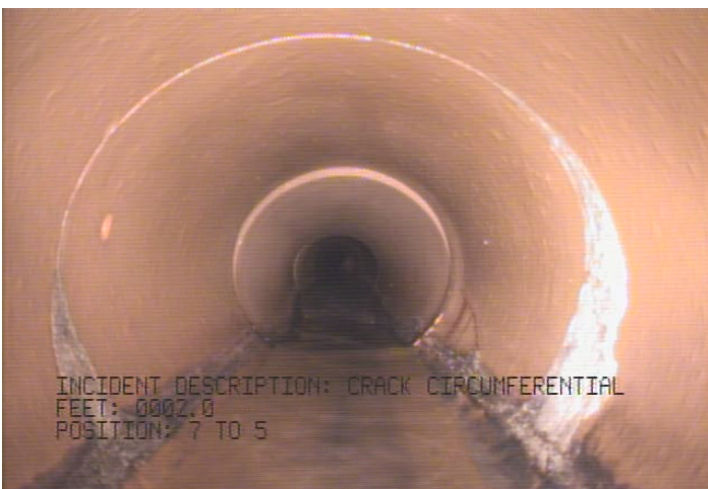
CC - Crack Circumferential @ 2.0 ft.

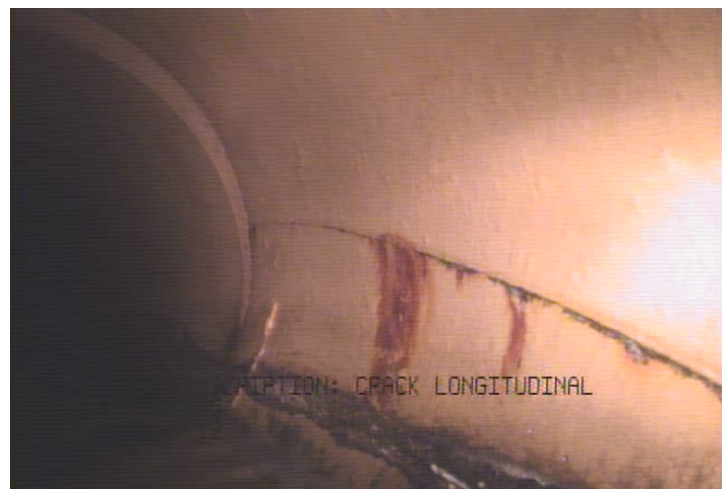
CL - Crack Longitudinal @ 4.5 ft.

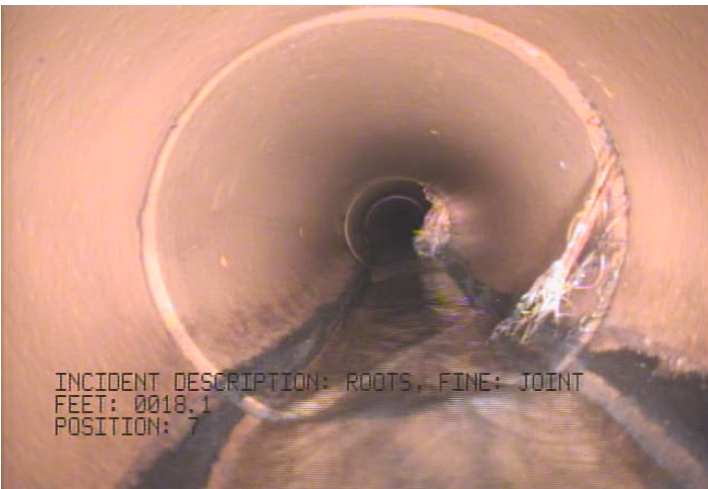
RFJ - Roots, Fine: Joint @ 18.1 ft.
