**Surveyors name** 
**Certificate Number** 
**System Owner** 
**Survey Customer** 
**Drainage Area** 
**Sheet**

**P/O No.** 
**Pipeline Segment Reference** 
**Date** 
**Time** 
**Location (Street Name and number)** 
**Locality**

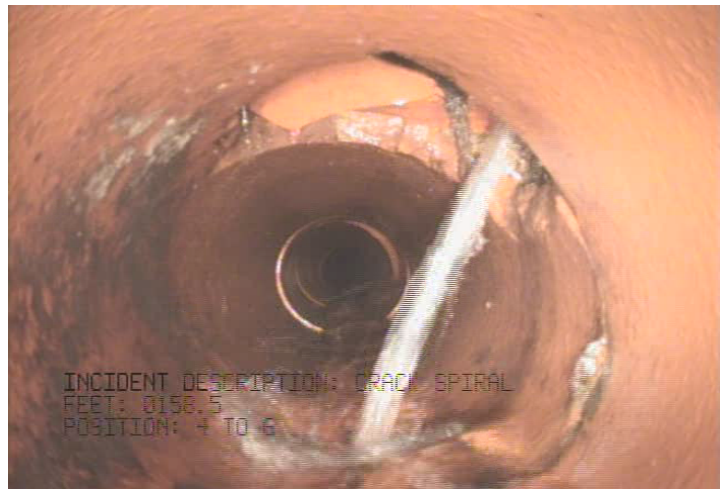
CS - Crack Spiral @ 158.5 ft.

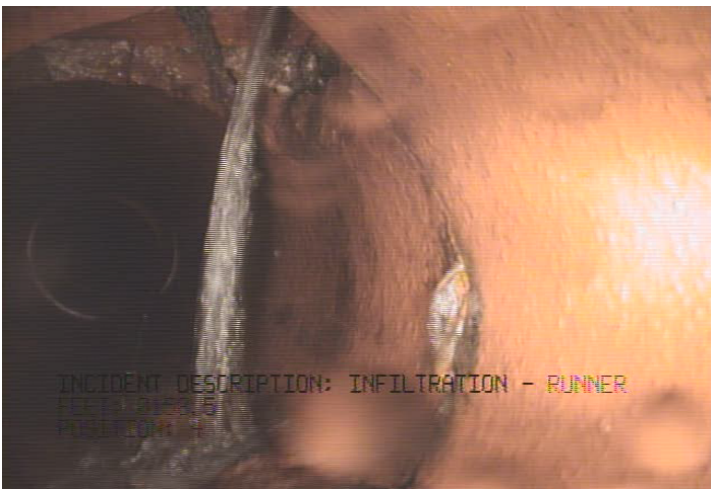
IR - Infiltration - Runner @ 158.5 ft.

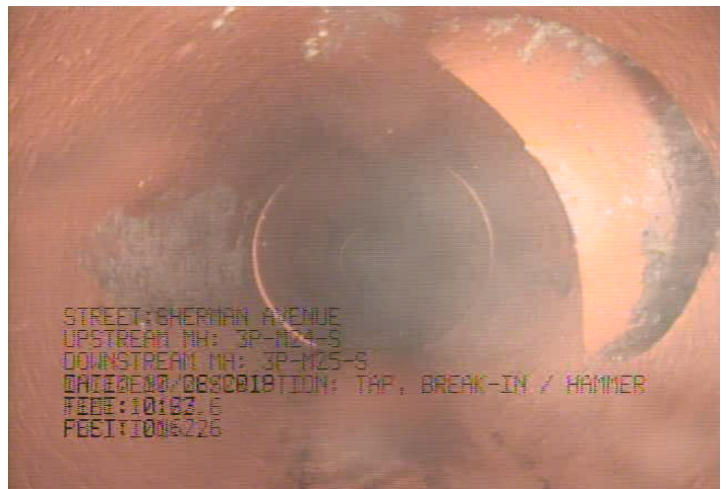
TFC - Tap, Factory Made: Capped @ 162.6 ft.

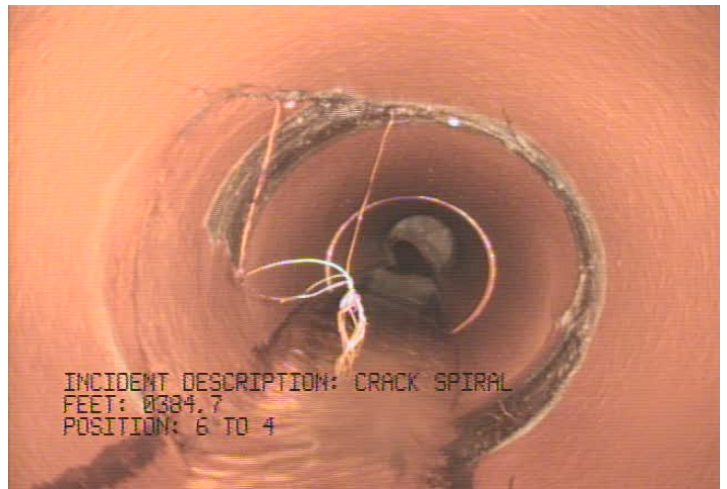
CS - Crack Spiral @ 384.7 ft.

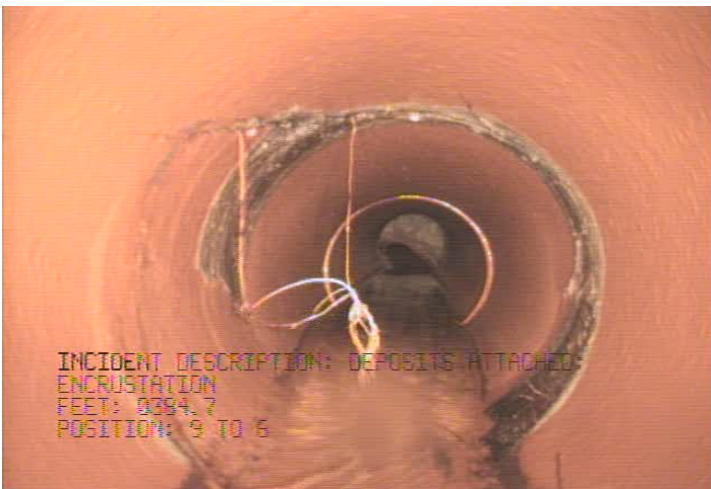
DAE - Deposits Attached: Encrustation @ 384.7 ft.

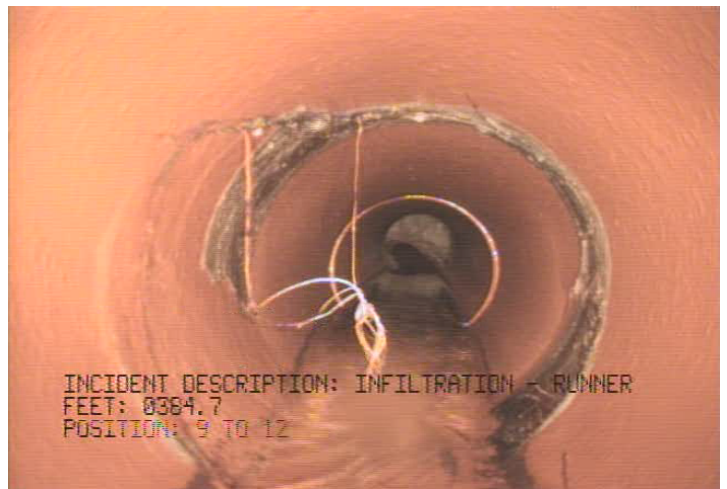
IR - Infiltration - Runner @ 384.7 ft.

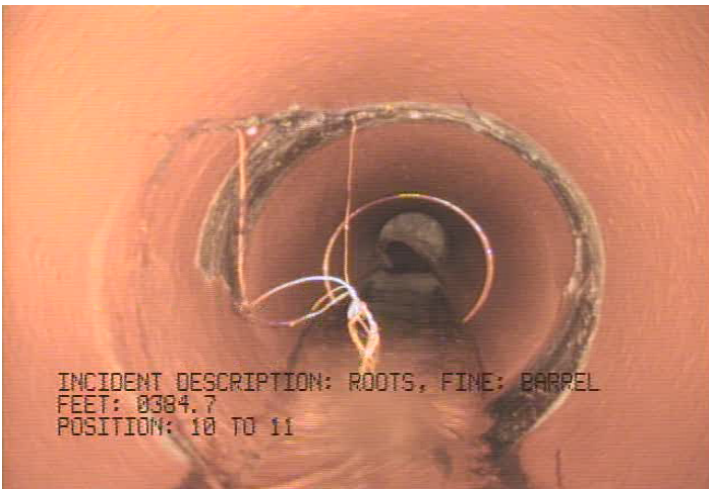
RFB - Roots, Fine: Barrel @ 384.7 ft.
