<b>Owner</b>	<b>Customer</b>	<b>Upstream MH</b>	<b>Downstream MH</b>	<b>Date</b>	<b>Time</b>
		40M09	40M08	10-24-2016	1:04 PM
<b>Surveyor</b>	<b>Street</b>		<b>City</b>	<b>Weather</b>	
john	South		Geneva	Dry	
<b>Size</b>	<b>Material</b>	<b>Sewer Use</b>	<b>Purpose</b>		<b>Length</b>
8	Clay Tile		Routine Assessment		
<b>Comments</b>				<b>Pre-Cleaning</b>	<b>TV Length</b>
				Jetting	42.6

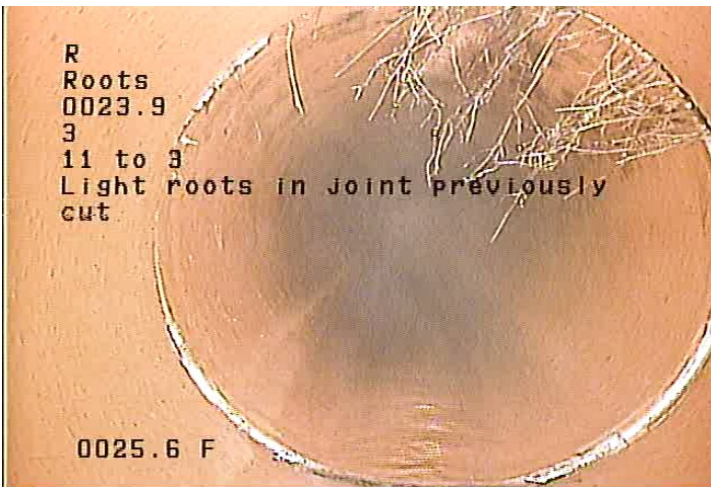
R - Roots @ 23.9 ft. Light roots in joint previously cut

Ftg.	Code	Description	Position	Severity	Comment
23.9	R	Roots	11 to 3	3	Light roots in joint previously cut
42.6	MH	Manhole			End Manhole 4OM08
