Owner	Customer	Upstream MH	Downstream MH	Date	Time
		4OM09	4OM08	10-24-2016	1:04 PM
Surveyor	Street	City	Weather		
john	South	Geneva	Dry		
Size	Material	Sewer Use	Purpose	Length	
8	Clay Tile		Routine Assessment		
Comments				Pre-Cleaning	TV Length
				Jetting	42.6

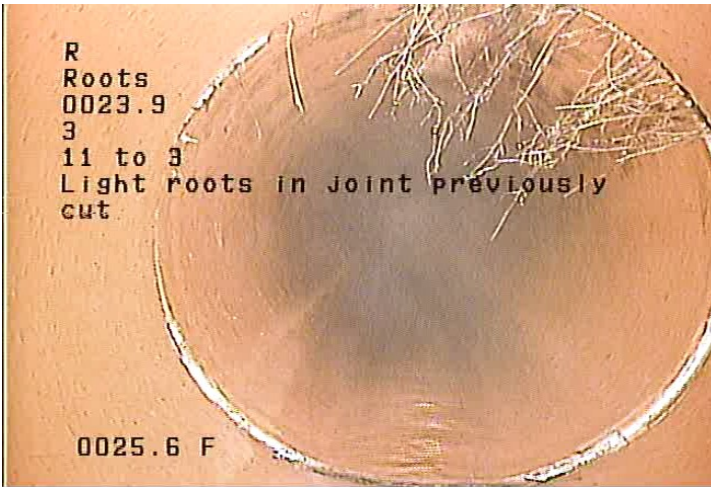
R - Roots @ 23.9 ft. Light roots in joint previously cut

Ftg.	Code	Description	Position	Severity	Comment
23.9	R	Roots	11 to 3	3	Light roots in joint previously cut
42.6	MH	Manhole			End Manhole 4OM08

23.9' [R] Roots 11 to 3 3 Light roots in joint previously cut
