Protocol of recordings

Date 24/02/2022
Recording 1RM25- 1RM37 Illinois 8 in clay downstream 2-24-2022

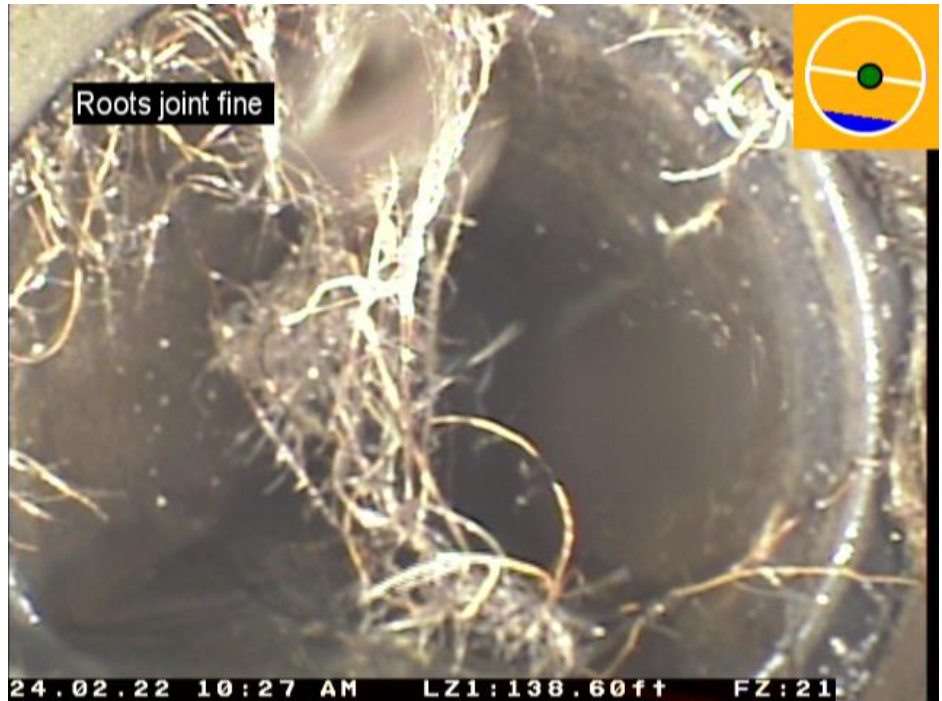
Roots joint fine

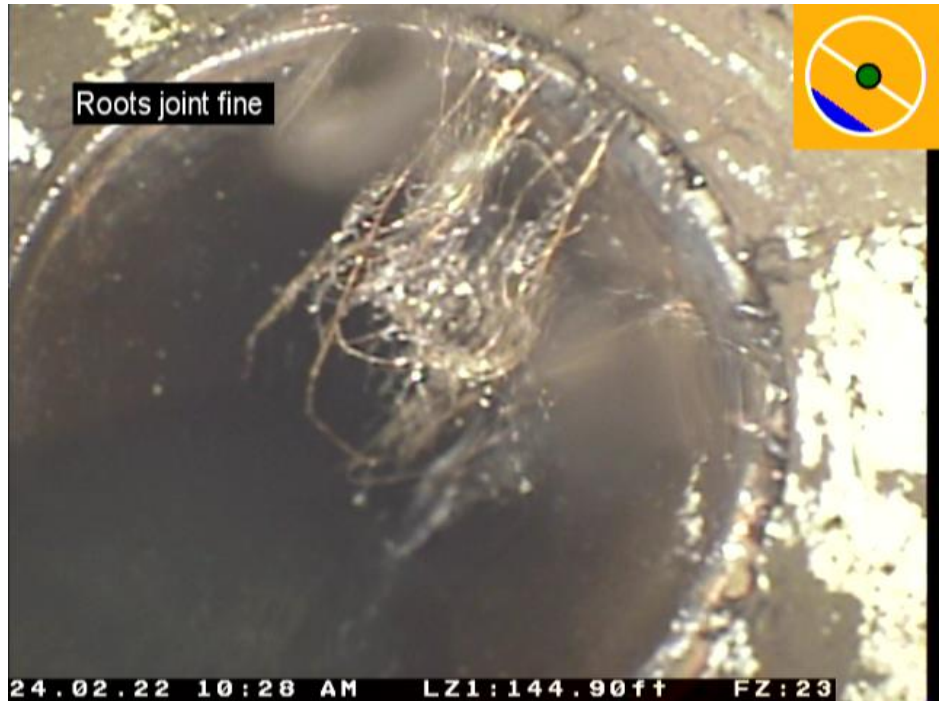
Picture 023

Roots joint fine

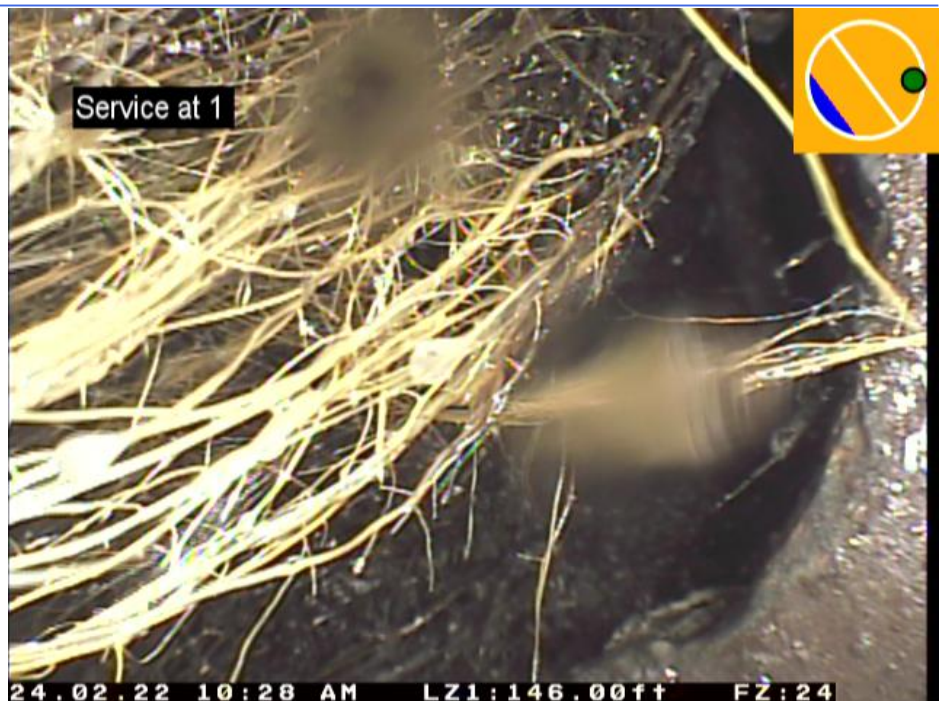
Picture 024

Service at 1

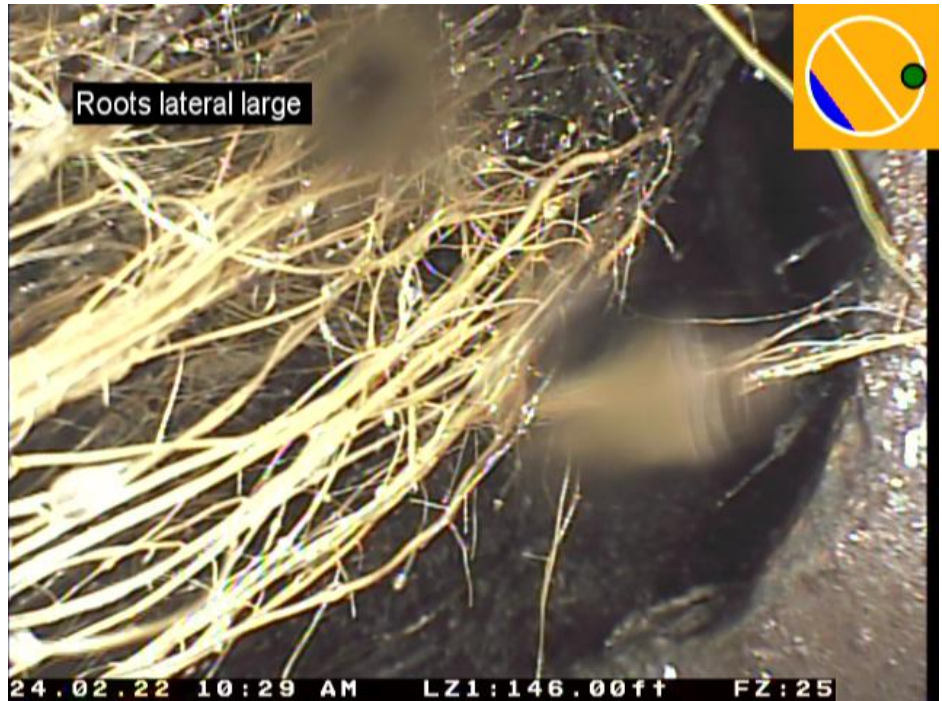
Picture 025

Roots lateral large

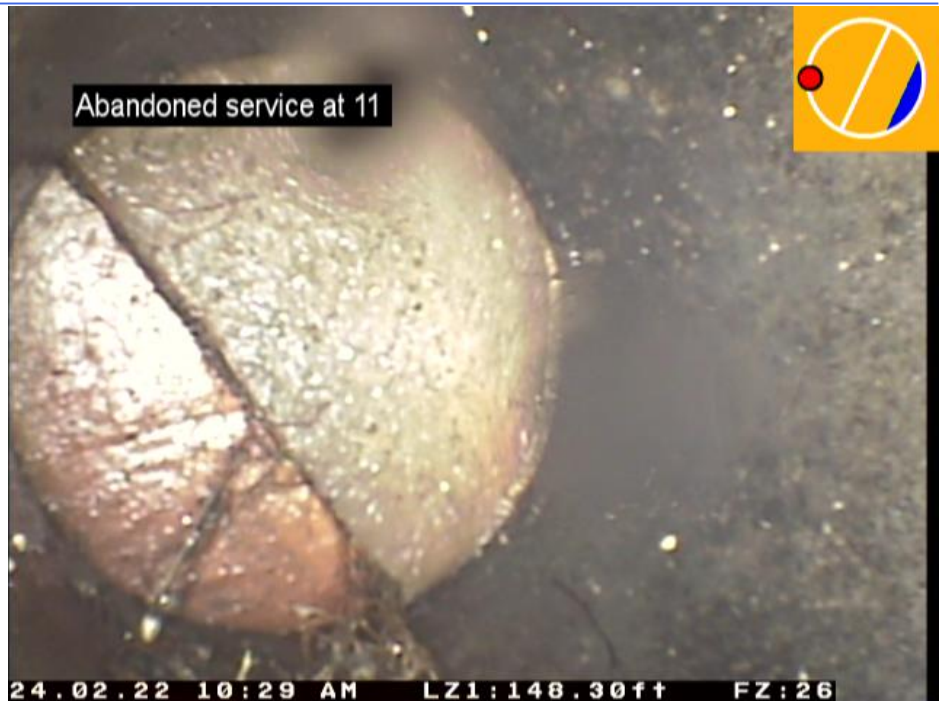
Picture 026

Abandoned service at 11

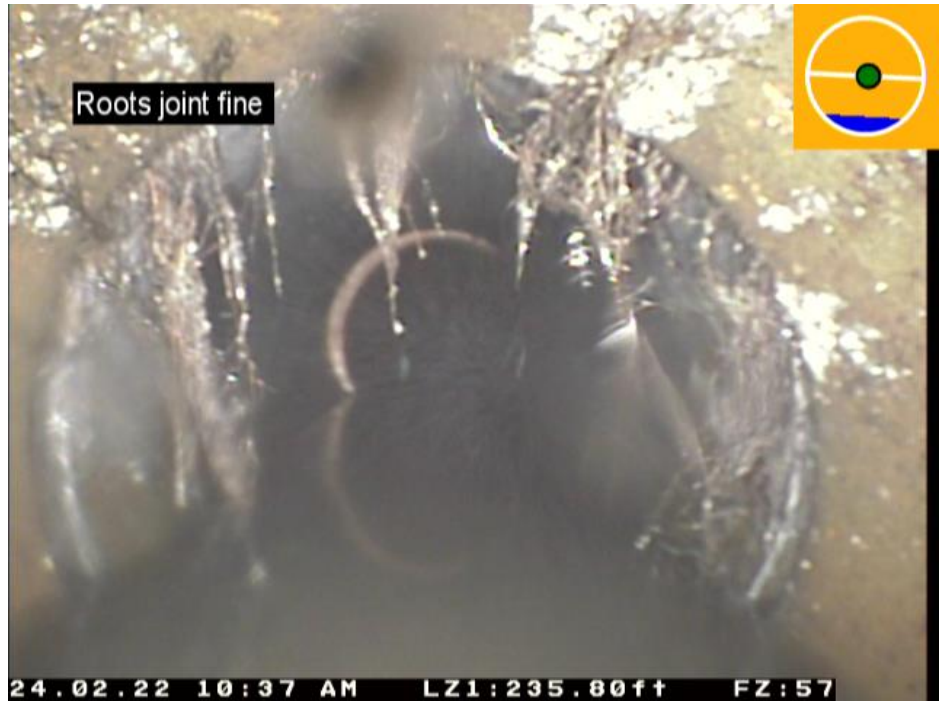
Roots joint fine

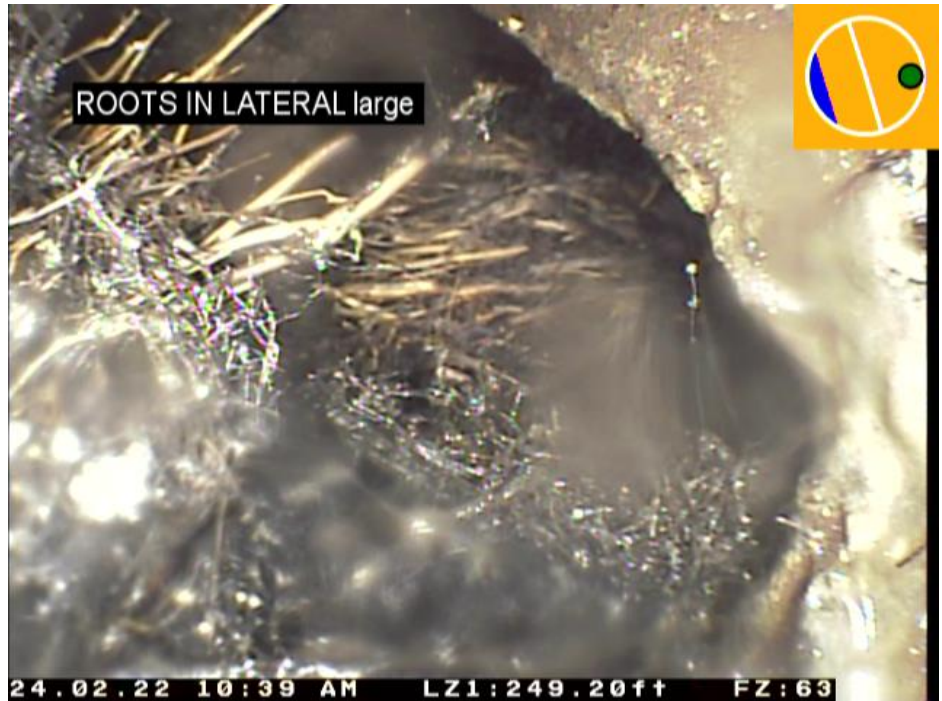
ROOTS IN LATERAL large

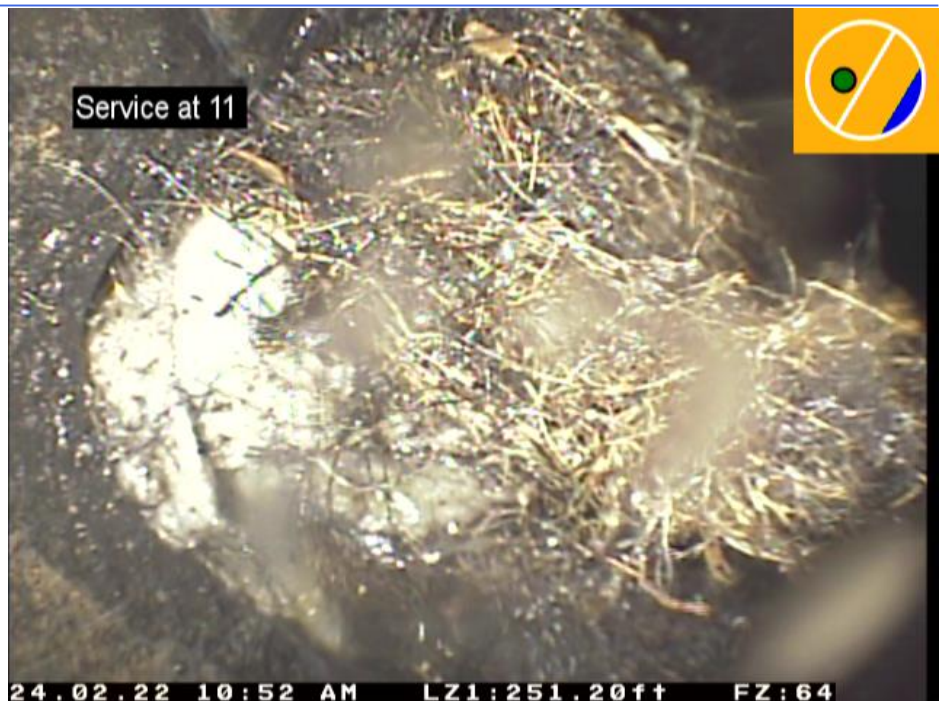
Picture 064

Service at 11

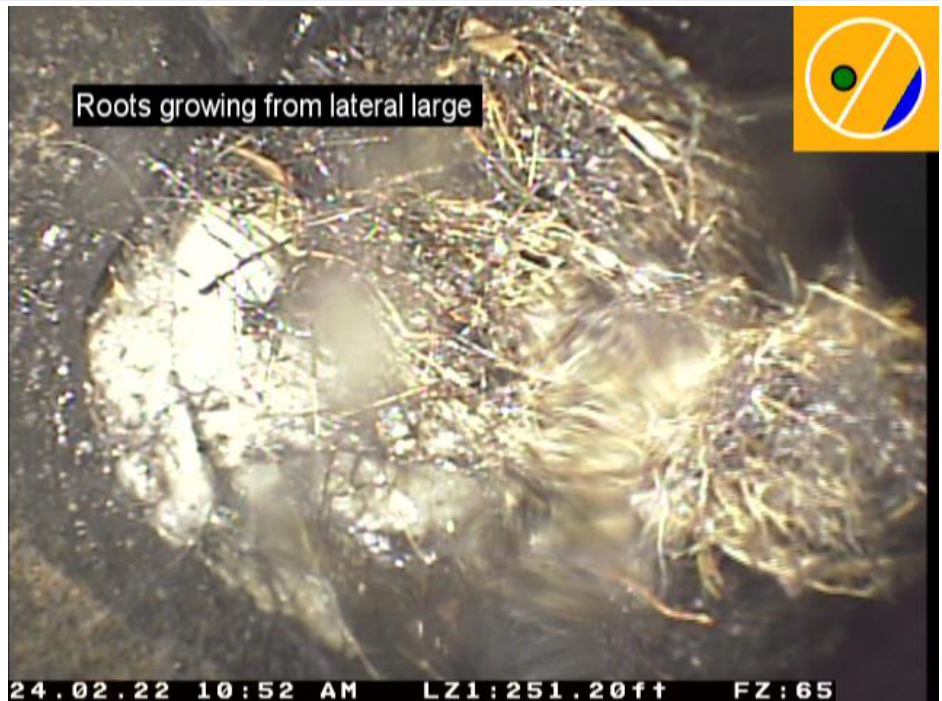
Roots growing from lateral large
